Town of Wolfeboro  
Public Safety Building

Feasibility Study Final Report  
August 8,2018

# EXISTING FACILITY CONDITIONS ASSESSMENT

WOLFEBORO PUBLIC SAFETY BUILDING - EXISTING CONDITIONS ASSESSMENT

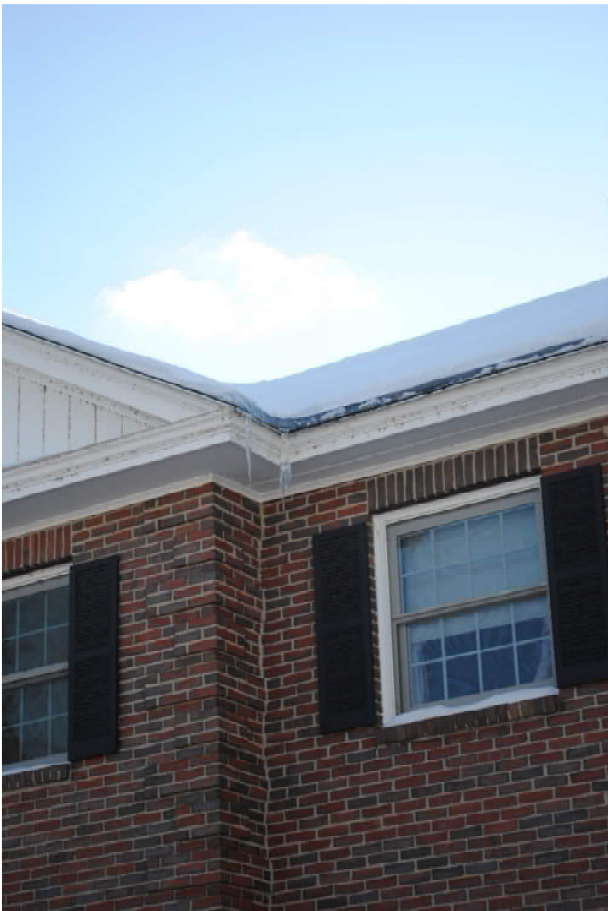
Minor ice damming on the east elevation roof in the small gable roof valleys above the public entry doors was observed. No similar conditions were observed elsewhere. Soffit venting was observed along the main roof and gable ends. Venting in the lower soffit above the masonry exterior wall was missing. In reviewing the construction drawings, the small gable roof section was built over the main roof plywood sheathing and supported by the main trusses. This creates a complex space and potentially difficult to vent. So, it is suspected that this valley ice buildup could be a result of trapped heat loss from below causing melting snow on the roof. Further study of this area might clarify what is causing this issue. Interior damage from water back-up was not apparent from inside the building. Ice damming was not observed on the west facing gable roof.

Minor ice damming at East façade roof

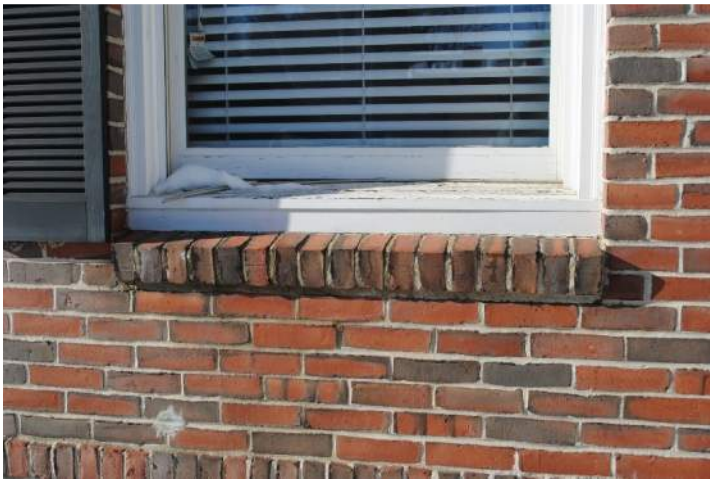
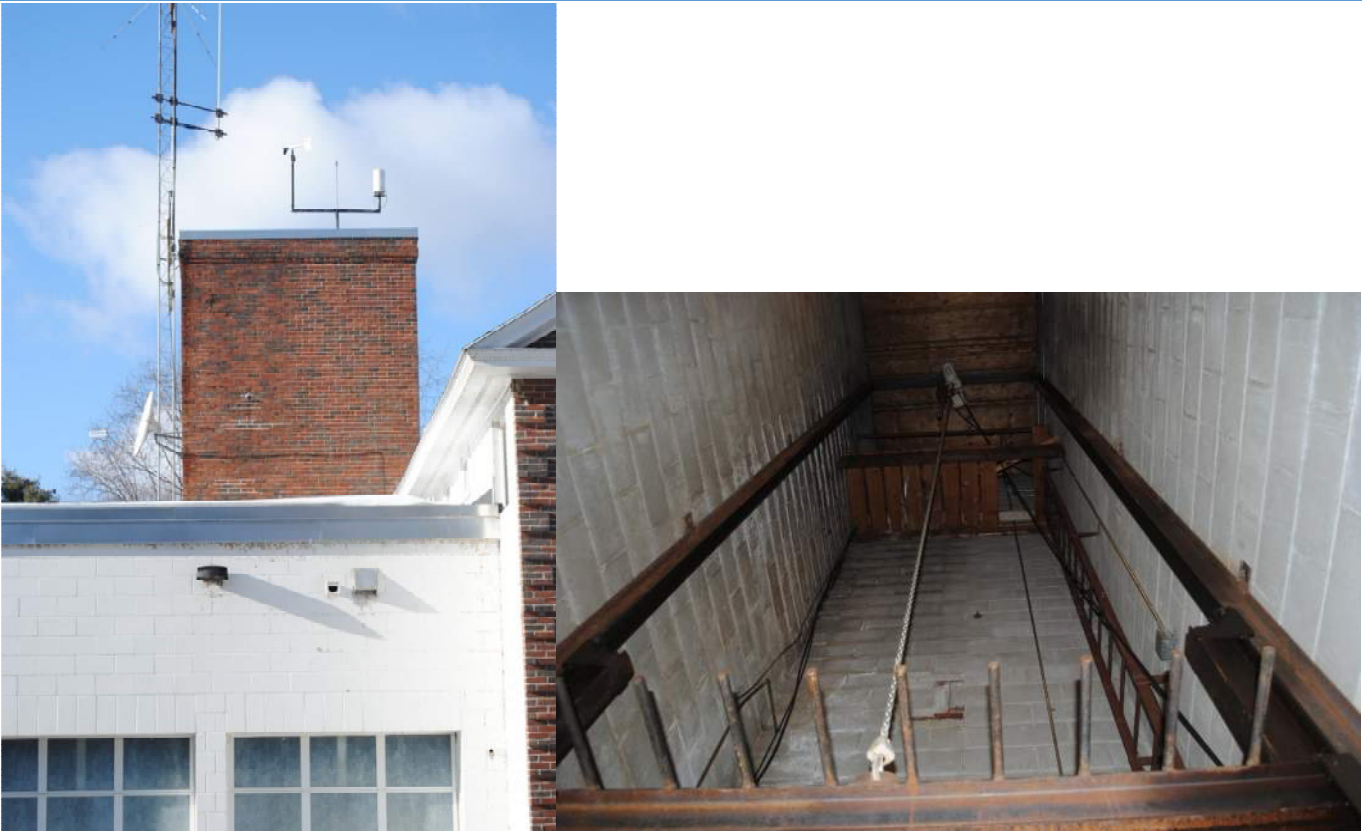
The exterior Hose Tower brick veneer was not accessible from the outside for a close review. They appear to be in good condition. According to the *Bergeron* report, the brick should have been repointed. However, it does not appear to have been repointed recently. The hose drying tower from the interior view appears to have moisture saturation on the interior concrete block surfaces on the south and west walls near the top of the shaft. This moisture could be due to warm air rising from inside the Apparatus Bay and condensing on the walls. However, this shaft is vented at the top with a wall louver on the west elevation and should relieve this possibility. A better possibility could be from a combination of roof and wall conditions. The tower roof pitch drains moisture over the roof edge allowing water to drain down the brick face. This can saturate the veneer surface and travel inside the wall. Similar moisture conditions were identified in the “*Bergeron*” report. Further review of this issue is warranted to resolve the cause of this condition.

Hose tower exterior and interior views of moisture saturation.

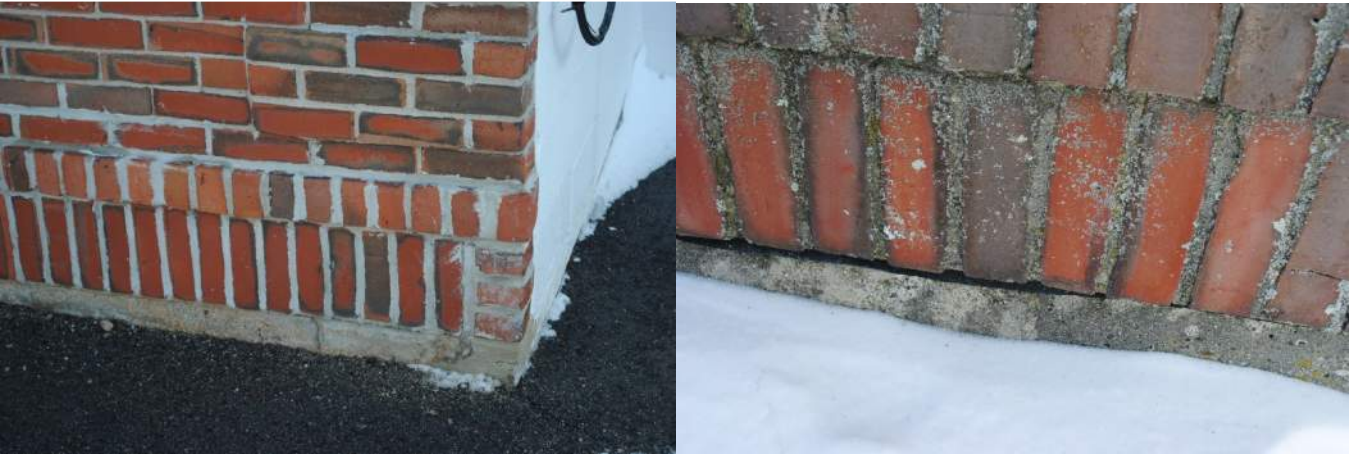
The brick veneer and mortar joints on all elevations appeared to be in good condition. There is evidence that some isolated repointing to wall mortar joints was executed. Brick sills at locations accessible to observe need some repointing where mortar has chipped and eroded. Sills see severe weathering, and should all be reviewed for attention. There is some minor build-up of liken and moss growth along the lower 16”+/- surfaces above grade only on the east elevation wall. This could be resulting of constant wetting of the brick surface from roof rain run-off and splashing up from the adjacent finish grade. This liken should be removed with a proper cleaning method. The *“Bergeron”* report recommended applying a waterproofing to all brick surfaces. If this was executed during the earlier restoration, a reapplication may be recommended following cavity weeps installation and brick cleaning.

Brick masonry previous repointing – no brick weeps

Liken growing on east façade brick.

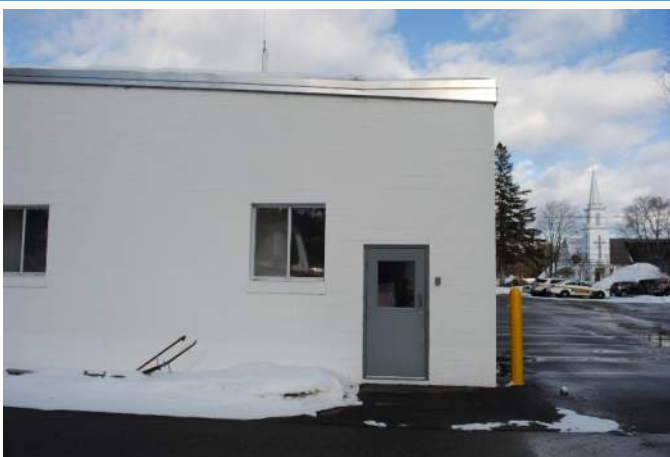
Exterior windows on the west wall of the Apparatus Bay are side-sliding aluminum frame with single pane glass. They appear to be original installed product. They look in good condition but are very poor energy efficiency performing. Considering the poor energy performance of the Apparatus Bay envelope, replacement of these windows may not prove a valued action until further overall envelop improvements are considered.

Apparatus Bay west windows

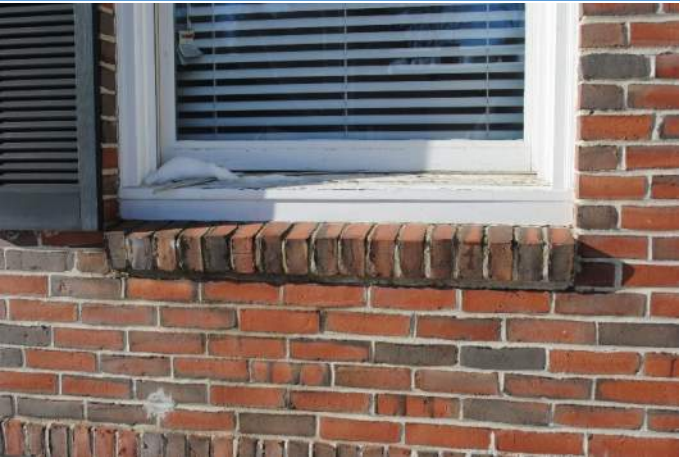
Exterior windows appear in general to be in good condition. They appear to be of a residential level quality product and expect are replacement units since the original building construction. The windows are of a thermal insulating glass and wood frame type with weather-stripping. Some conditions were observed where the bottom weather-stripping on lower sash have come free. It would be our recommendation to review all windows and replace or repair weather-stripping as necessary. Reducing air infiltration through windows is a major step in increasing building energy performance. And, this maintenance is a very cost-effective action to take. Perimeter joints between window frame and brick masonry are very important to maintain building energy efficiency as well in the reduction of air infiltration. These joints should be inspected annually and replaced about every 7+/- years. It was observed from inside the attic and outside that the south attic semi-circular window joint between frame and brick had no sealant. Although the attic is an unheated space, this opening also allows moisture into the building which can then create damage to the interior wall system along with air infiltration. It is unknown when sealant joints were last reviewed. It usually happens when wood trim is repainted. A review of all joint conditions should be scheduled to determine the full extent of repairs necessary.

Office section window weatherstripping repair

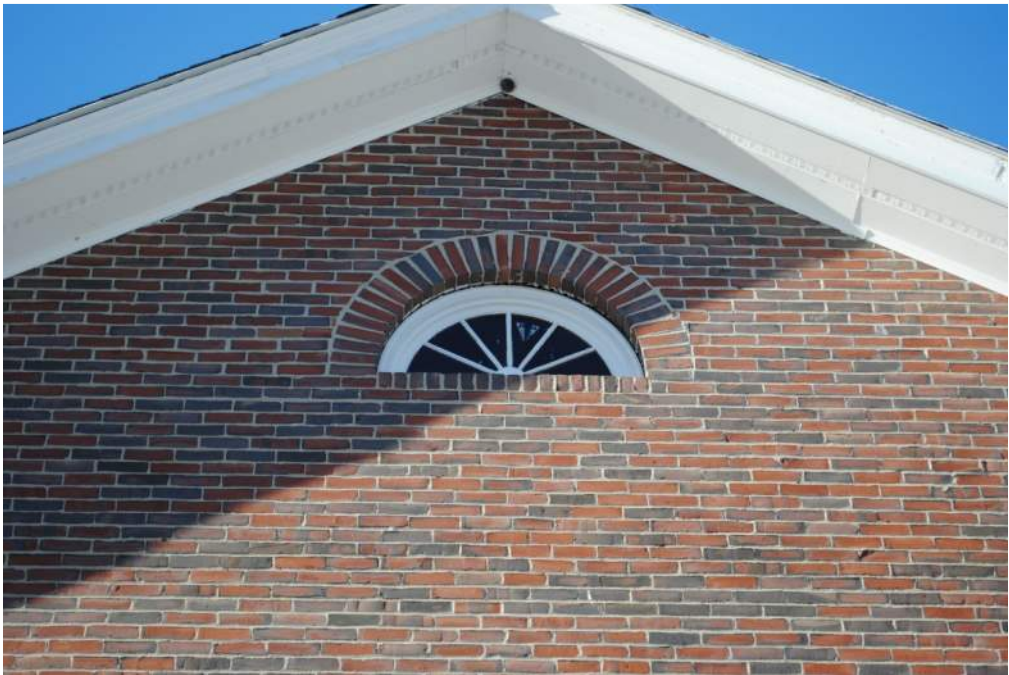
Missing sealant around window to brick joint.

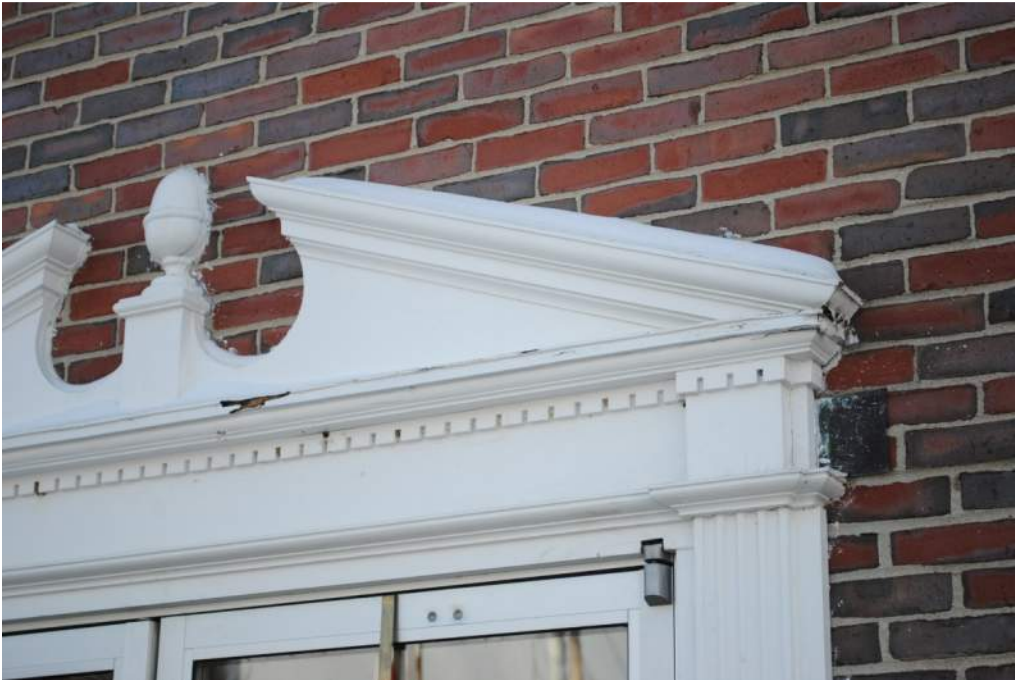
In general, all trim at roof soffits, windows and doors appear to be in good condition with no observed chipping or peeling. There are numerous insect cocoons collected on the wood surfaces. The colonial wood decorative trim over the front entry door is showing some rotting. Considering the advanced condition, it looks like this condition may have been here for a while. Moisture may be gathered on the flat top surface and soaking into the wood. Repair or replacement would be recommended.

Trim rotting above front public entry doorway

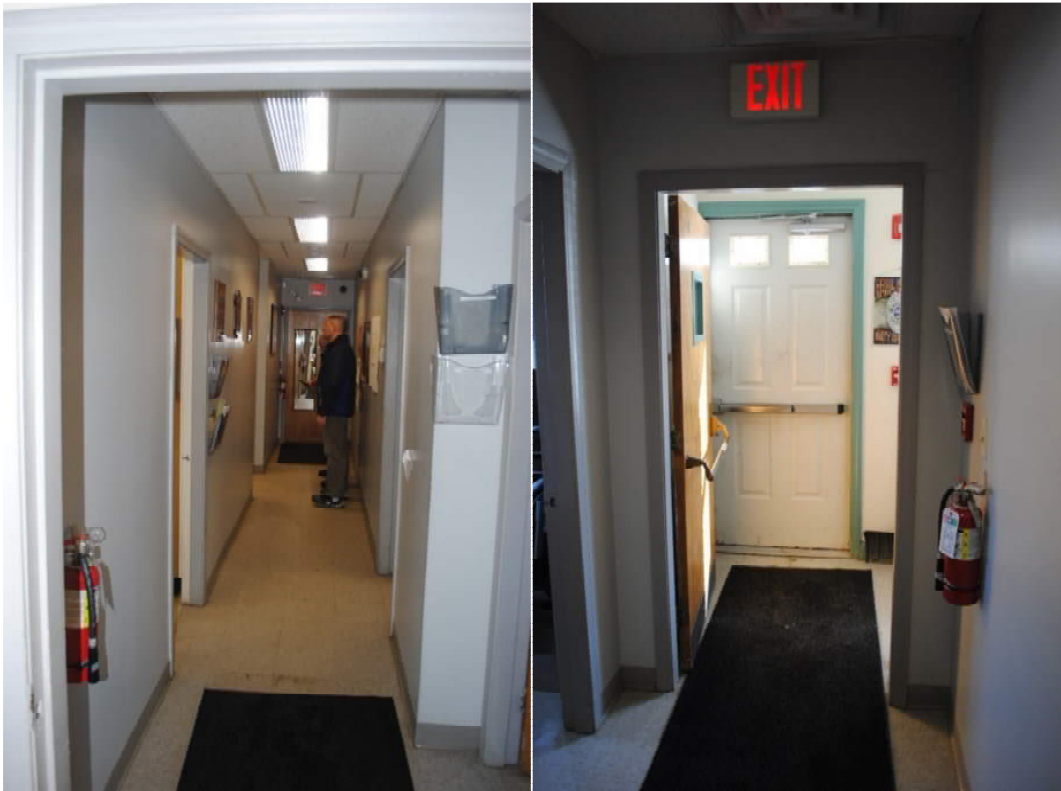
Interior finishes

Door opening missing interior closers

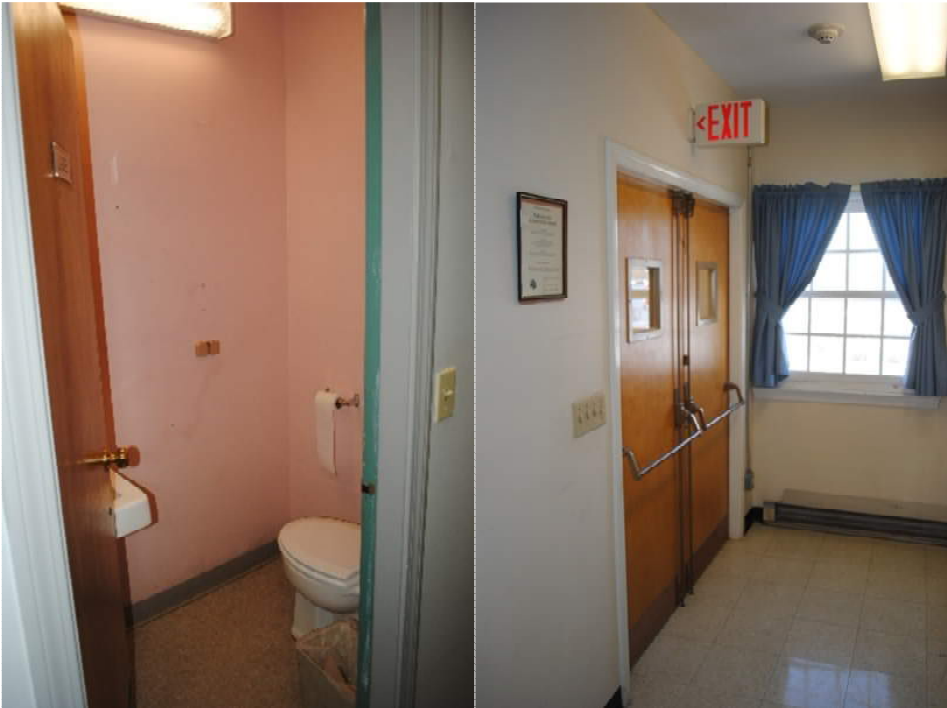
The existing toilet facilities provided are split between the Police Department, Fire Department and Public spaces. A new ADA handicap compliant public toilet was recently installed off the Pubic lobby (see AG Architects documents). This is the only fully accessible toilet in the facility. Toilets for the Fire Department and Police Department appear to be original to the facility. By present Building Accessibility and ADA Code requirements, these facilities would not comply. The door swing accessing the toilets on the Police department side were restricted by toilet fixtures severely limiting access.

Toilet Room door swing conflict

Missing door closer hardware

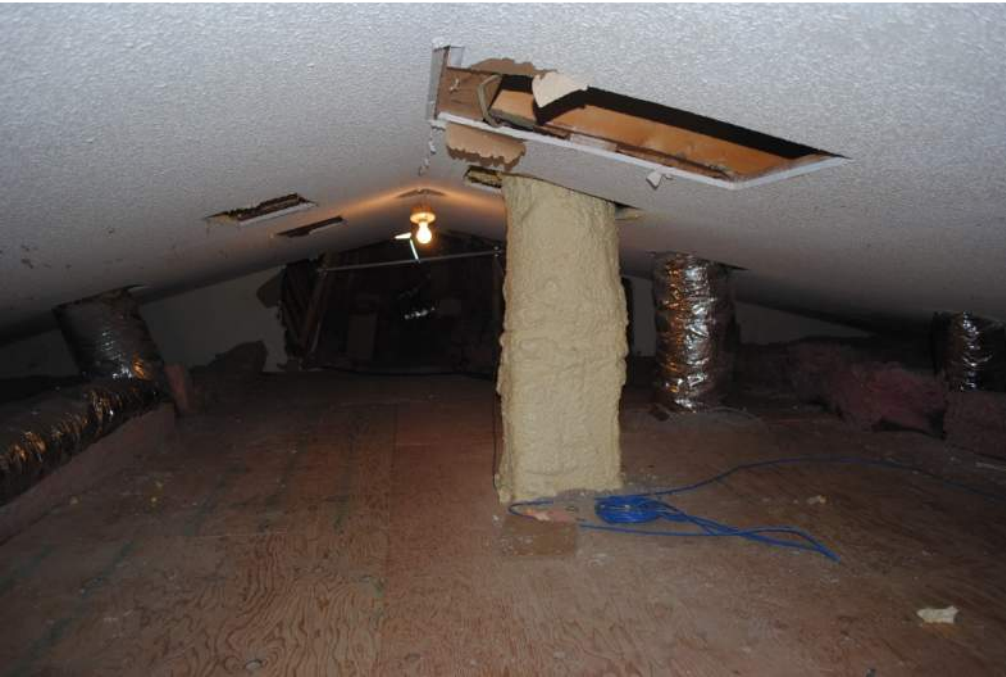
Apparently at some time after occupancy, this second floor area was renovated to create Police Department rooms. A flat ceiling framing was added over top of new stud walls. A sheet plywood deck was added across the top of ceiling joist framing. There was no documentation when this renovation work was completed. The purpose for this deck was documented in the “Bennett” report as being used as storage of files. We observed that this area is clear and not being used for storage. There is only a plywood walkway installed over the midspan of the “Fink” truss bottom cord to access existing mechanical equipment.

Scissor Truss area with plywood decking atop ceiling joists and openings to access H&V equipment controls.

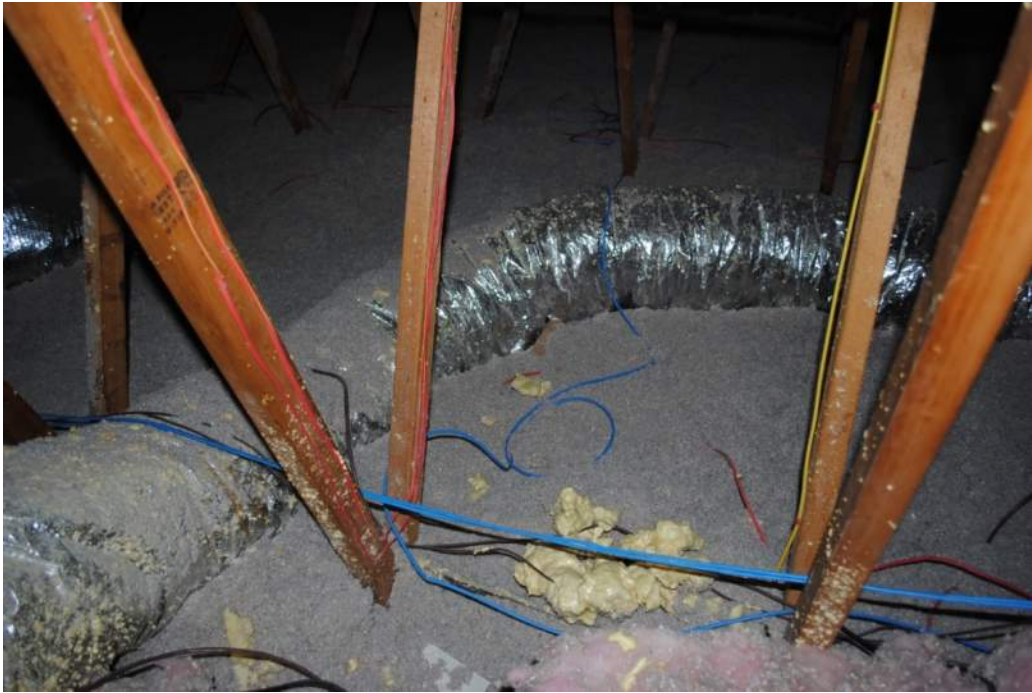
The effective attic insulation layer is between ceiling framing and truss lower cord members. The material appears to be a loose blown-in cellulose product. Thickness was measured at 6”+. Random placement of 6” fiberglass batt insulation was also observed above cellulose but not in any effective placement to add thermal value.

Loose blown-in cellulose insulation - uneven layered.

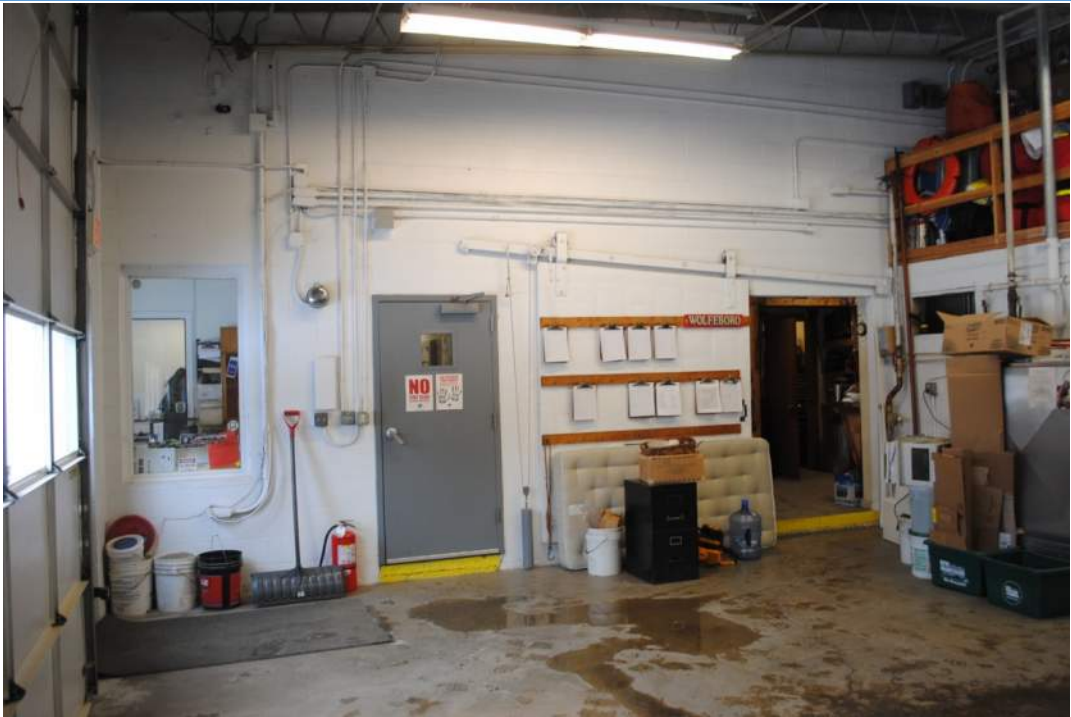
Fire Department Apparatus Bay (Storage Use Occupancy) block wall and rated sliding fire door. NOTE: window on left of wall is an unprotected opening through the concrete block separation wall into the Office (Business Use Occupancy)

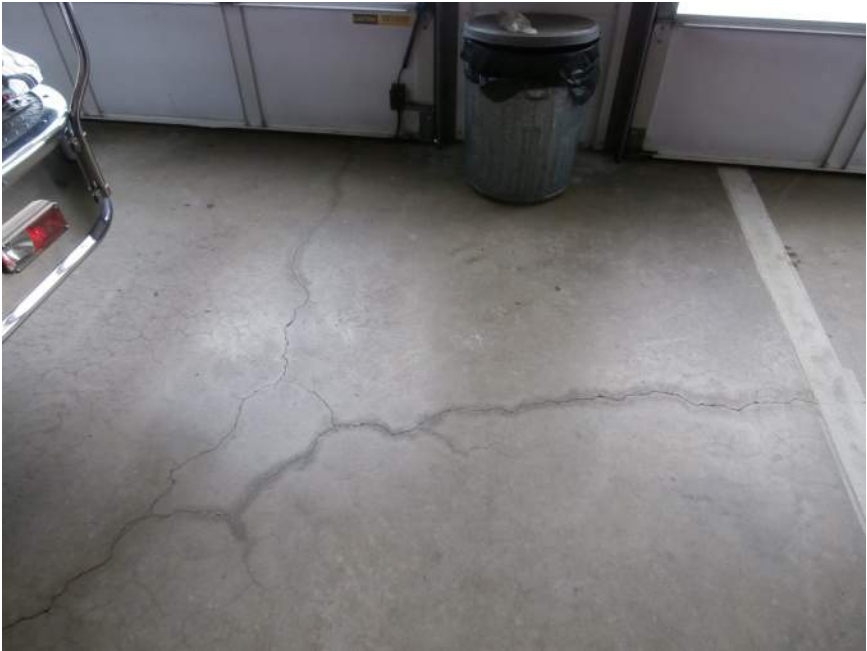
Cracked floor slab, Apparatus Bay

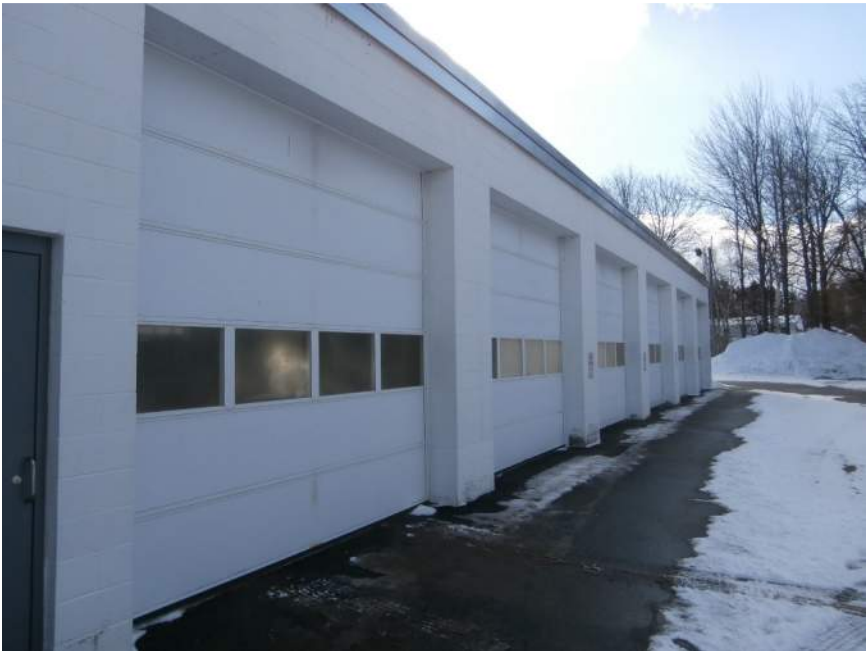
Reconstructed/Repaired masonry bearing walls and door headers, Apparatus Bay

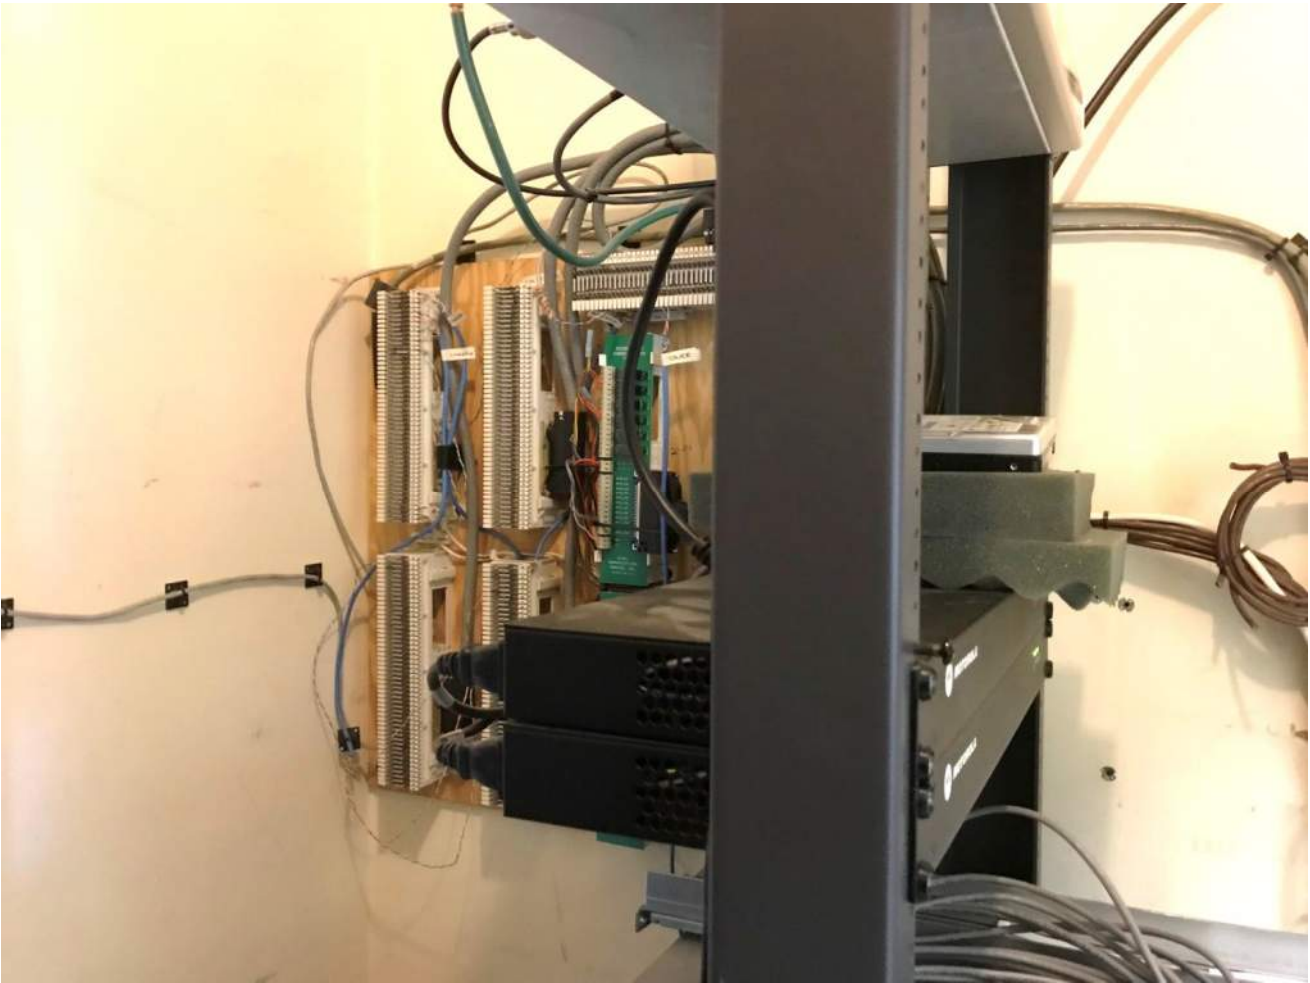
The IT closet located in the Police Department suffers from excessive heat gain. An open ended duct off the heat pump system currently allows cool air, when the unit is providing air conditioning, into the space in an un-controlled manner. A sign on the door clearly states that the door is to remain open, indicating the open-ended duct does not provide enough air movement to prevent overheating. Additionally, should the heat pump system be in heating mode, the warm air introduced to the space adds heat to the space instead of removing it. The heating load produced by the equipment should be evaluated, and a properly sized, dedicated exhaust fan is recommended to remove the heat.
