Feasibility Study

Conversion of the Wolfeboro Municipal Electric Department
Former Power Plant to a Community Center
22 Lehner Street, Wolfeboro

MARCH 18, 2022

Feasibility Study
Conversion of the Municipal Electrical Department former Power Plant to a Community Center
22 Lehner Street
Wolfeboro, New Hampshire

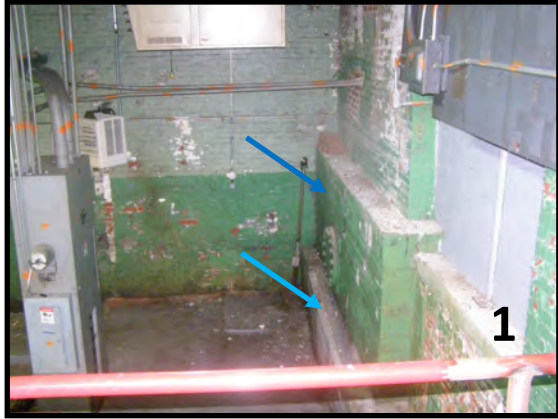
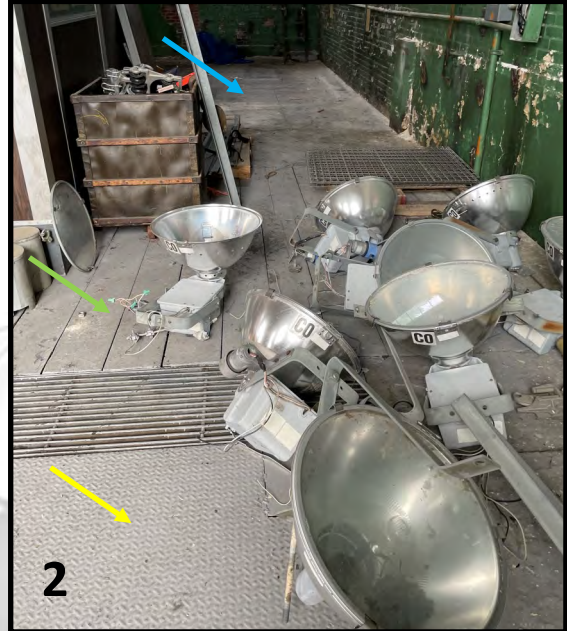
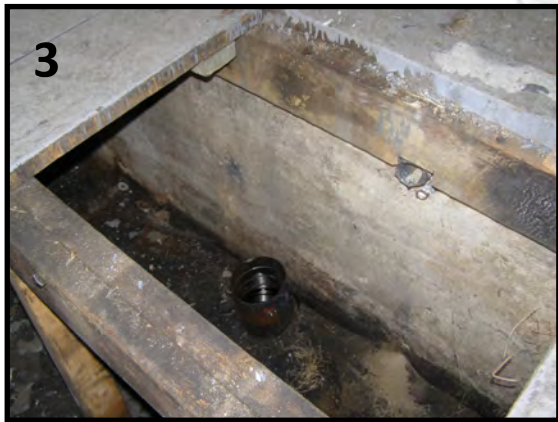
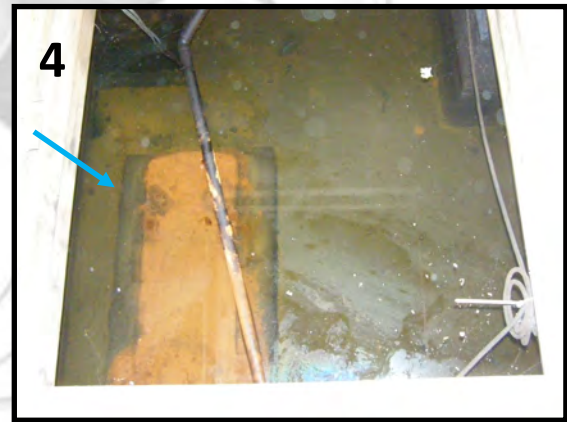
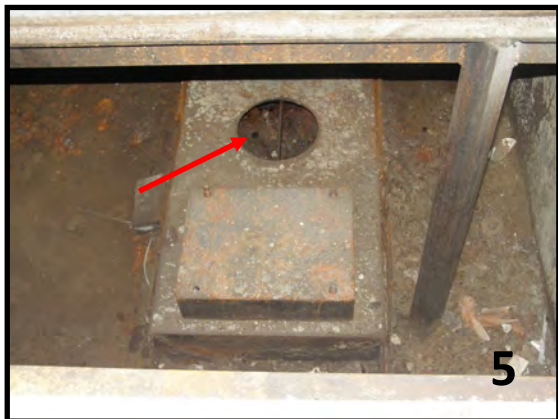
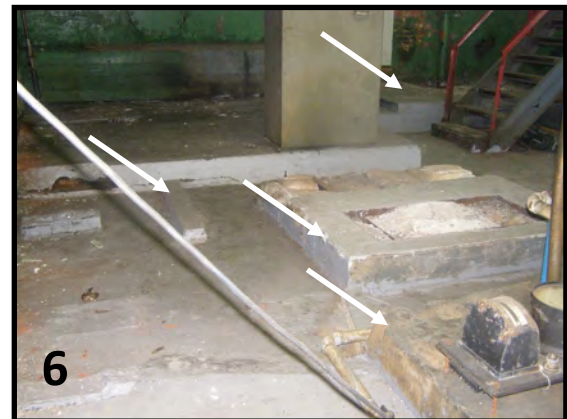
The foundations of both the north and south sections of the building are constructed of cast-in place concrete. The footings of the southern section of the building can be viewed from the interior along the south wall of the northern section of the building. At the south foundation wall along Lehner street there is vertical cracking in the concrete.

1. Photo of the original building foundation wall and footing, from the north end; 2. Various floor materials in the south end; 3, 4 & 5. View inside various pits; 6. Raised sections of floor at north end of building.

The various pits and trenches are covered with metal access hatches in some locations and removable wood plank hatches in other locations. When opened, the pits covered with wood panels were found to have a midspan beam supported by wood posts. Many of pit floors appear to have oil present on the floor surface. Additionally, a floor drain was noted at the pit located at the southeastern most corner of the building. This drain needs to be further inspected and should be tested for contamination. The pits and trenches that were observed appear to be constructed of cast in place concrete floors and walls. Some have dirt floors. At the north section of the building, the subfloor pits and trenches have become flooded with water, apparently site groundwater has infiltrated these areas. During our visits to the building the observed water level in the pit (viewed from the hatch door at the northeast corner of the building), varied in depth at different times of the year, seemingly changing as the seasonal water table rises and falls.

The condition of the floors throughout the building are generally poor. The concrete sections of the floors are uneven and there are areas where there are small lips and cracks. Additionally there are indentations and raised areas that were necessary for mounting of electrical generation and supply equipment. Should the building be used for a public community center the floors would, at a minimum, need to be blasted clean, the pits and trenches be filled in and then the floor topped with new concrete to provide an even, level surface. Some areas may need to be removed previous to new concrete being placed.

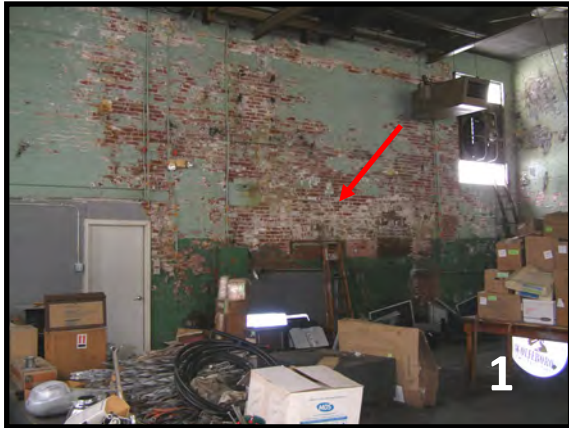
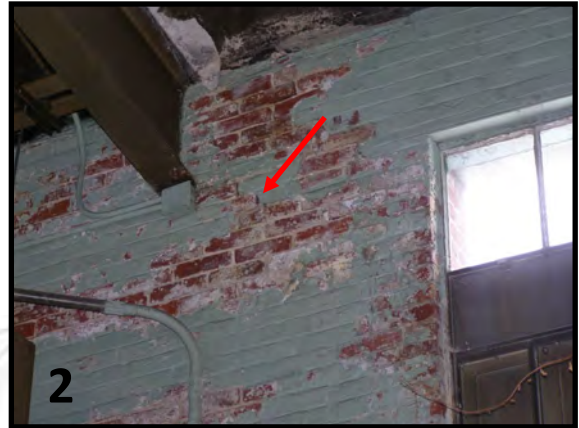
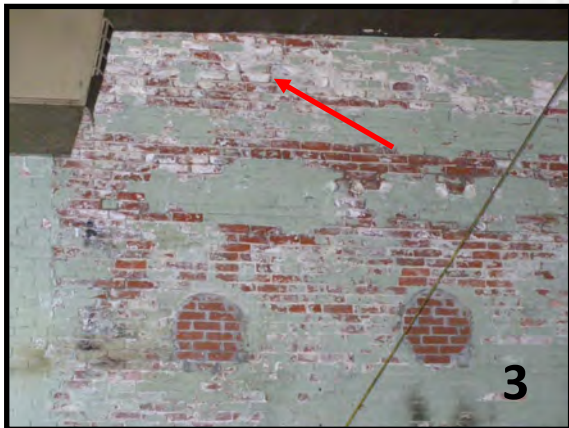
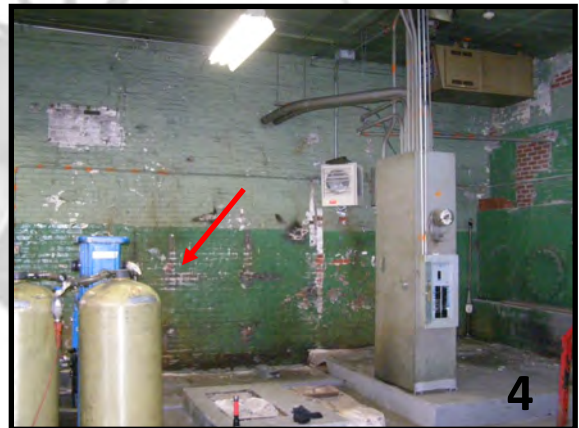
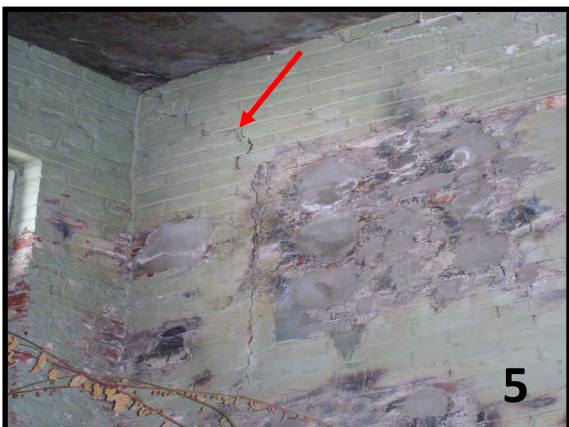
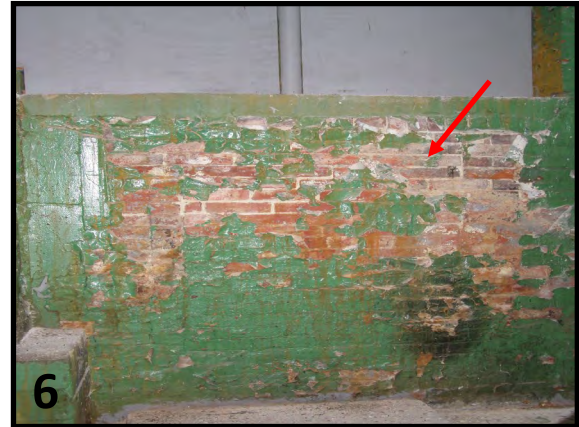
The most concerning area of wall deterioration that was noted is the wall that separates the interior areas of the building, which originally had been the north exterior wall of the earliest constructed section of the building. This wall is significantly deteriorated with signs of efflorescence, spalling, deteriorated and missing mortar at joints, and displacement. As mentioned in the Bergeron Technical Services report for the roof of this building prepared in 2014, this wall, from the interior and exterior has become moderately deteriorated and has or has had numerous openings which have allowed water infiltration. This condition was also identified as a possible water entry point contributing to roof leaks and deterioration of the north section's gable roof. This wall also has multiple areas of masonry that have been infilled, patched, and/or removed to various degrees in terms of scope and quality of workmanship.

1. Dividing wall between north and south ends (original exterior north-wall of 1897 building), viewed from the south; 2. Close up of same wall adjacent to window—shows displacement and deterioration.; 3. East wall of south end of the building; 4. East wall at the north end of the building; 5. Close up of east wall at south section (portion of 1897 structure), again there are signs of displacement and deterioration; 6. Close up of deterioration of the dividing wall viewed from the north end.

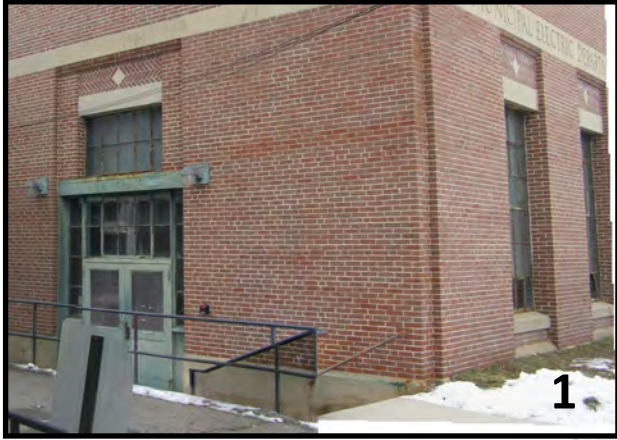
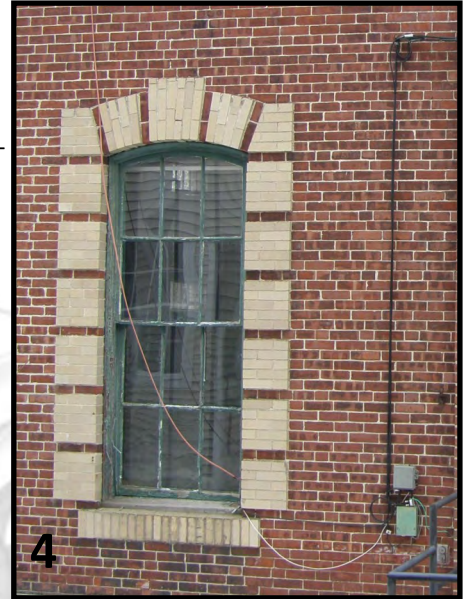
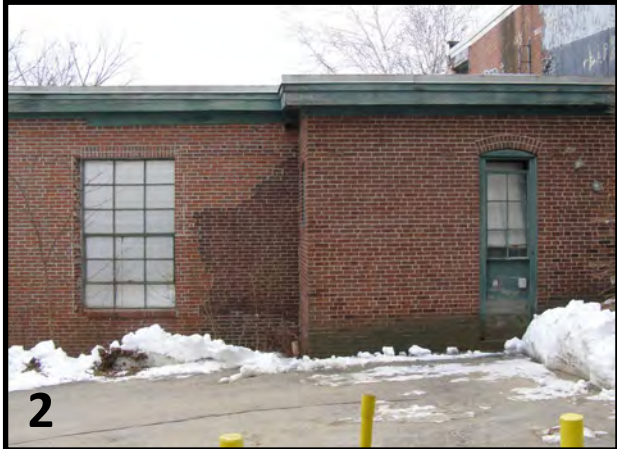
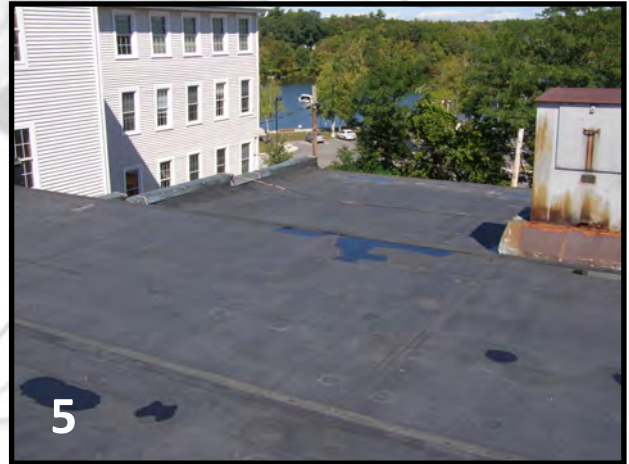
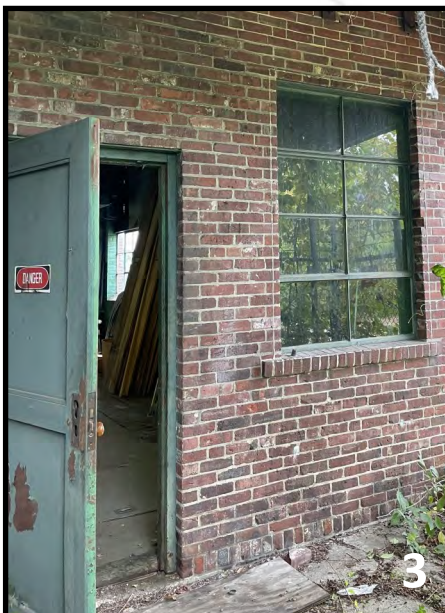
The condition of windows and doors is poor to fair. Given the age and condition of these items it makes little sense to keep any of the existing units.

1. Main entry door and surrounding windows; 2. Windows at the west side of the north end of the building; 3. Entry door and window at the east side of the north end; 4. window at the west side of the south section (original section of the building)

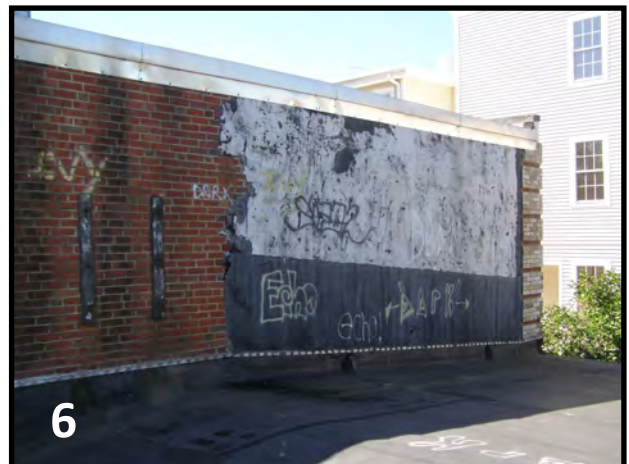
In 2014 Bergeron Technical Services performed an inspection and provided a report to the Wolfeboro Electric Department, specifically addressing the conditions of the roofs at the Lehner Street MED building. Several areas of concern were noted in this report, specifically regarding areas of deterioration and water infiltration. Areas of deterioration, not necessarily leading to water infiltration at the time, were identified along the lap seams of the EDPM roofing material and around the curb supporting the roof-mounted ventilation equipment located in the north half of the southerly flat roofs. Infiltration was identified as likely occurring at the common wall between the north and south building sections, as stated previously within this report. While performing the inspection for the feasibility study, multiple areas of water damaged ceiling finishes were noted throughout the building. Specifically, along the common wall at the north section of the building where water damaged gypsum was observed above the upper landing. Additionally, an area where the ceiling finish has been either damaged or purposely removed was observed at the southeast corner of the north section of the building. The damage in this area exposed the wood roof framing and wood roof deck above. In the southeast corner of the south section of the building, an area of the finished ceiling (believed to be cellulose fiber board, a.k.a. Homasote) has also been damaged or removed, again, exposing the underside of the roof deck.

It is likely that there is concealed damage and rot located within the encapsulated areas of the roofs due to the previous and on-going water infiltration issues of the roof and exterior walls. The extent of the damage to the roof decks throughout and roof framing of the northern most roof will be unknown until finishes can be removed, however it should be expected that there will be significant damage requiring repair.

5. South section roofs, looking north, roof ventilator at the right; 6. South roof looking at the common wall above the roof. (Photos 5 & 6 taken during roof inspection in 2014)

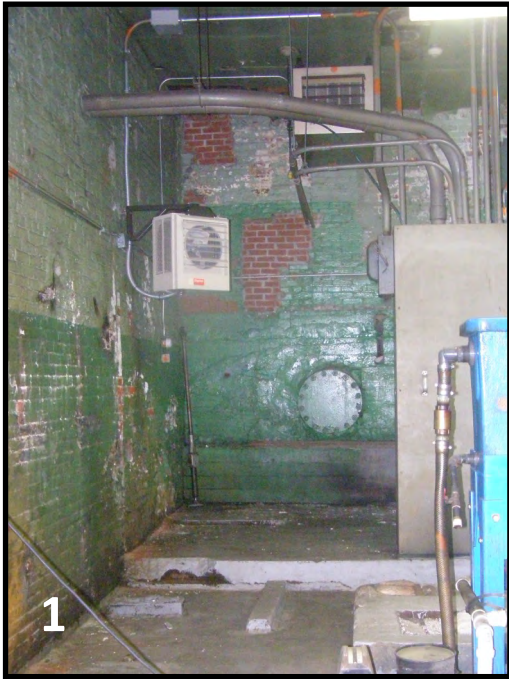
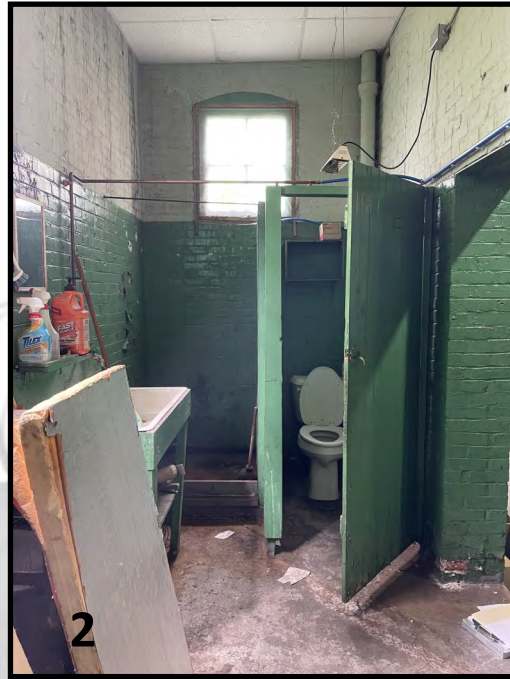
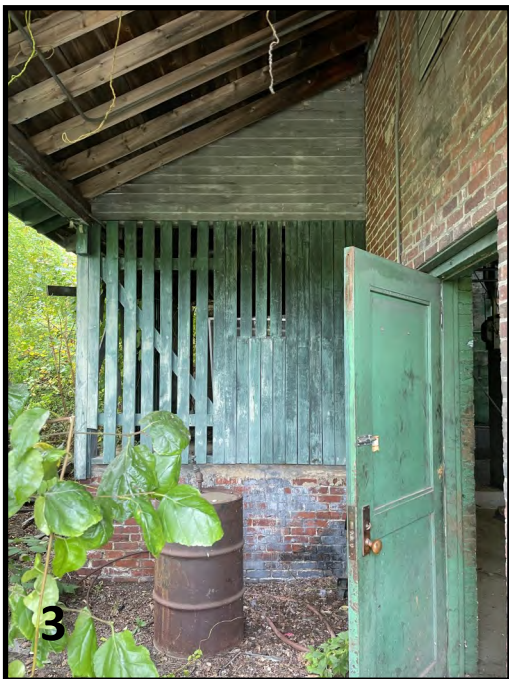
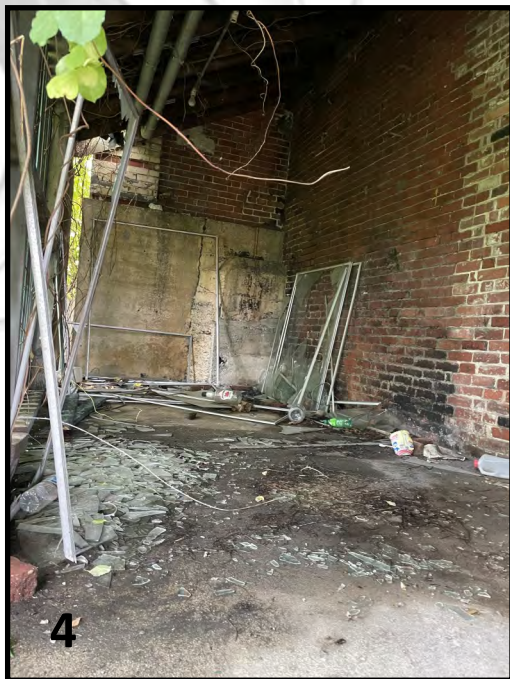
Generally, the building interior is in poor to fair condition. There are few interior partition walls, only the dividing walls between the north section and south section of the building. There is one restroom area containing a lavatory, water closet and shower located off the west side of the north end of the building, this area being accessed by a set of three-riser concrete stairs. There is water damage to areas of the ceiling finishes in all areas of the building and as mentioned the brick and mortar of the walls are quite deteriorated in many areas. The paint finishes on the walls and floors are cracked, flaking, peeling and entirely gone in some areas. There are multiple areas of the walls where openings for windows, doors and equipment or machinery have been infilled with newer brick masonry, to varying degrees of quality and workmanship.

1. Southeast corner of the north section of the building showing old systems and infrastructure. 2. The existing restroom at the west side of the north section, the lavatory of partially shown in front of the shower stall, on the left with the water closet stall on the right. 3. Just outside the north section exterior door on the east, looking south at the enclosed platform under the she roof. 4. The interior of the enclosed platform at the east side of the north section.

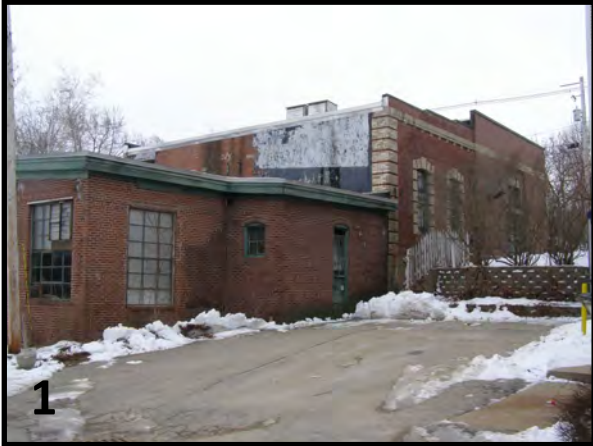
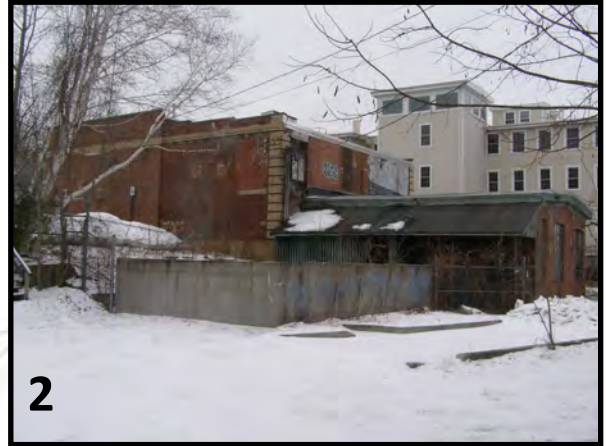
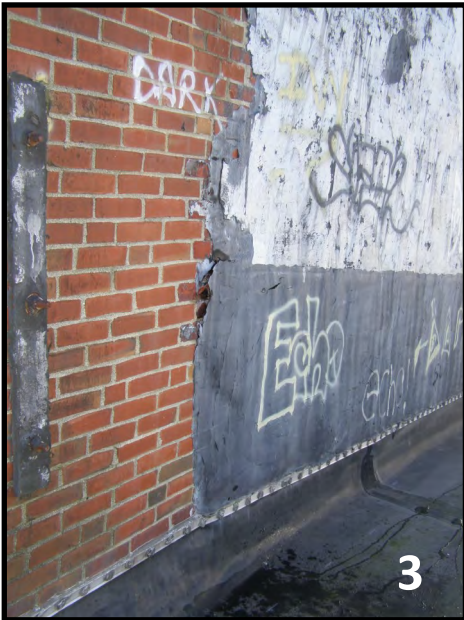
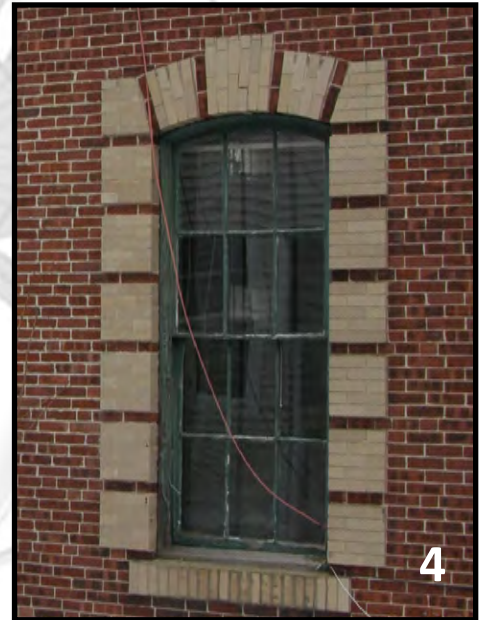
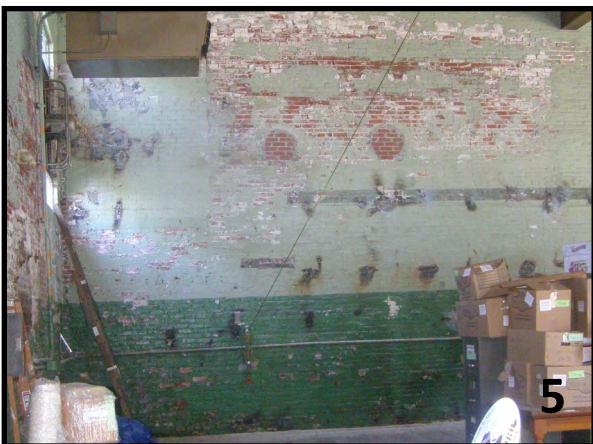
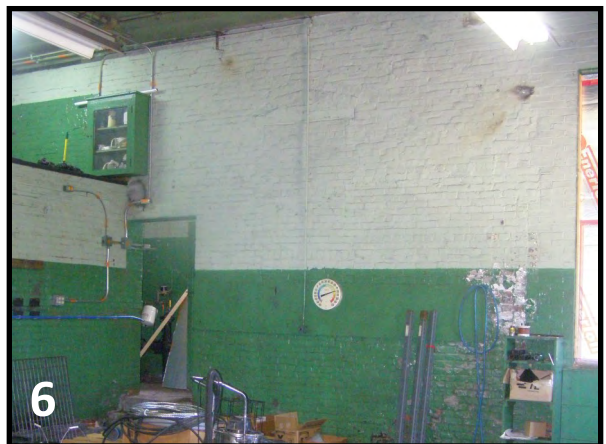
1. West side of the building, showing the grade sloping down from the road side to the rear. 2. East side of the building, showing topography and the concrete containment. 3. Photo of the materials on the exterior, above the north roof, containing asbestos. 4. Photo of one of the windows that tested positive for asbestos. 5. Both the light green and dark green paints on the interior walls of the south section of the building tested positive for lead with the dark green containing 19.42%. 6. Similarly the paint in the north section tested positive for lead with the light green containing 11.8%.

Should the building be repurposed these materials will need to be abated by trained, properly equipped professionals using all required protection methods. The lead paint waste and asbestos waste will need to be disposed of as hazardous materials. The most appropriate method for paint removal from the masonry will be media blasting, however this process will need to be done in a lead safe manner and the media used will need to be chosen carefully so that the paint is removed, but the masonry is not further damaged.
