**SUMMARY REPORT
AND
FINAL DOCUMENTATION**

**WOLFEBORO ROADWAY
EVALUATION**

**TOWN OF WOLFEBORO
WOLFEBORO, NEW HAMPSHIRE**

UEI PROJECT 2211

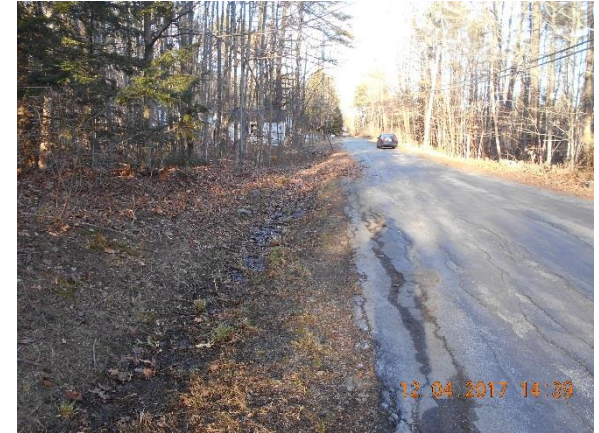
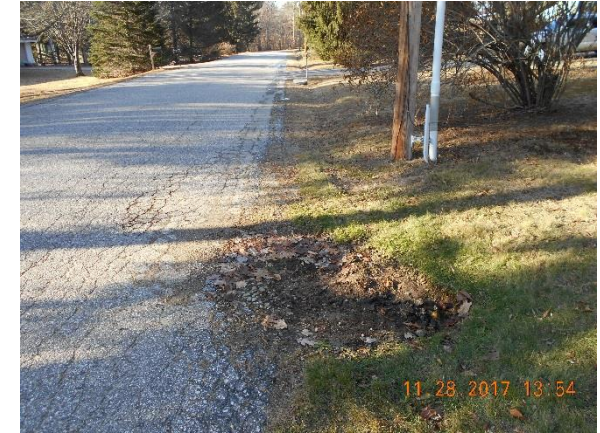
ANAGANCE STREET

- PCI = 41
- Evidence of shoulder pumping up
- Sump pump discharge onto road surface creates ponding in rutted areas
- Cracking observed on “cut” side of road likely due to high groundwater and/or poor base materials
- Lower priority residential dead-end road

- Reclamation with supplemental stone aggregate
- 3” nominal pavement thickness
- Closed drains and underdrains
- Ditching
- Gravel backing
- Year scheduled = 2022

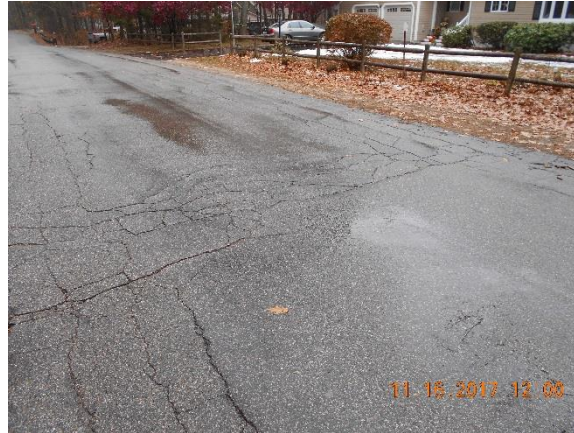
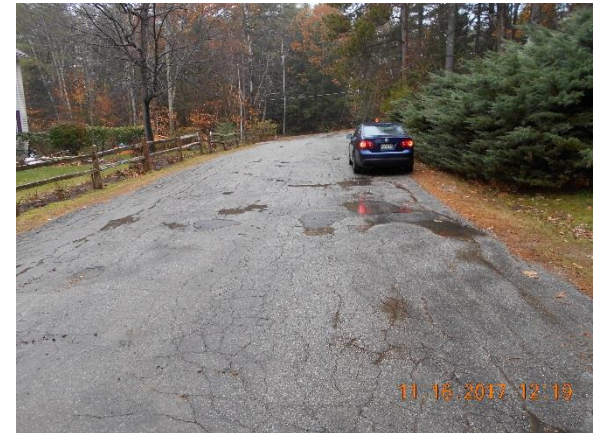
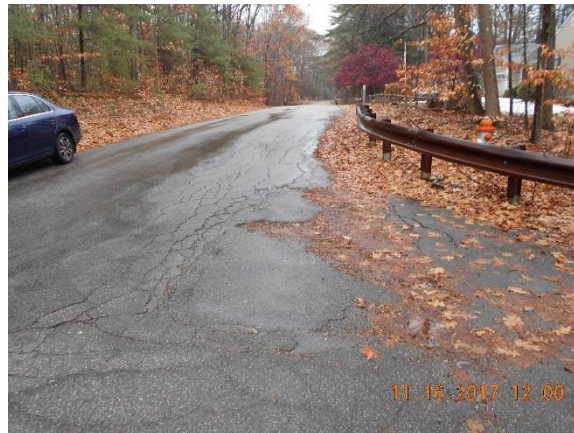
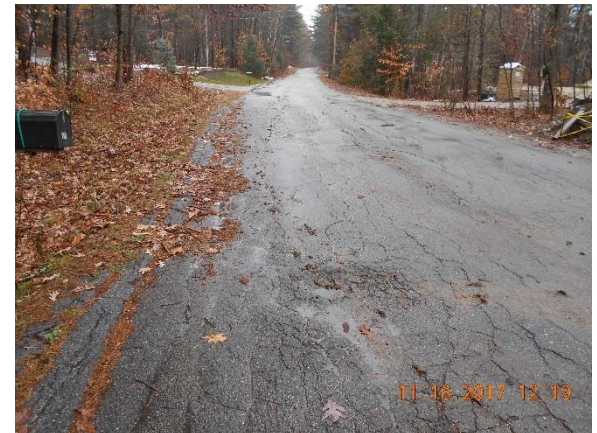
BREWSTER HEIGHTS

- PCI = Varies 74 to 63
- Drainage in fair condition, some puddling observed at Pleasant Valley Rd.
- Crack sealing work previously completed
- Deteriorated asphalt in upper section likely due to elevated groundwater and base failure
- Lower priority loop road

- Reclamation with supplemental stone aggregate
- 3" nominal pavement thickness
- Closed drainage and underdrains
- Gravel backing
- Ditching
- 1.5" overlays on better rated sections
- Year scheduled = 2024

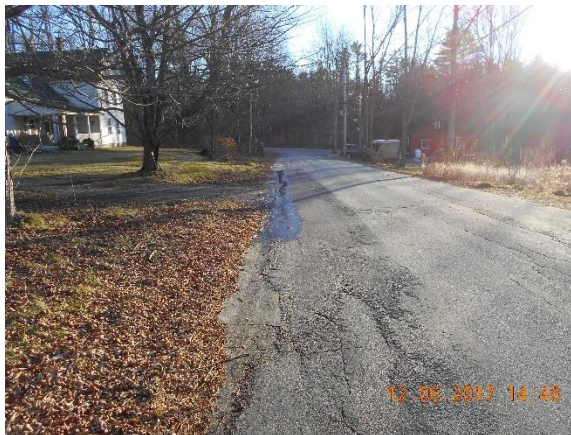
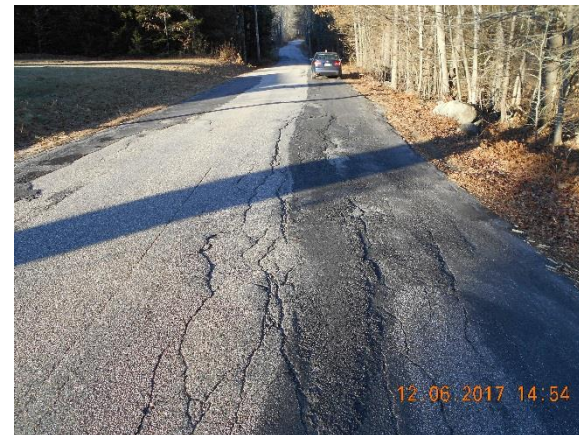
BRYANT ROAD

- PCI = 31
- Previous shimming completed
- Ditching where observed appears functional but needs cleaning
- Isolated locations where surface water drains onto roadway. Some locations coincide with previous shim work
- Grade crossing with rail trail is rough
- Wetlands encroach close to edge of pavement in some areas

- Reclamation with supplemental stone aggregate
- 3" nominal pavement thickness
- Closed drainage and underdrains
- Asphalt curbing/swales
- Gravel backing
- Ditching (turf and stone)
- Year scheduled = 2020

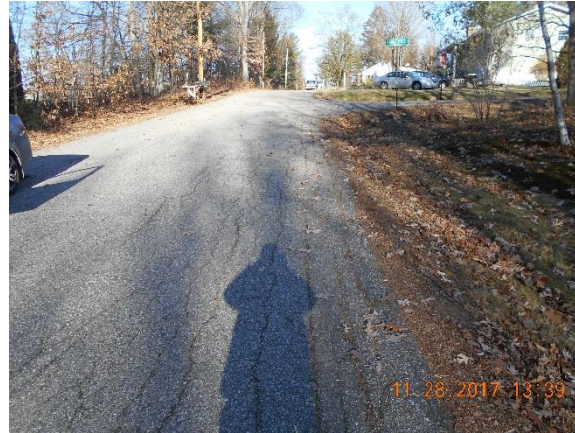
CANOPACHE ROAD

- PCI = Varies 37 to 32
- Road surface in poor condition
- Drainage systems are in poor condition
- Utility observed 12" to 15" from edge of pavement
- Lower priority road

- Reclamation with supplemental stone aggregate
- 3" nominal pavement thickness
- Closed drainage and underdrains
- Asphalt curbing/swales
- Gravel backing
- Ditching
- Year scheduled = 2019

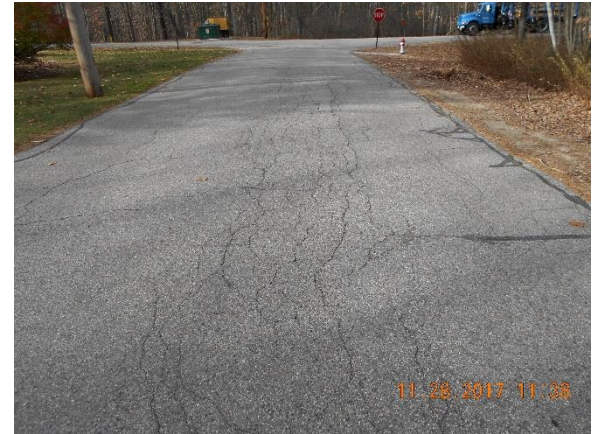
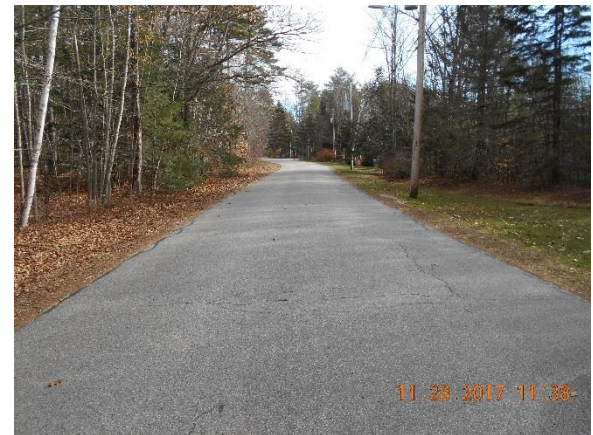
CLOW STREET

- PCI = 53
- Low shoulders
- Extensive cracking throughout
- Shallow drainage crossing causing protrusion in road surface
- Generally, a low priority road dead end road. However, the Sewall Trail Head is at end of road

- Reclamation with supplemental stone aggregate
- 3" nominal pavement thickness
- Asphalt berm/swales
- Gravel backing
- Ditching
- Year scheduled = 2028

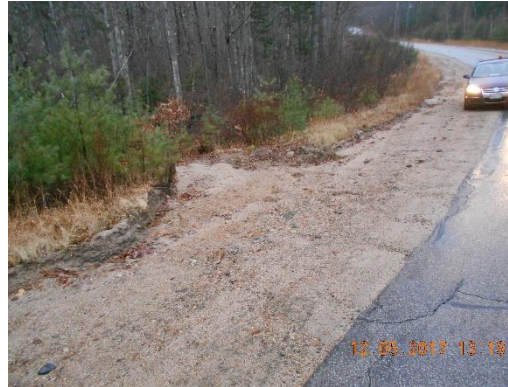
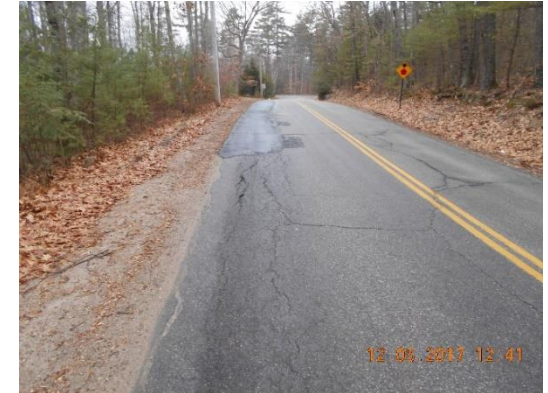
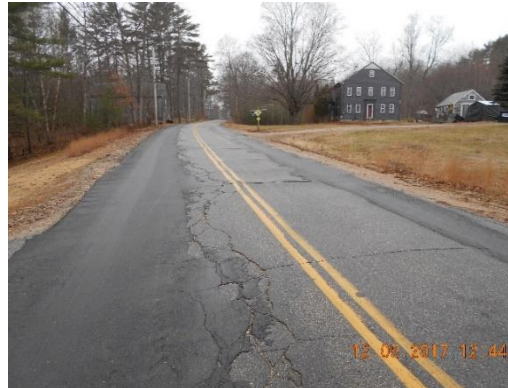
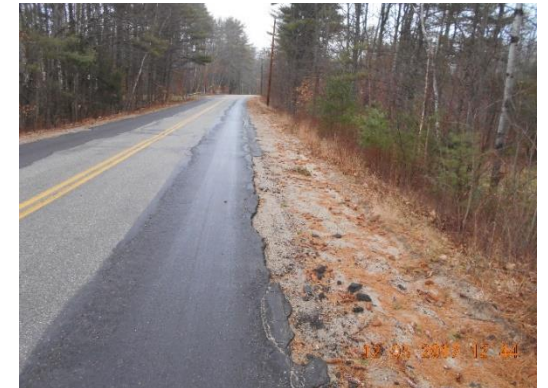
COLLEGE ROAD

- PCI = Varies 76 to 19
- Section for Westwood (east entrance) to Bryant Road in newer condition than balance of road
- Large areas of shimming through older section of road
- Severe cracking through older section of road
- Sedimentation potential into adjacent wetlands due to shoulder erosion into “cut out” locations to promote drainage in isolated areas
- Large diameter culvert (36” dia +/-) observed to have blocked inlet
- Elevated traffic levels due to collector road status

- Crushed gravel base (section 1 only)
- Reclamation (rehandled) with supplemental stone aggregate
- 4” nominal pavement thickness (section 1 only)
- Closed drainage and underdrains
- Asphalt curbing/swales
- Evaluate large diameter culvert for replacement
- 1.5” overlay (Section 3)
- Consider implementation of BMPs where sedimentation could occur due to shoulder erosion

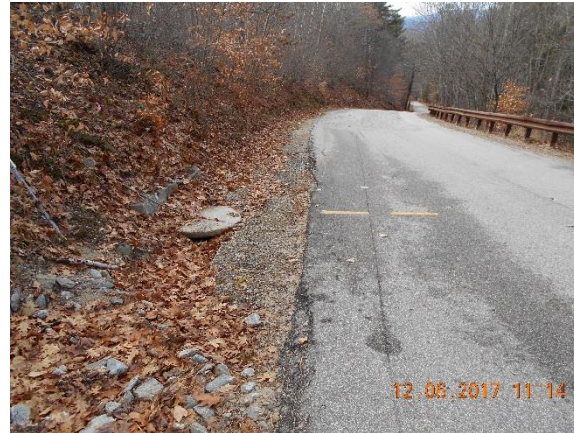
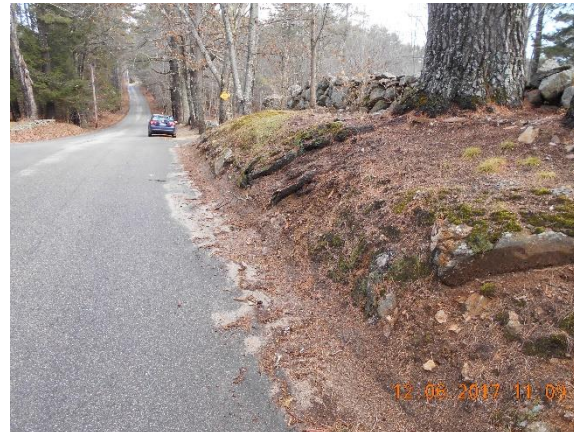
- PCI = 43
- Extensive cracking observed, particularly in the steep sloped areas
- Steep back slopes appear to be eroding or encroach edge of pavement with large trees and protruding ledge
- Drainage structures observed in ditch lines
- Some shoulder erosion noted.
- Lower traffic volume

- Reclamation with supplemental stone aggregate
- 3" nominal pavement thickness
- Asphalt berm/swales
- Closed drainage and underdrains
- Ditching (turf and stone)
- Gravel backing
- Year scheduled = 2027

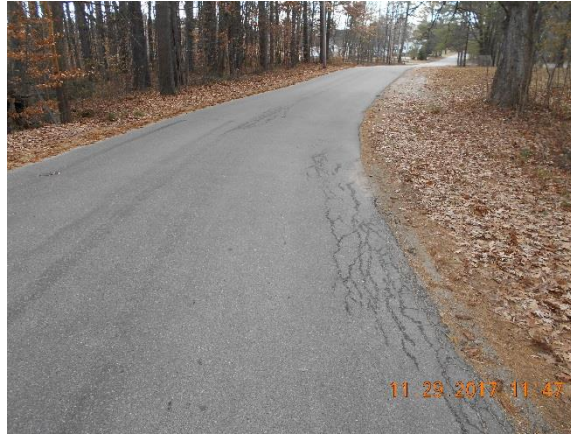
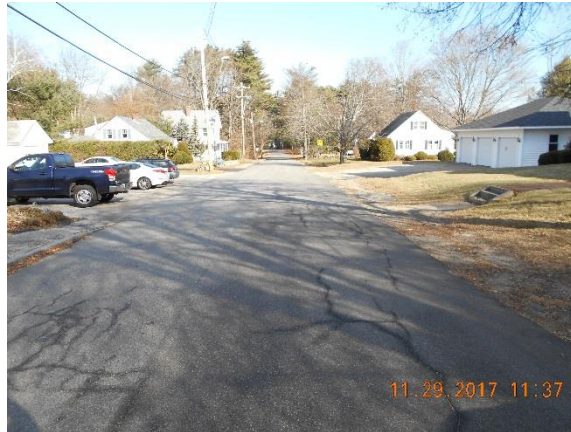
CRESCENT LAKE AVENUE

- PCI = 69
- Heavier than expected traffic noted. Road appears to be a cut through to avoid the 109/28 intersection.
- Low to moderate severity cracking throughout
- Lower priority road despite traffic volume observed

- Crack sealing
- 1.5" overlay
- Asphalt swales
- Gravel backing
- Ditching
- Year scheduled = 2024

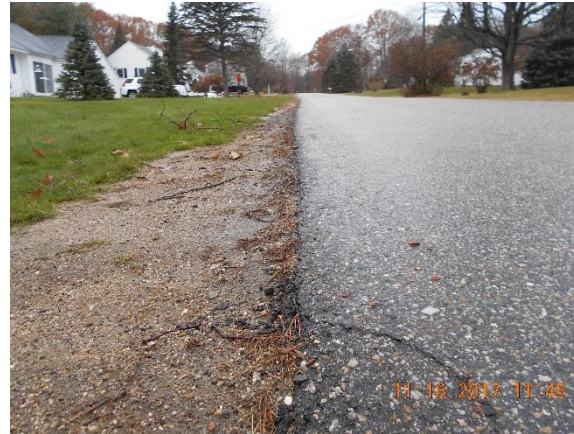
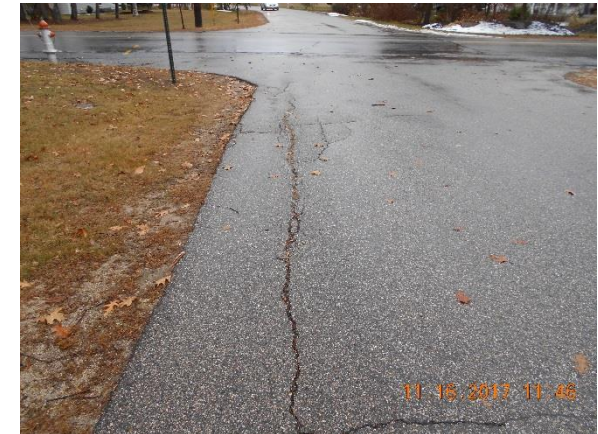
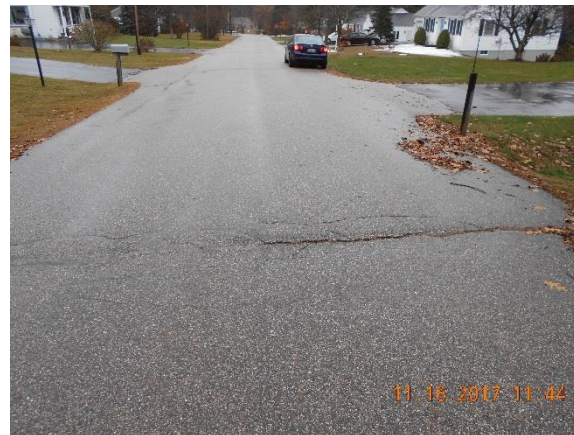
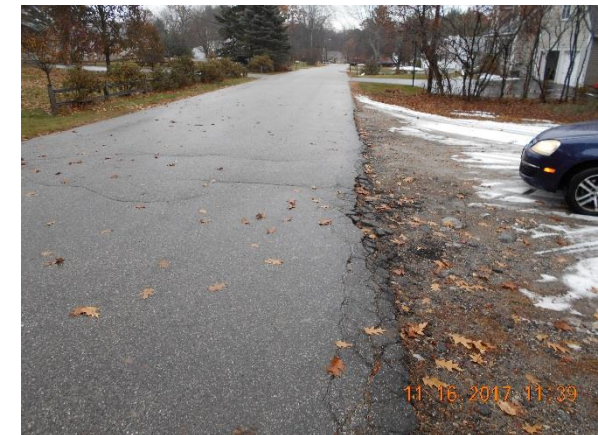
CROPLEY HILL ROAD

- PCI = 61
- Drainage improvements apparent from trench patching along top section of road
- Drainage swale should be re-graded to better promote run-off into CB
- Low to medium severity cracking
- Low priority road

- Crack sealing
- 1.5" overlay
- Asphalt swales
- Gravel backing
- Year scheduled = 2019

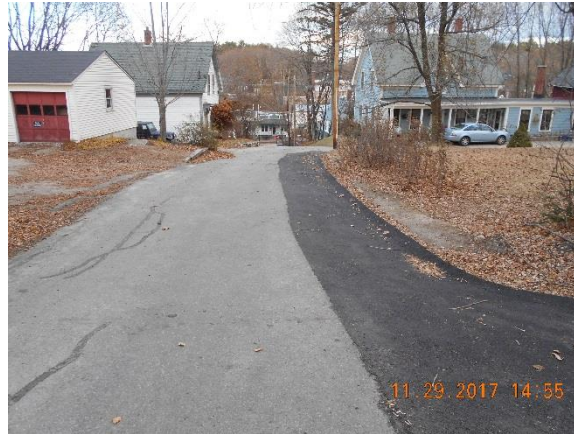
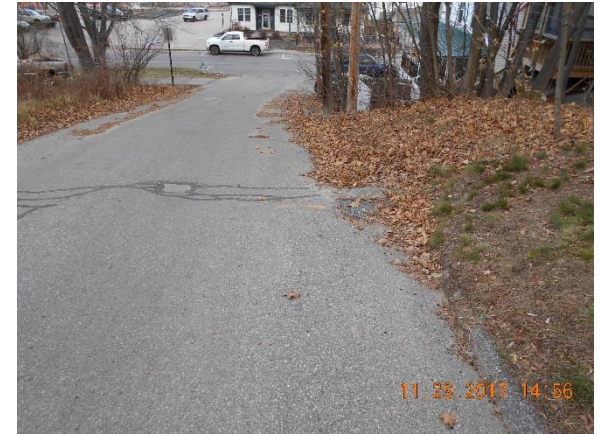
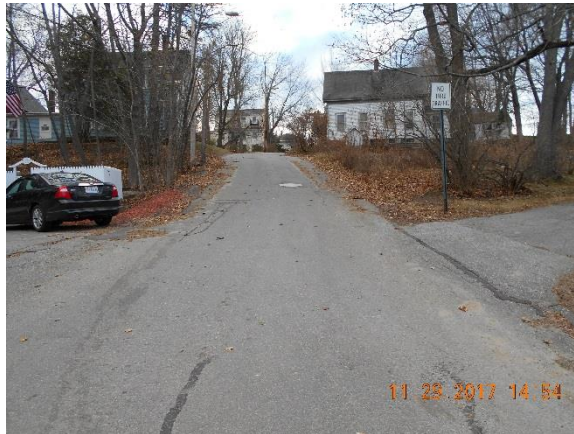
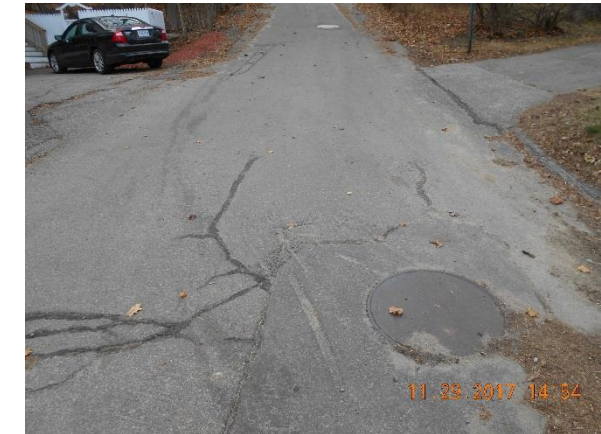
DEER RUN

- PCI = 88
- Roadway overall appears to be in good condition
- Ditching observed in place
- Low severity edge cracking noted
- Some patching observed
- Low priority cul-de-sac road

- Crack sealing
- 1.5" overlay
- Gravel backing
- Ditching
- Year scheduled = 2025

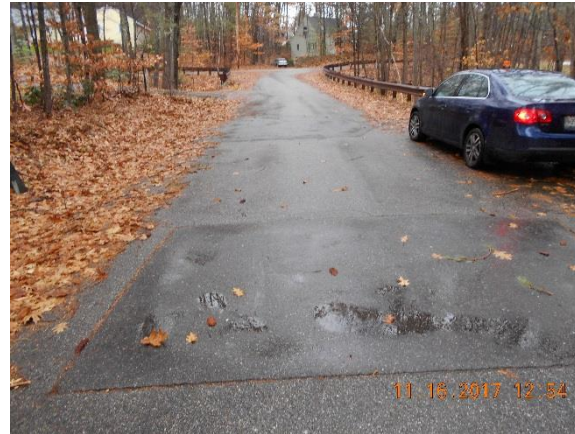
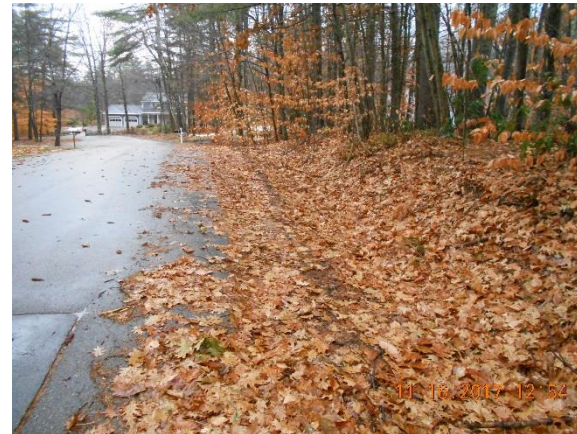
DOCKSIDE STREET

- PCI = 67
- Road is entrance and exit to parking lot for docks.
- Recent utility work apparent due to trench patching observed
- Sedimentation accumulated around CB
- Various types and levels of cracking observed through out

- Mill and 1.5" overlay
- Year scheduled = 2021

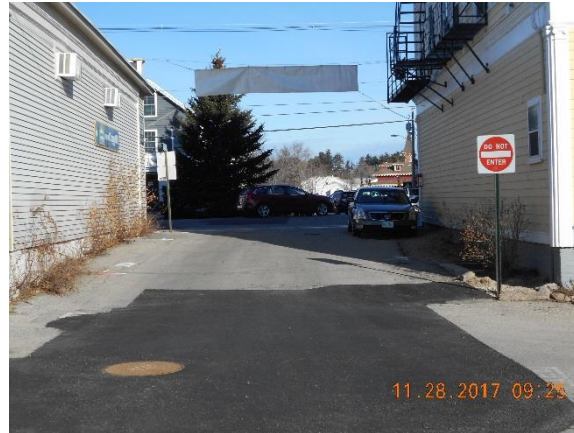
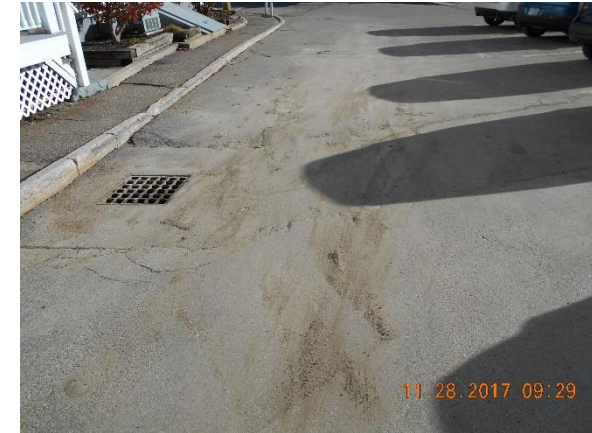
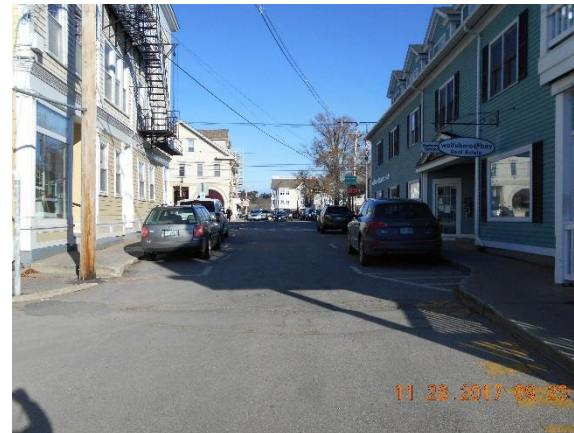
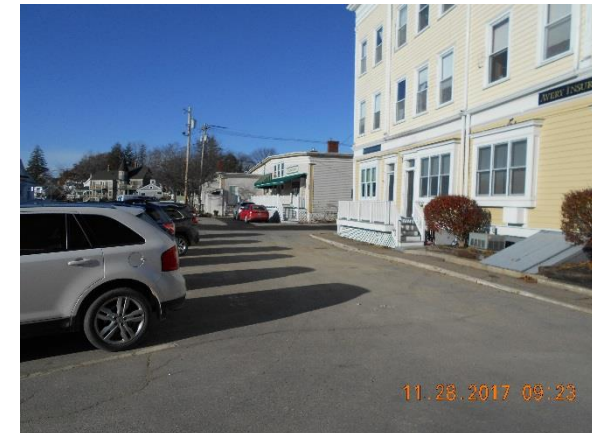
EAGLE TERRACE

- PCI = Varies 85 to 79
- Severe edge cracking in areas
- Drainage (culverts and ditching) appears to be in place and functional
- Low priority cul-de-sac road

- Crack sealing
- 1.5" overlay
- Gravel backing
- Ditching
- Year scheduled = 2029

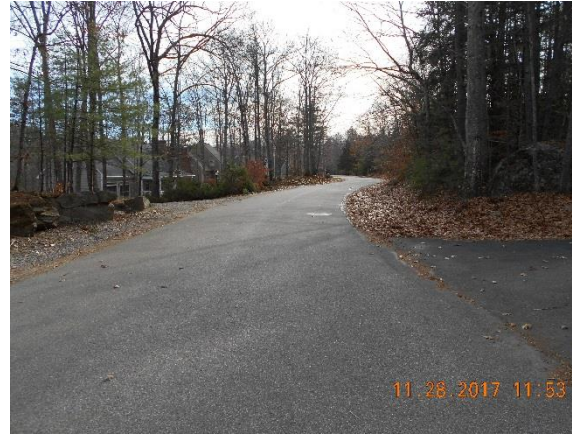
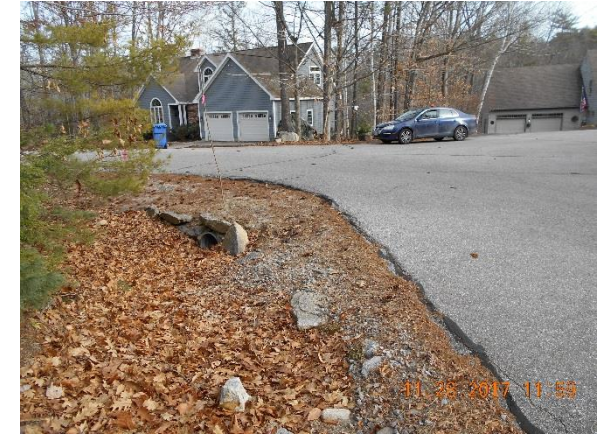
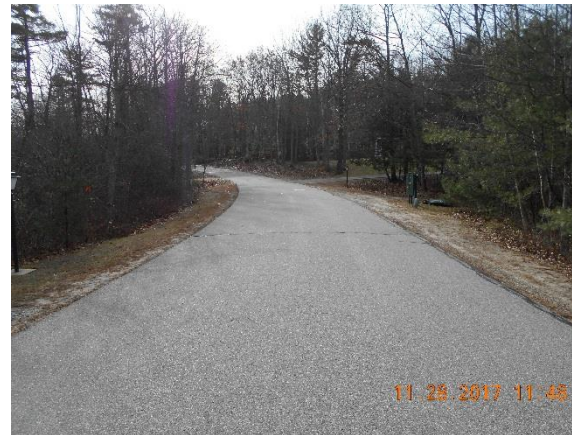
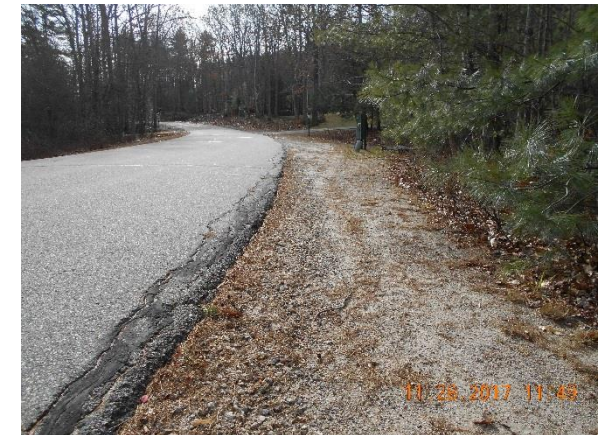
EAST CLARK ROAD

- PCI = 52
- Severe alligator cracking throughout
- Various severities of other cracking types through out
- Drainage in fair condition
- Low priority road

- Reclamation with supplemental stone aggregate
- 3” nominal pavement thickness
- Underdrains
- Asphalt curbing
- Gravel backing
- Year Scheduled = 2028

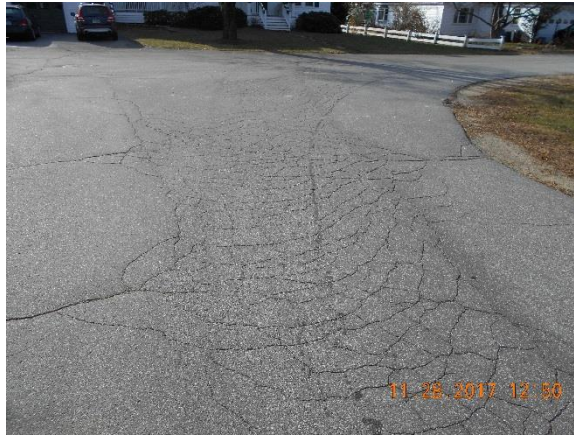
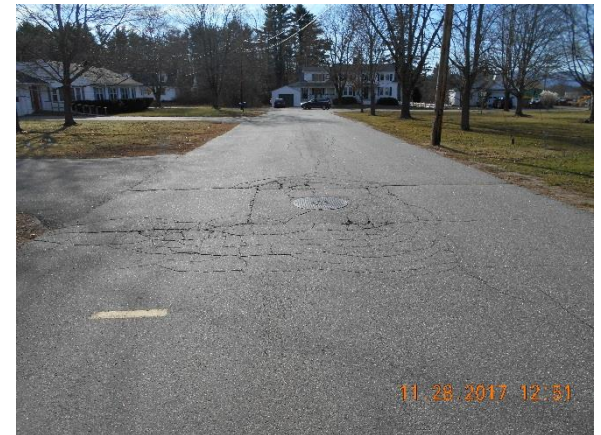
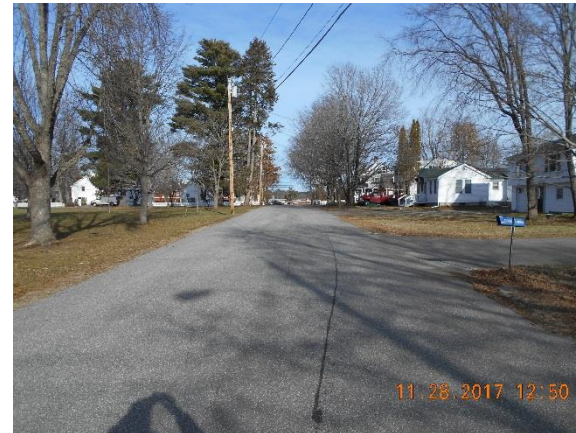
ESTABROOK ROAD

- PCI = 53
- Road is access to Brewster Academy Smith Center
- Ditching is in place but needs improvement
- Existing ditching appears to discharge at grade causing puddle on music center walk ways
- Lower priority road

- Reclamation with supplemental stone aggregate
- 3" nominal pavement thickness
- Underdrains
- Asphalt curbing
- Ditching
- Gravel backing
- Year Scheduled = 2028

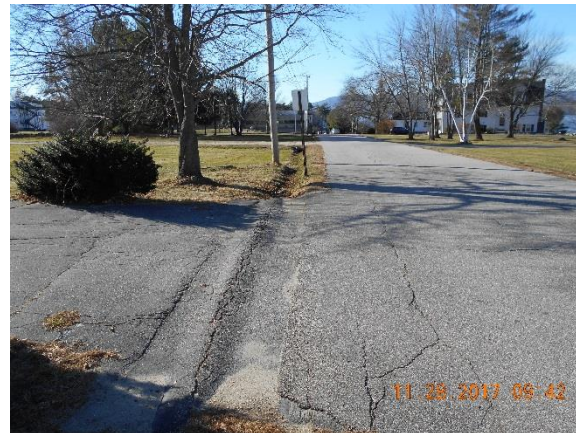
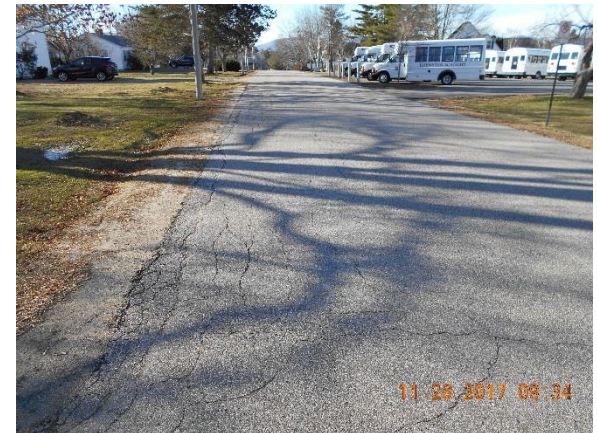
FAIRWAY DRIVE

- PCI = 67
- Road appears to have been constructed through a wetland area.
- Severe edge cracking and low shoulders observed
- Failed trench repairs

- Crack sealing
- Shim and 1.5" overlay
- Gravel backing
- Ditching
- Year scheduled = 2021

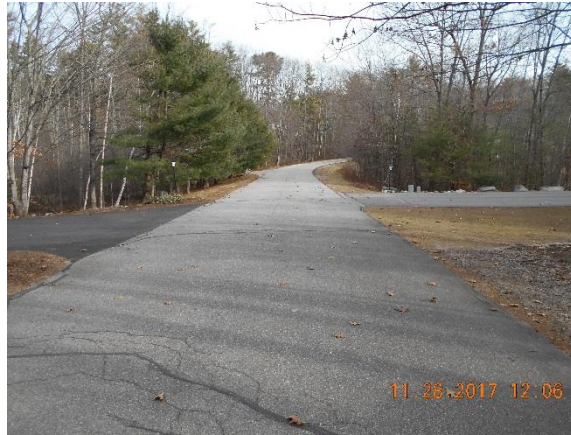
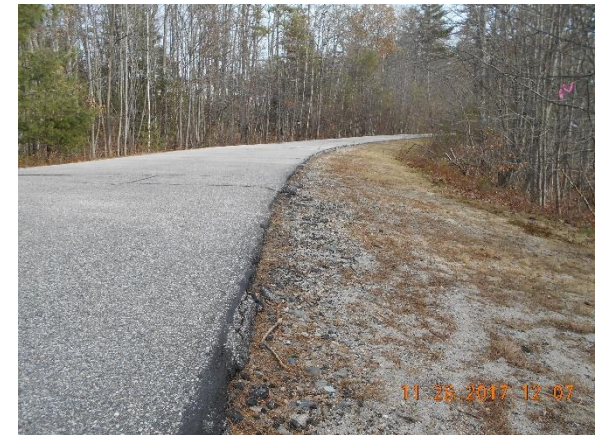
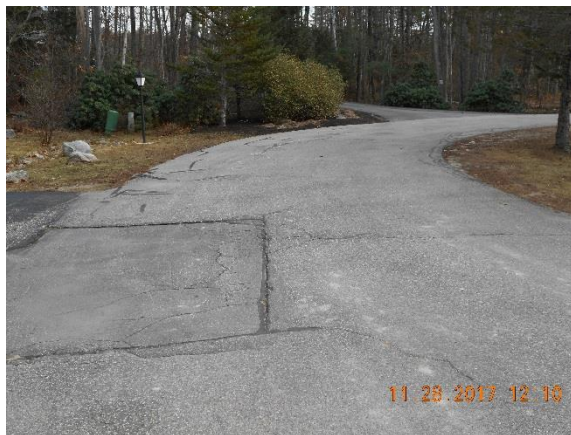
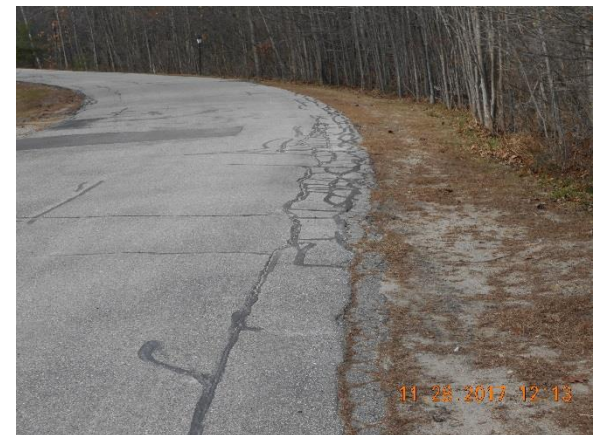
FILTER BED ROAD

- PCI = 50
- Road is access to WWTF
- Loss of cross section observed
- Failed trench repair
- Cross culverts appear to be raised creating bulges in the road

- Crushed gravel road base
- Reclamation with supplemental stone aggregate
- 4" nominal pavement thickness
- Underdrain
- Gravel backing
- Ditching
- Year scheduled = 2028

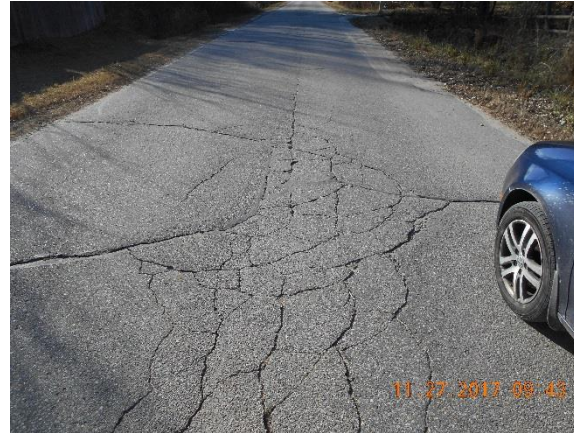
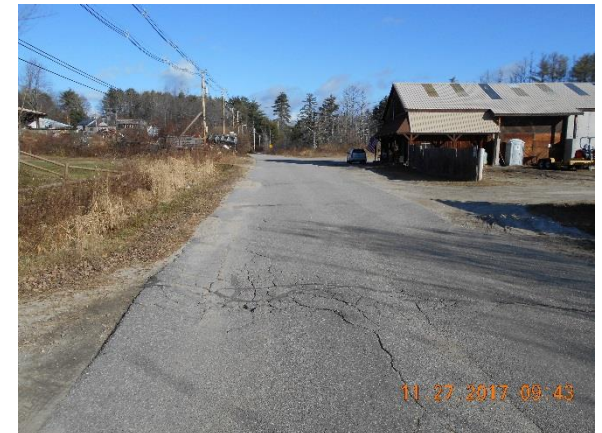
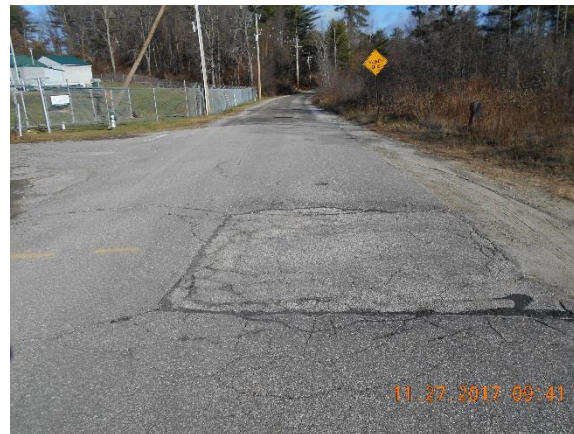
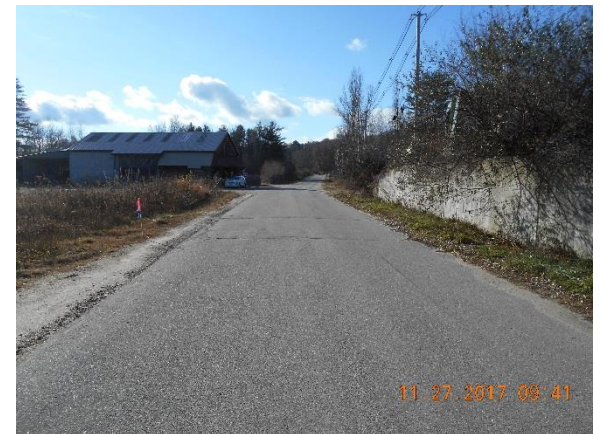
FOREST ROAD

- Portion Reconstructed in 2013 (End to Hopewell Point Road)
 - PCI = Varies 98 to 91
- Remaining Portion (Rt 109 to Hopewell Point Road)
 - PCI = Varies 86 to 72
- Various cracking throughout older sections
- Low shoulders observed throughout
- Good ditching on newer section, older section needs ditching improvements
- Tree removal may be desired to improve site distance
- Alligator cracking observed in isolated spot of reconstructed area

- Crack sealing
- 1.5" overlay
- Ditching
- Gravel backing
- Year scheduled = 2025
- Routine maintenance should particularly be completed on a regular basis on section recently reconstructed

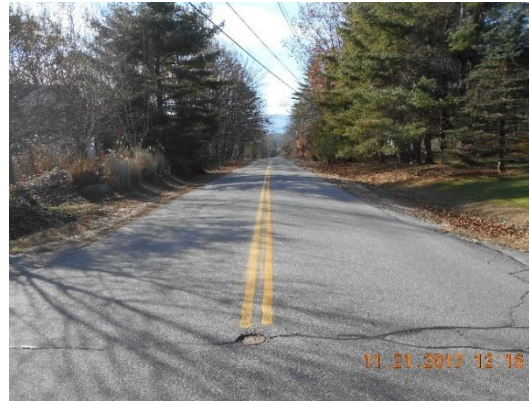
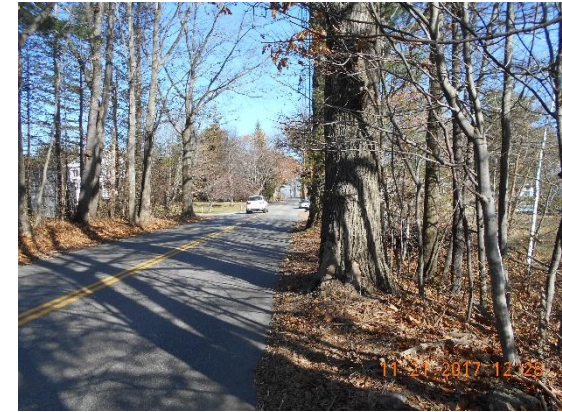
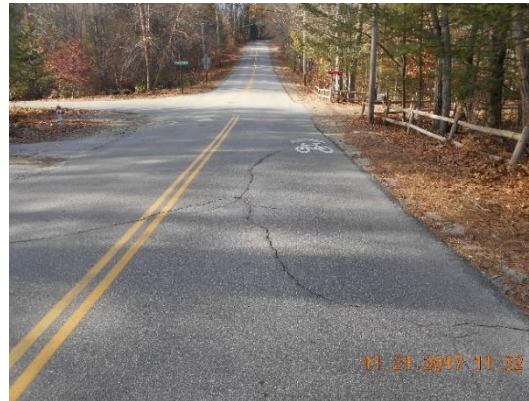
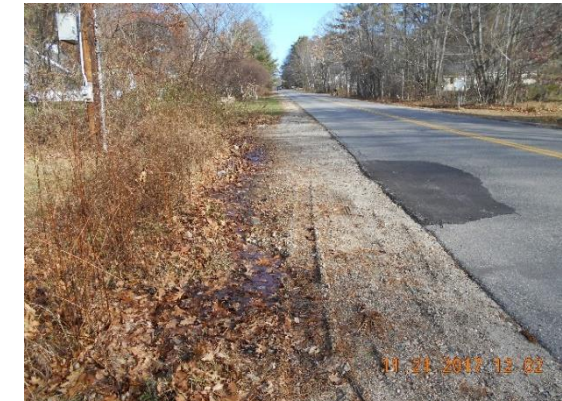
FRIAR TUCK WAY

- PCI = 73
- Previous crack sealing work completed
- Low shoulders
- Some shoulder erosion observed
- Cross section appears satisfactory
- Lower volume residential loop road

- Crack sealing
- 1.5" Overlay
- Ditching
- Gravel backing
- Year scheduled = 2027

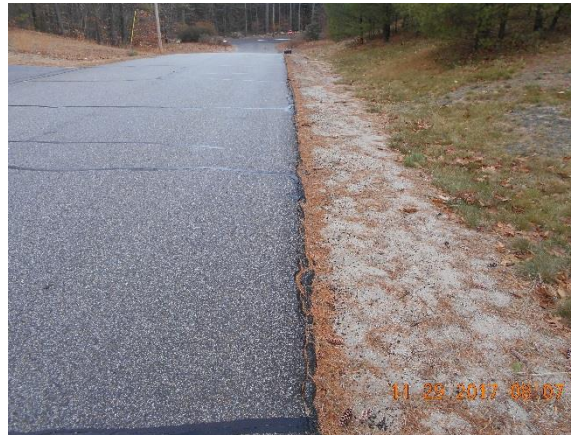
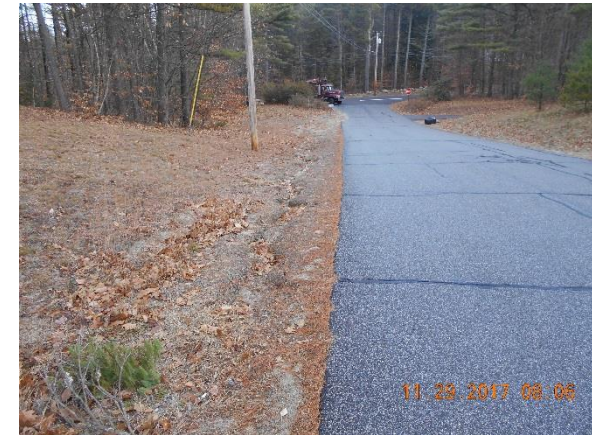
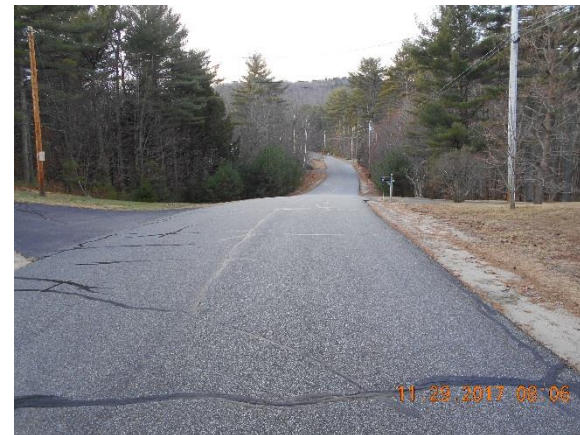
GOODRICH ROAD

- PCI = Varies 67 to 31
- Areas of cross section loss with alligator cracking at centerline
- Low shoulders at off pavement catch basins
- Low volume dead end road

- Crack sealing
- 1.5" overlay
- Gravel backing
- Year scheduled = 2019

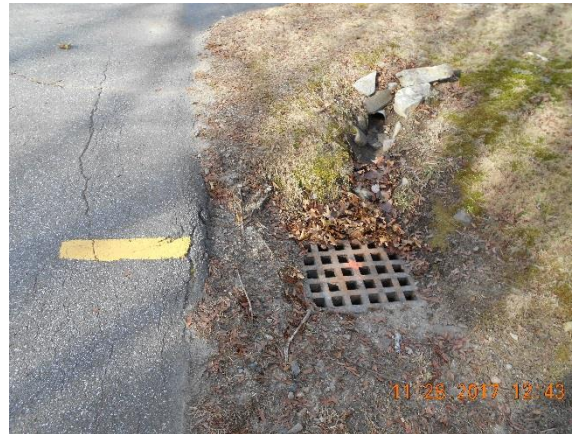
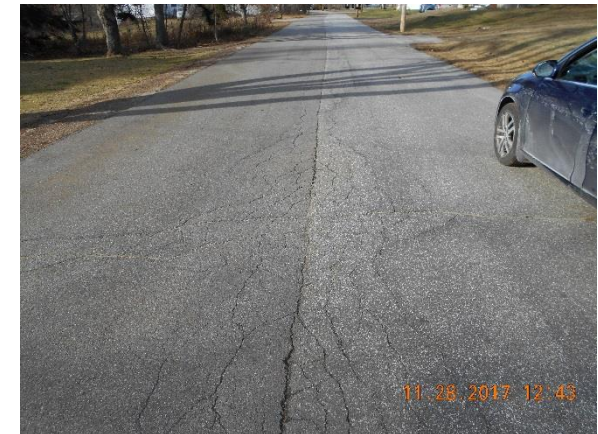
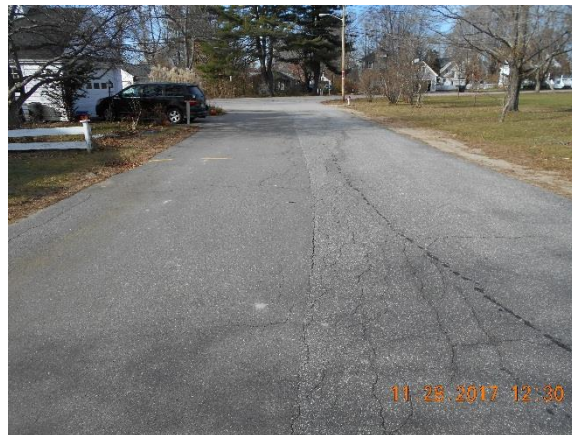
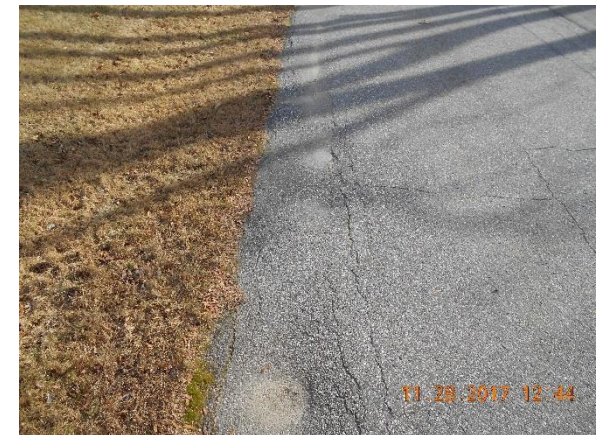
GREENLEAF DRIVE

- PCI = 75
- High extent of longitudinal and transverse cracking
- Low shoulders in areas
- Drainage generally appears satisfactory

- 1.5" Overlay
- Ditching
- Gravel Backing
- Schedule year = 2028

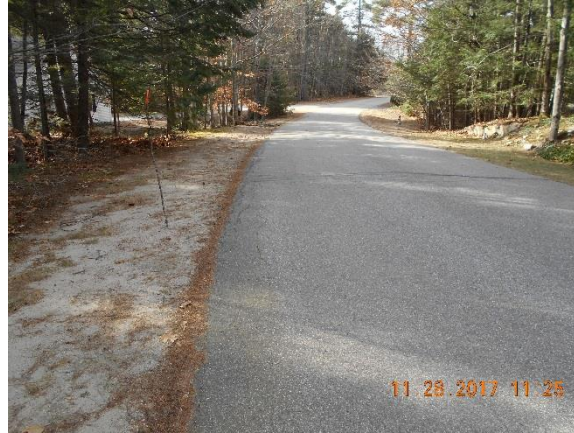
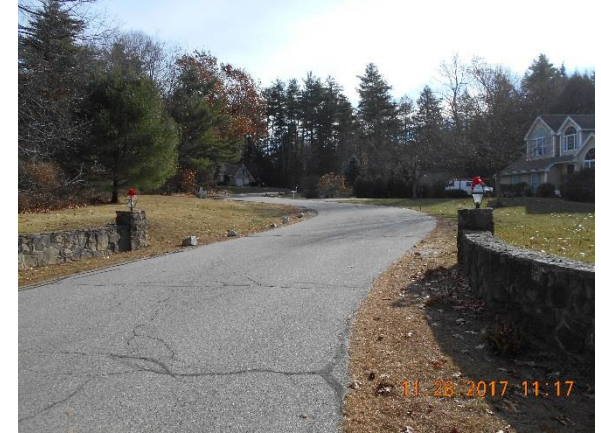
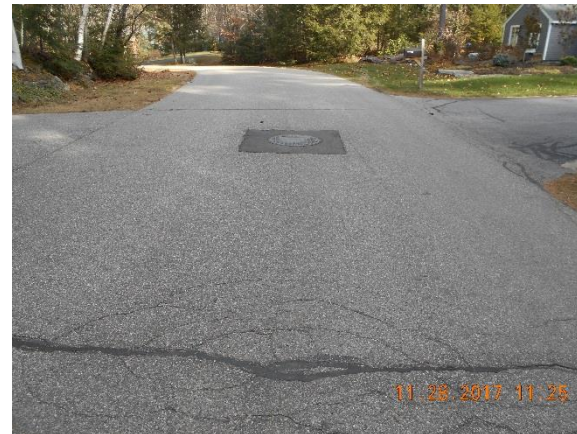
HAINES HILL ROAD

- PCI = 38
- Extensive cracking throughout paved sections
- Drainage noted to be fair however standing water observed in some areas adjacent to road outside the ROW

- Reclamation with supplemental stone
- 3" pavement
- Ditching
- Underdrains and Enclosed drainage
- Scheduled year = 2023

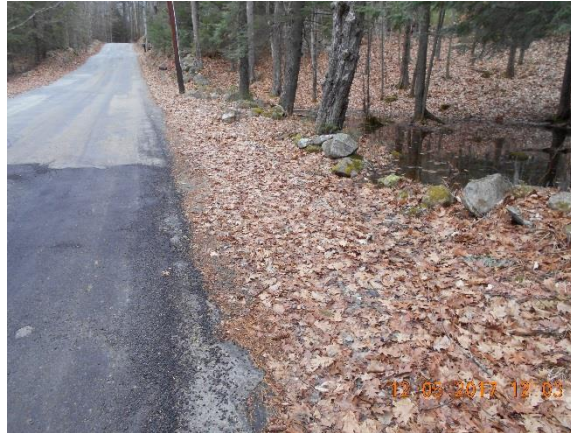
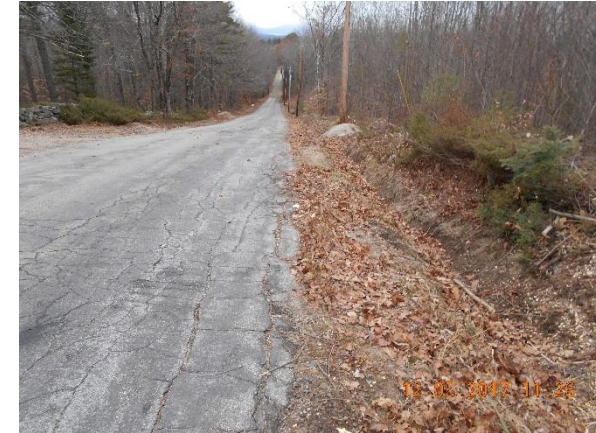
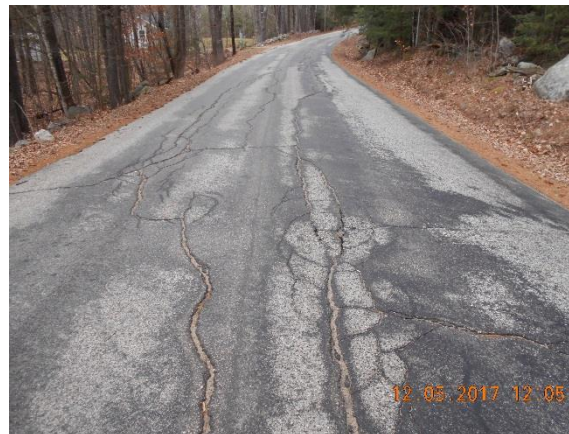
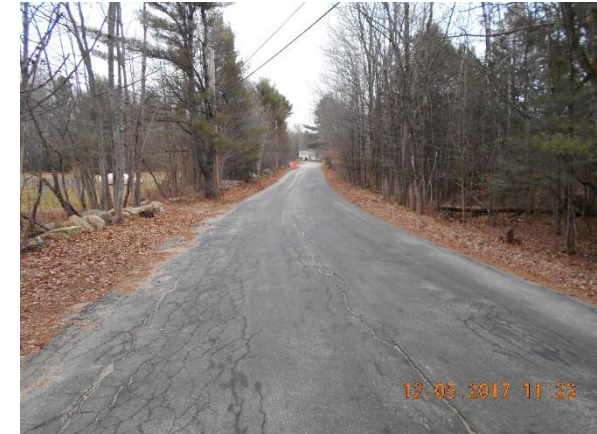
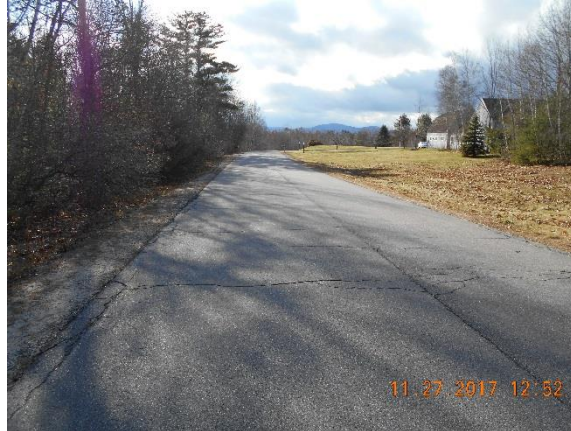
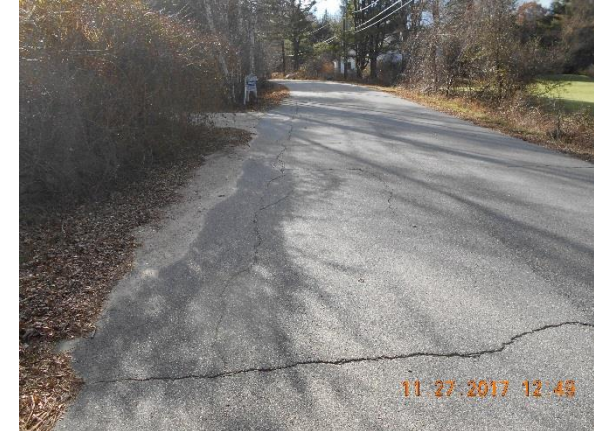
HEMLOCK DRIVE

- PCI = 66
- Some low shoulders with signs of erosion
- Moderate longitudinal and transverse cracking
- Drainage generally appears satisfactory however sand on road from gravel drives and previously noted shoulder erosion indicates some drainage concerns in select areas
- Electrical boxes observed within 3' from edge of pavement

- 1.5" Overlay
- Ditching
- Gravel Backing
- Year scheduled = 2021

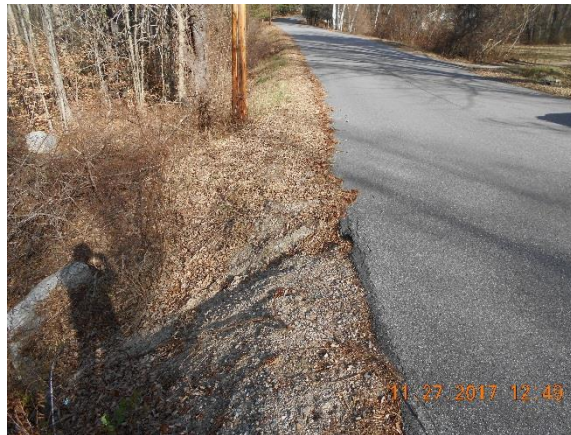
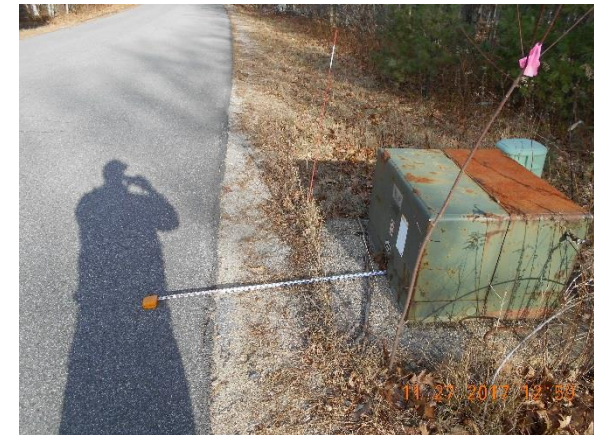
HIGH STREET

- PCI = 34
- Road surface is in failure
- Extensive cracking
- Paved swales and catch basins observed

- Reclamation with supplemental stone
- 3" pavement thickness
- Closed drainage system and underdrains
- Asphalt curbing and swales
- Year scheduled = 2019

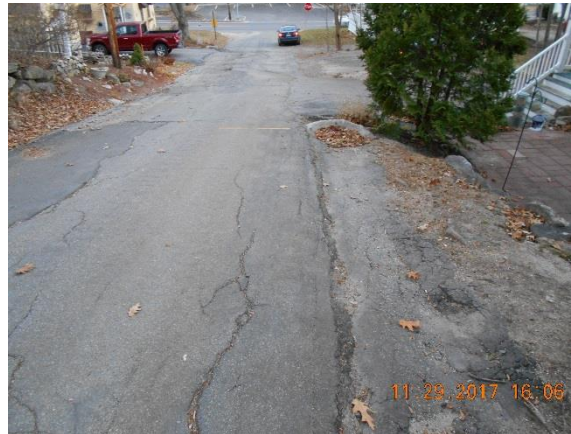
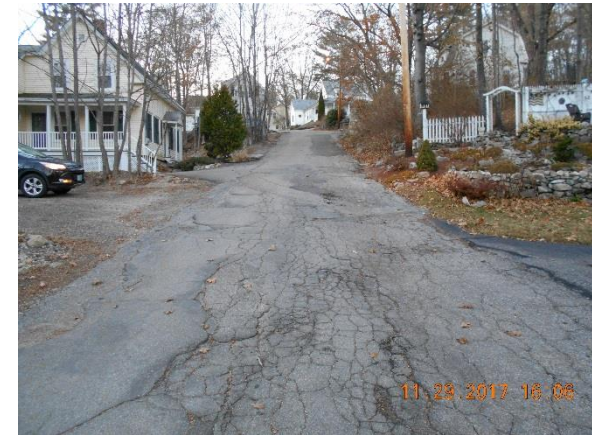
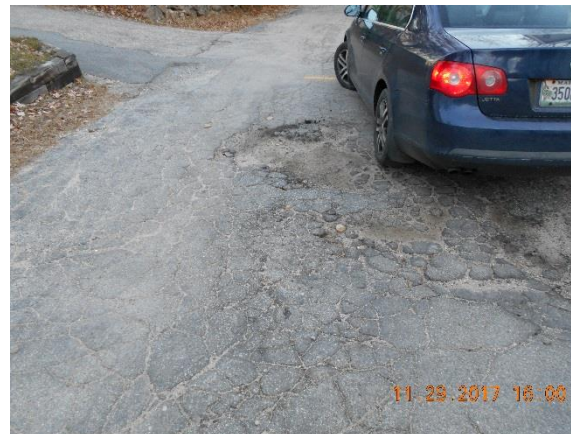
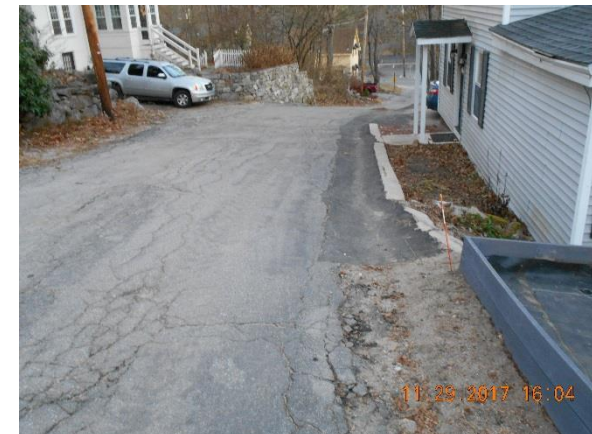
HIGHLAND TERRACE

- PCI = 75
- Low to moderate cracking observed
- Drainage observed to be fair
- Some wetland areas noted in close proximity to edge of pavement

- 1.5" Overlay
- Ditching
- Gravel Backing
- Year Schedule = 2027

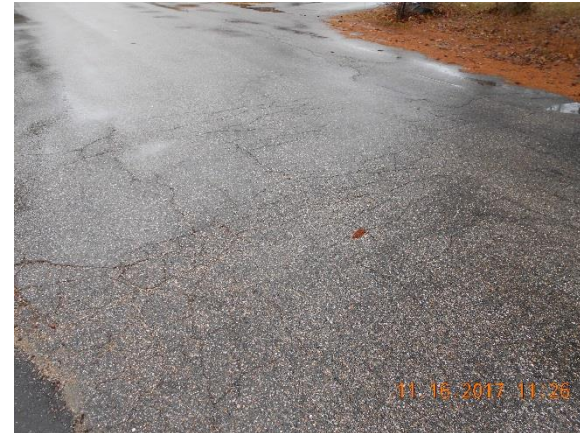
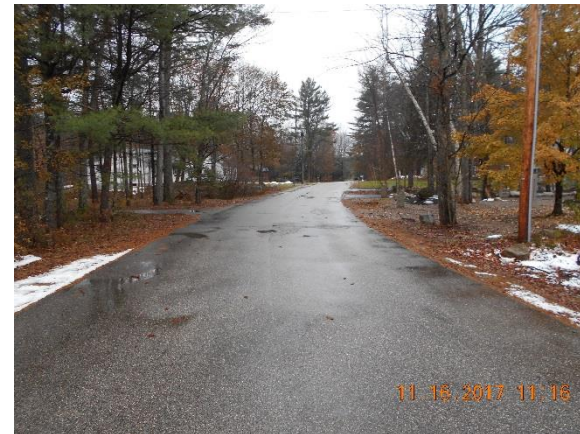
JENNESS FARM ROAD

- PCI varies 68 to 90
- Short paved section at top of road appeared to be recently paved
- Longer paved section has poor drainage with ground water percolating through cracks and running along edge of pavement
- Extensive longitudinal and transverse cracking observed on lower paved section
- Larger diameter CPE drain pipe appears to be functioning properly
- Embankment erosion
- Large trees encroaching roadway

- 1.5" Overlay
- Ditching
- Gravel Backing
- Underdrains should be considered
- Year Scheduled = 2021
