**SUMMARY REPORT
AND
FINAL DOCUMENTATION**

**WOLFEBORO ROADWAY
EVALUATION**

**TOWN OF WOLFEBORO
WOLFEBORO, NEW HAMPSHIRE**

UEI PROJECT 2211

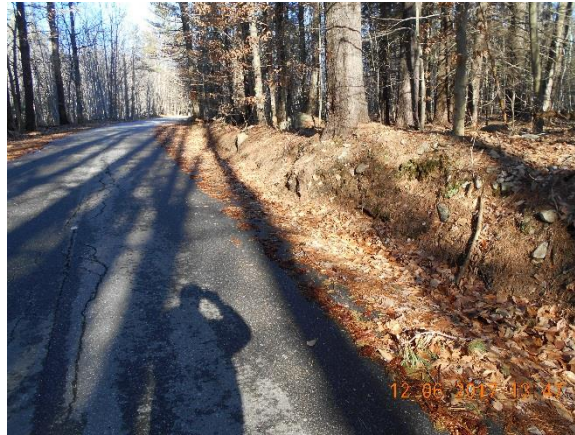
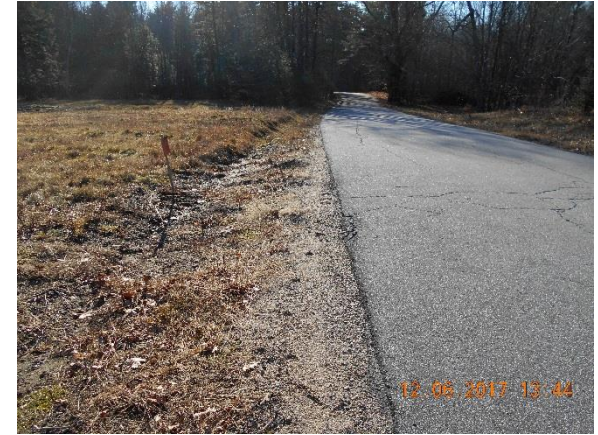
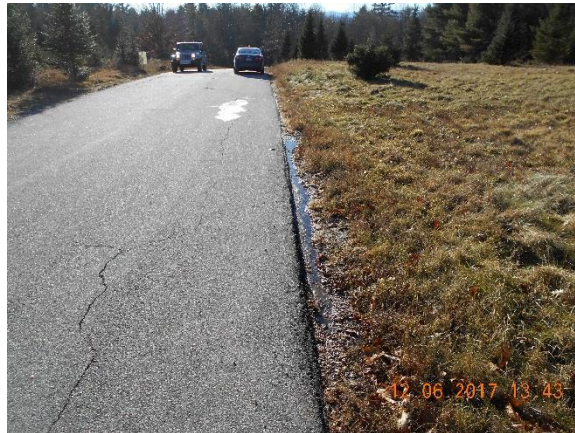
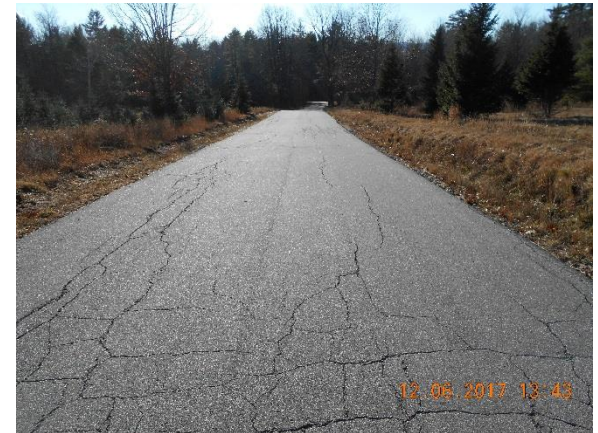
JIMINY DRIVE

- PCI = 46
- Ditching and drainage appear satisfactory
- Extensive longitudinal and transverse cracking observed
- Low shoulders in some areas

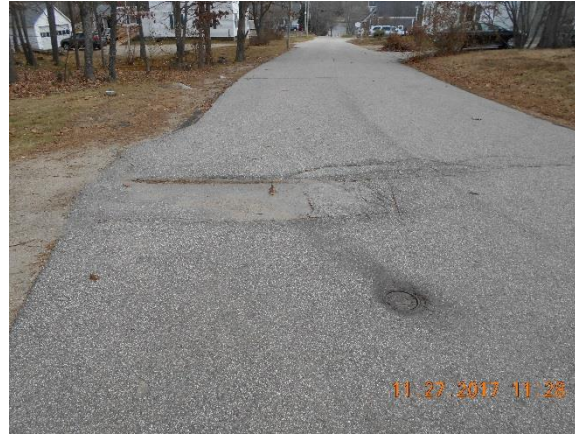
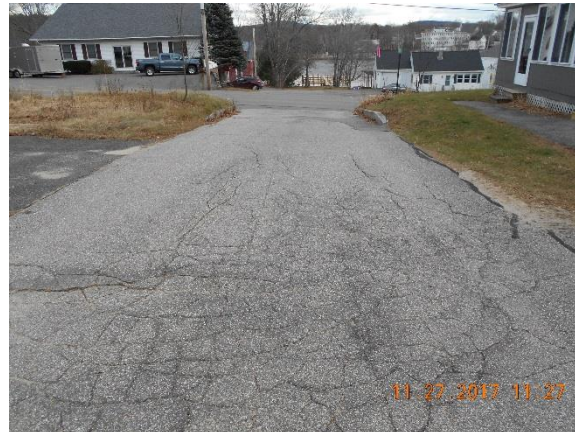
KING STREET

- PCI varies 49 to 69
- Some rutting at Bay Street
- Moderate rutting
- Poor drainage due to lawns graded towards roadway
- Utility poles measured to be approximately 1' away from pavement

- Reclamation with supplemental stone aggregate
- 3" pavement
- Enclosed drainage and underdrains
- Vertical curbing
- Gravel backing
- Year scheduled - 2027

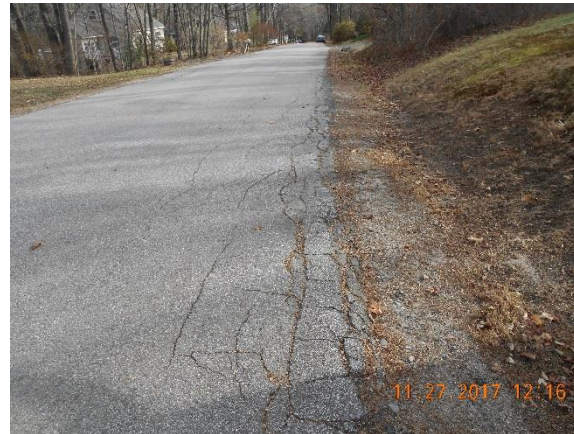
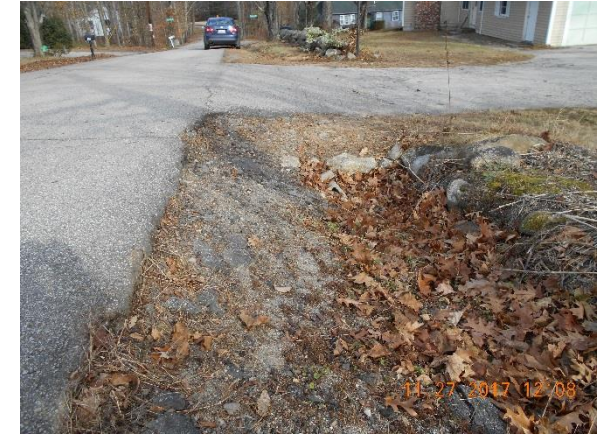
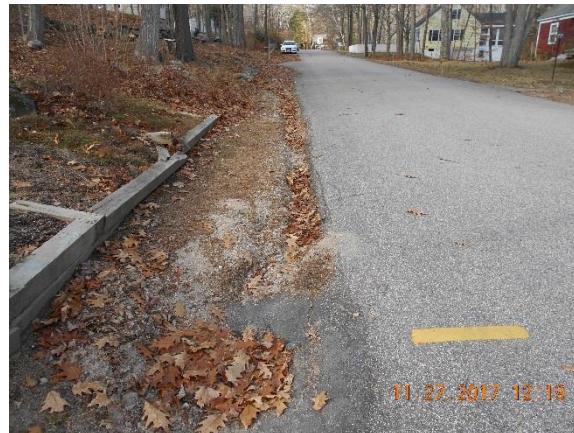
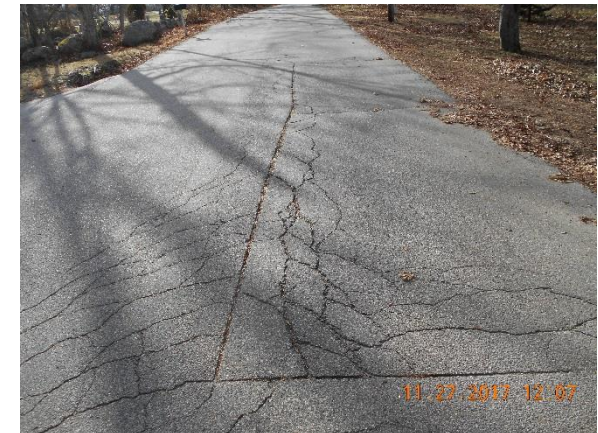
LAKEVIEW DRIVE

- PCI varies 61 to 72
- Severe cracking in isolated areas
- Ditches exist on up-gradient side of road
- Some shoulder erosion
- Low shoulders

- 1.5" overlay
- Reclamation with supplemental stone aggregate
- 3" pavement thickness
- Closed drainage and underdrains
- Gravel backing
- Ditching
- Year scheduled = 2024

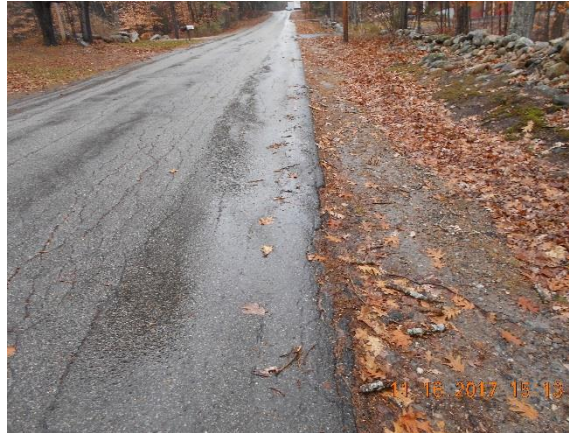
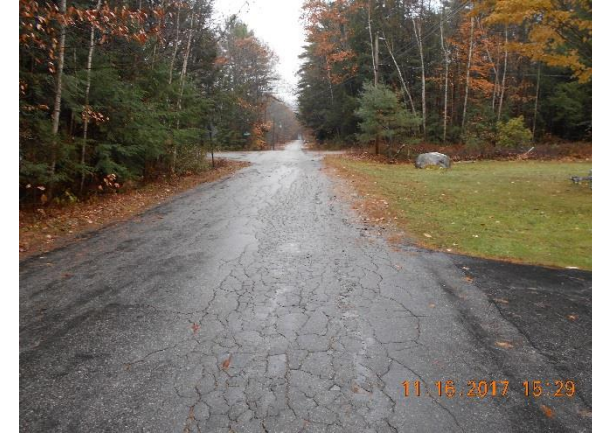
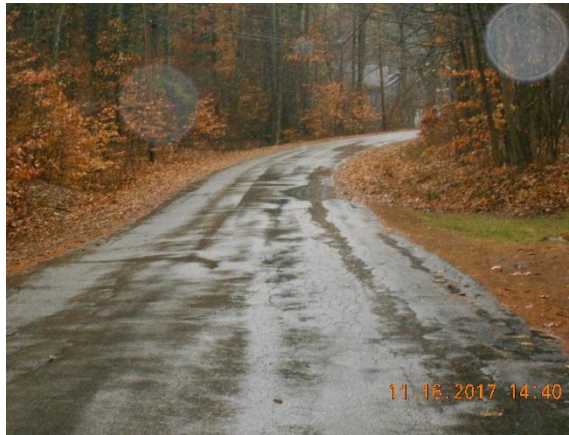
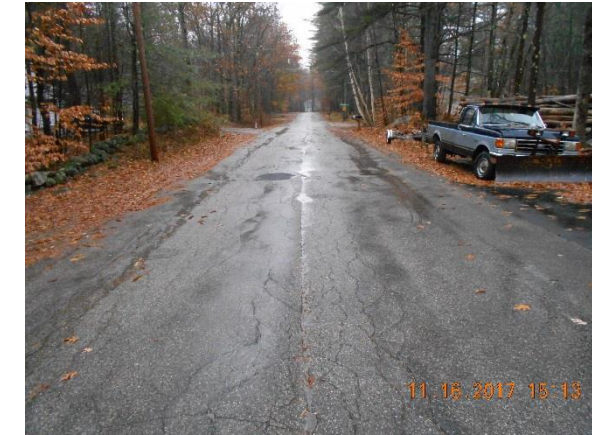
MAPLEWOOD DRIVE

- PCI varies 38 to 69
- Section 4 is a dead end with shoulders graded towards the road
- Rutting is isolated areas with puddling on the roadway
- Some area of good ditching
- Moderate and severe cracking through most of the roadway

- Reclamation
- 3" nominal pavement thickness
- Gravel backing
- Ditching
- Asphalt Swales in isolated areas
- Year scheduled = 2025

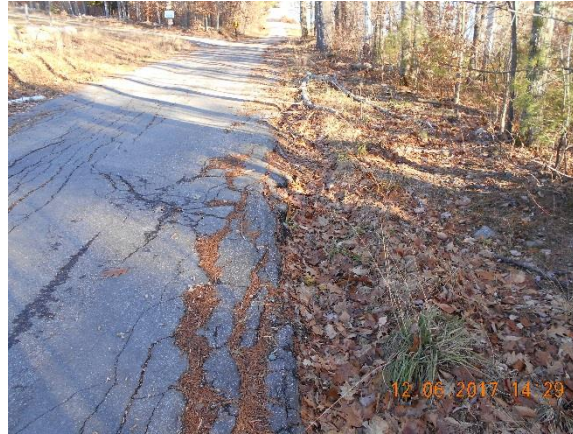
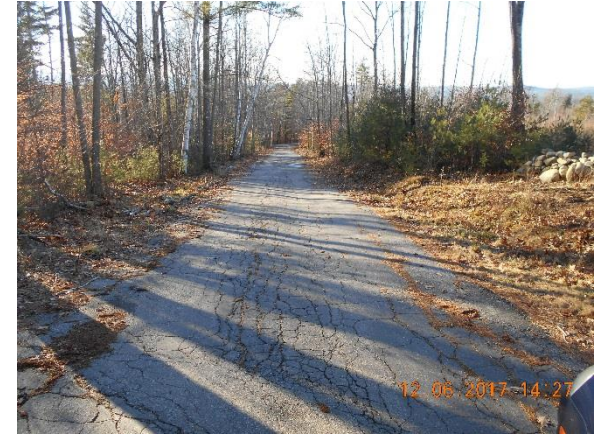
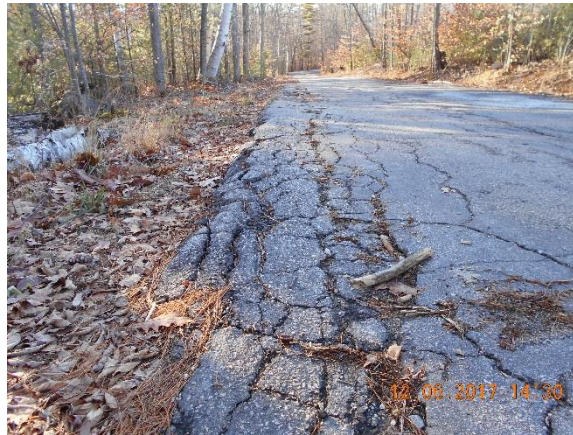
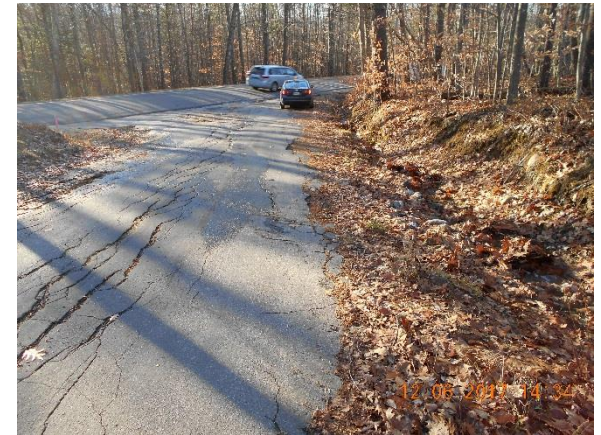
MARTIN HILL ROAD

- PCI = 16
- Road has failed
- Groundwater flowing through pavement
- Poor shoulders

- Reclamation with supplemental stone aggregate
- 3" nominal pavement thickness
- Closed drains and underdrains
- Ditching
- Underdrains
- Year scheduled = 2019

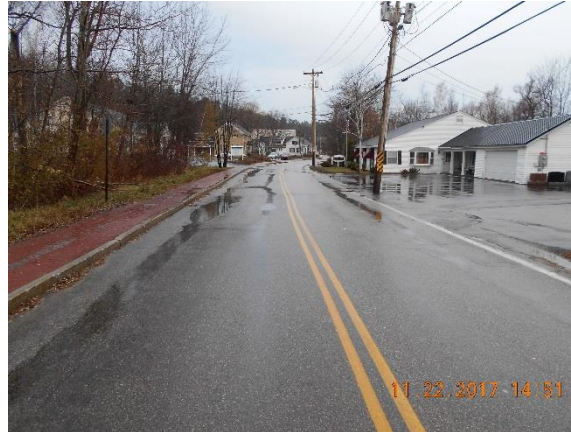
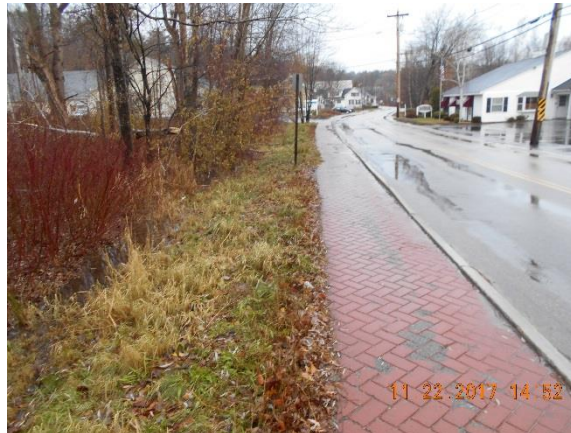
MILL STREET

- PCI varies 81 to 56
- Settlement and rutting adjacent to wetland area that appears higher than roadway
- Some road drainage drains onto adjacent to roadway

- Reclamation and supplemental stone aggregate
- 3" nominal pavement thickness
- Closed drainage and underdrains
- Year scheduled = 2028

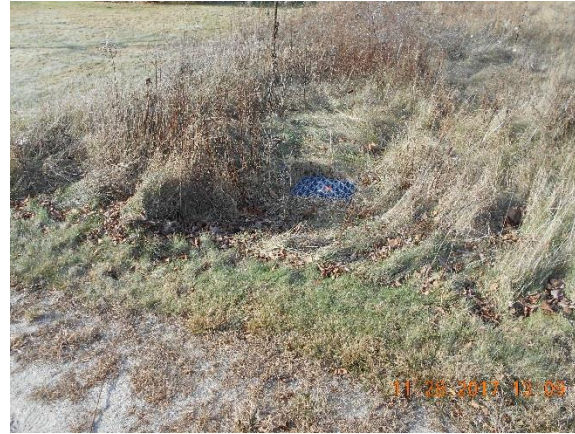
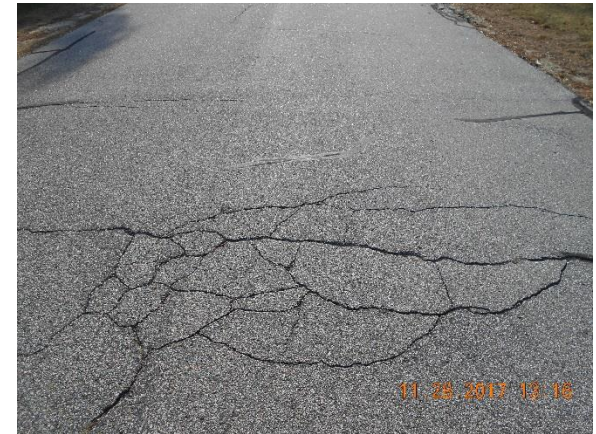
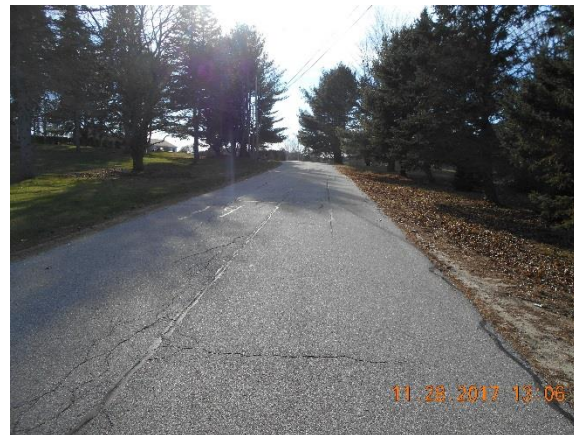
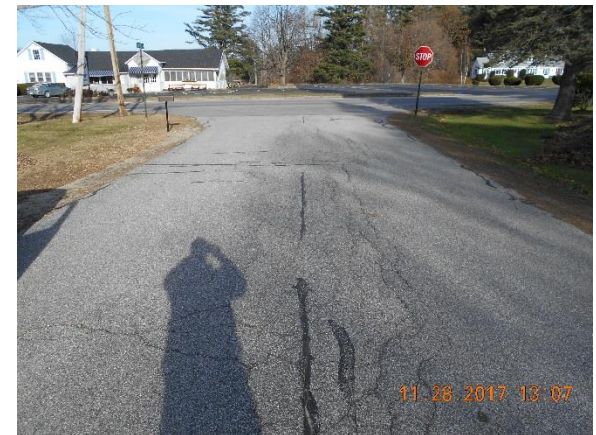
OLD MILL DRIVE

- PCI = 69
- Some shoulder areas grade towards pavement. Roadway must still drain as surface is in fair shape.
- Moderate cracking throughout

- Crack seal
- 1.5" overlay
- Gravel backing
- Year Scheduled = 2024

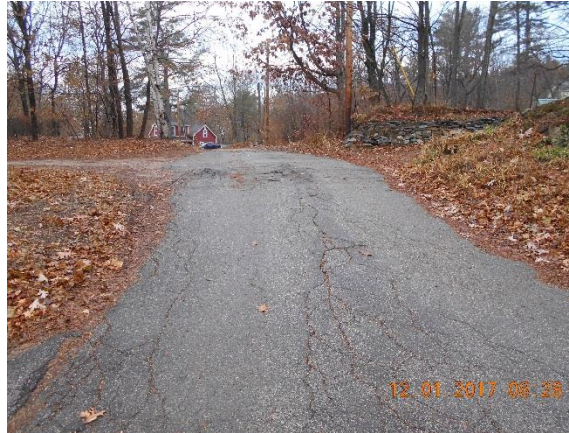
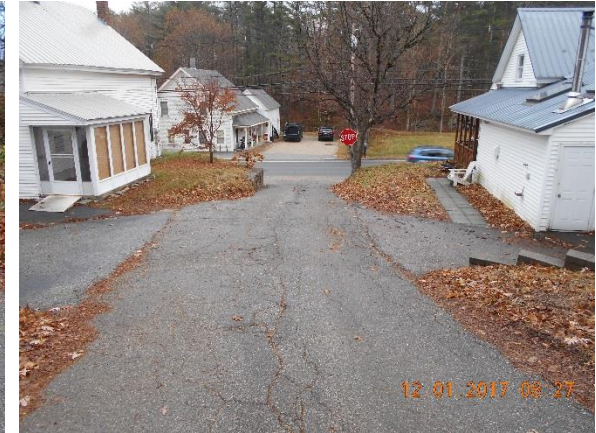
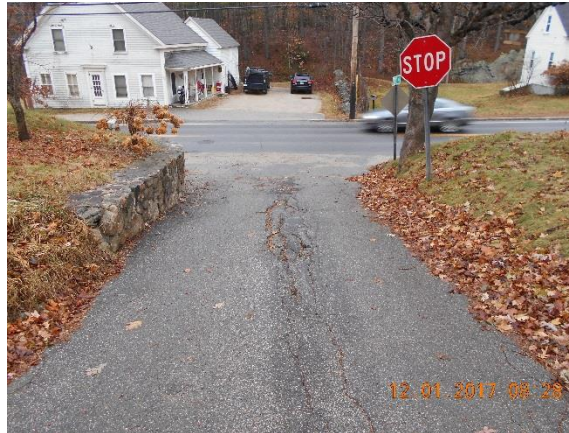
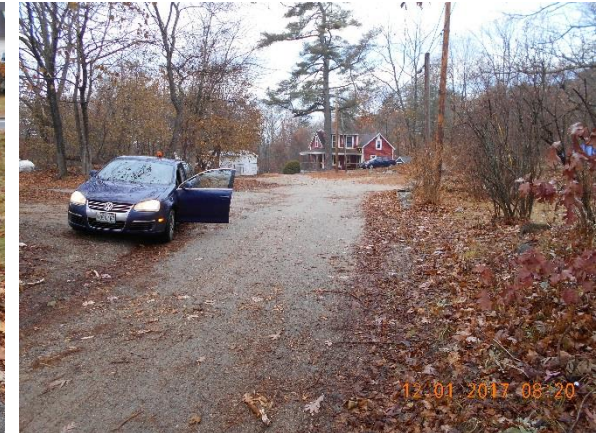
PARK AVENUE

- PCI = 34
- Gravel section (top of hill) in satisfactory shape.
- Paved section in poor condition
- Extensive cracking throughout
- Road very narrow due to retaining wall at intersection with Rt 28. Sight distance did not seem impacted

- Reclamation with supplemental stone aggregate
- 3" nominal pavement thickness
- Asphalt berm
- Closed drainage and underdrains
- Gravel backing
- Year scheduled 2019

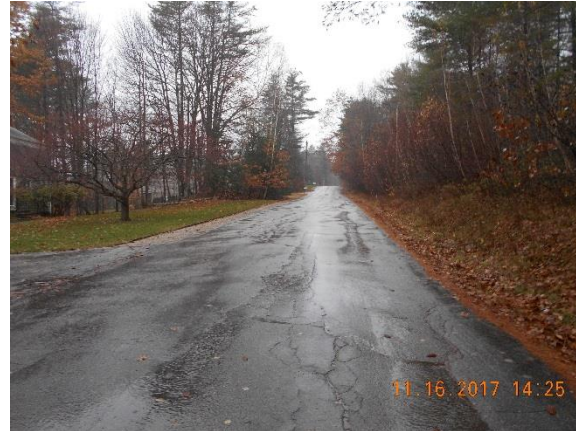
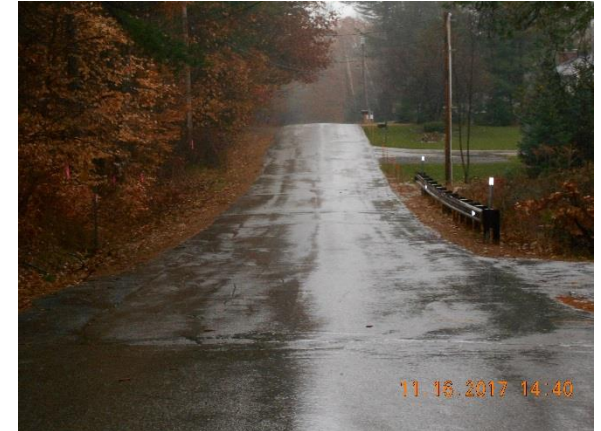
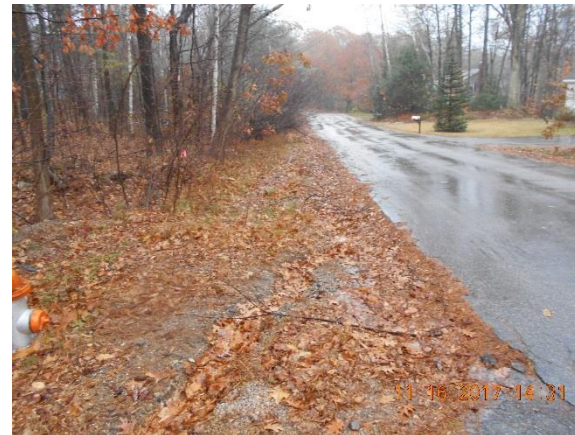
PARTRIDGE DRIVE

- PCI varies 55 to 58
- Slight wheel rutting with runoff in wheel path
- Needs ditching in some areas
- Shoulder erosion observed in areas where ditches exist

- Reclamation with supplemental stone aggregate
- 3" nominal pavement thickness
- Asphalt berms
- Underdrains
- Ditching
- Gravel backing
- Year schedule = 2028

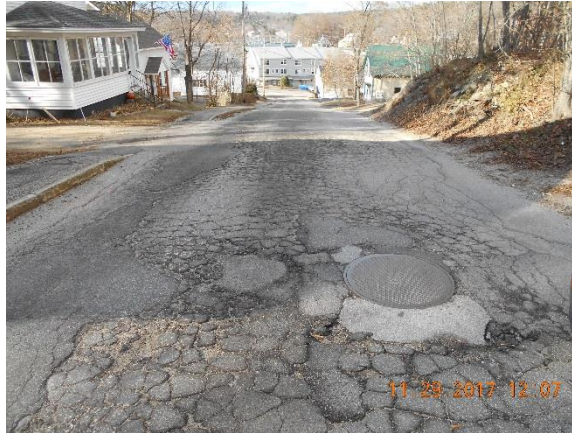
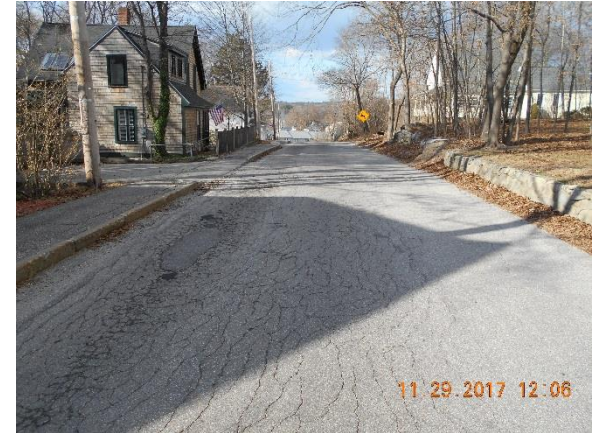
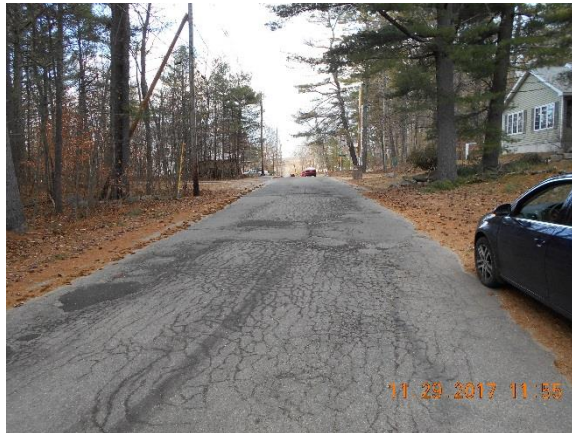
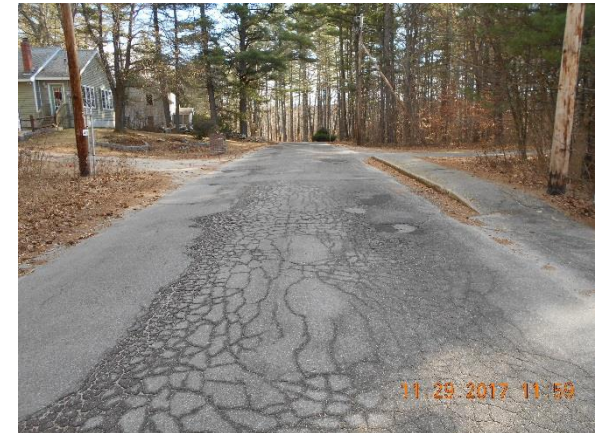
PINE STREET

- PCI varies 44 to 52
- Edge of pavement no visible due to quantity of needles on ground
- Road appears to have been previously shimmed
- Road in poor condition
- Traffic observed to be heavy for type of road. Assumed that used as short cut to avoid intersection at RT 109 and RT 28

- Reclamation with supplemental stone aggregate
- 3" nominal pavement thickness
- Vertical granite curbing
- Underdrains
- Ditching
- Gravel backing
- Consider posting road as "No Thru Traffic"
- Year scheduled = 2027

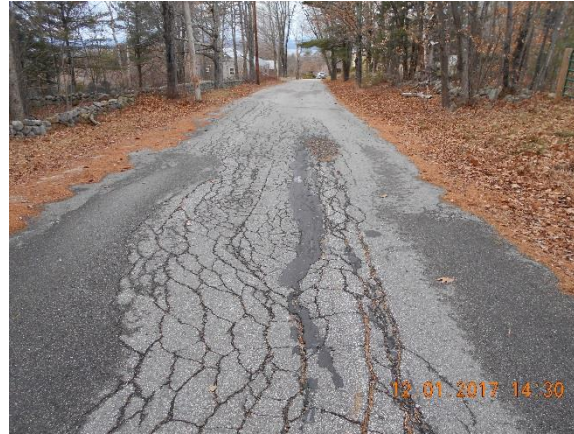
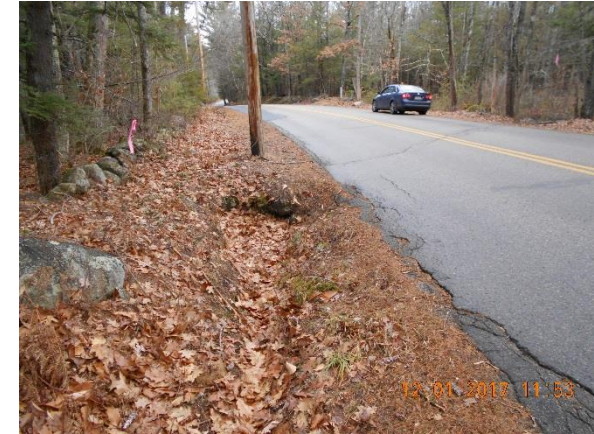
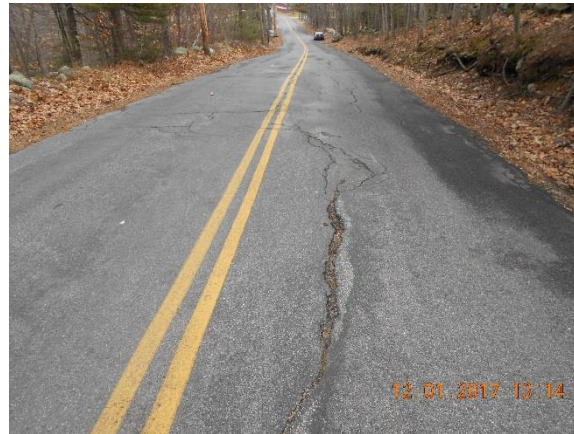
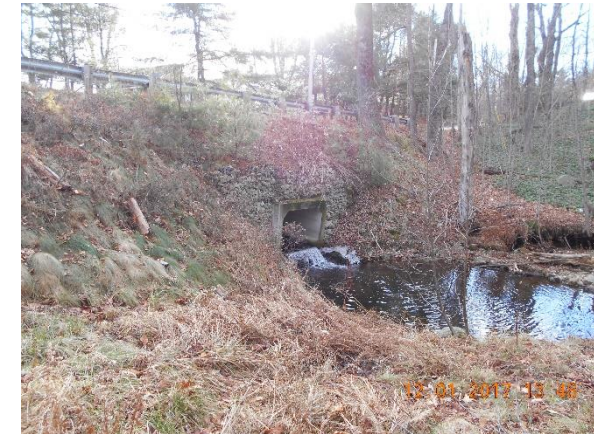
PLEASANT VALLEY ROAD

- PCI varies 32 to 89
- Between Rt 28 and New Garden Road in poor condition
- Some sections beyond New Garden Road previously overlaid
- Short section of deteriorated pavement in overlaid area near Sunset Point Road.
- CBs present in some areas
- Some shoulder erosion in areas
- Section 15 assessed is beyond Town line but reported to be maintained by Town
- Large diameter culverts appear to be previously reconstructed, however gabion walls could be leaning.

- 1.5" overlay on previously overlay/reconstruction areas
- Reclamation and supplemental stone aggregate on areas not previously reconstructed
- 4" nominal pavement thickness
- Closed drainage systems and underdrains
- Asphalt berms
- Gravel backing
- Ditching
- Year Schedule = 2021 & 2022 (2 years due to estimated budget)

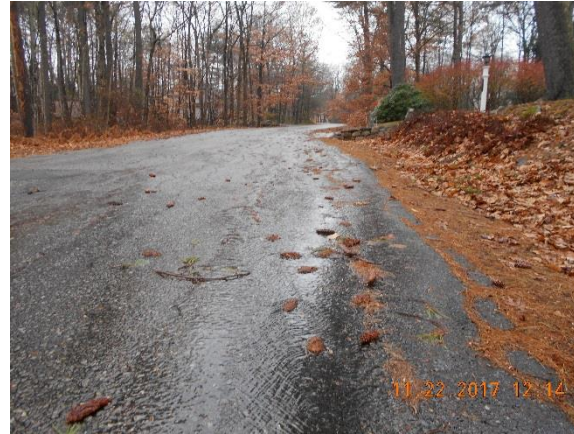
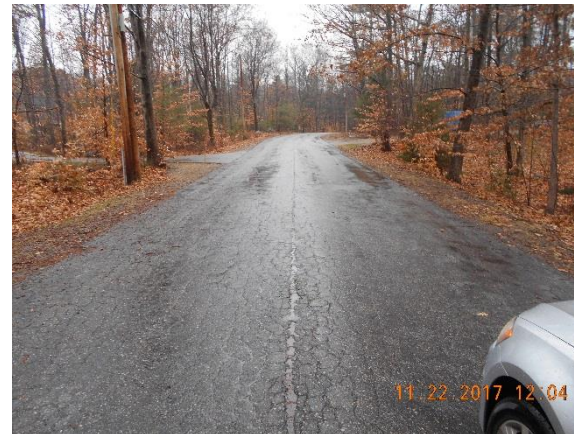
- PCI = 41
- Ditching appeared to be in place where needed
- Isolated areas of sediment transport and shoulder erosion
- X-section generally satisfactory except for isolated area and rutting
- Significant alligator cracking
- Moderate longitudinal and transverse cracking

- Reclamation with supplemental stone aggregate
- 3" pavement nominal thickness
- Closed drainage systems and underdrains
- Ditching
- Gravel backing
- Year schedule = 2026

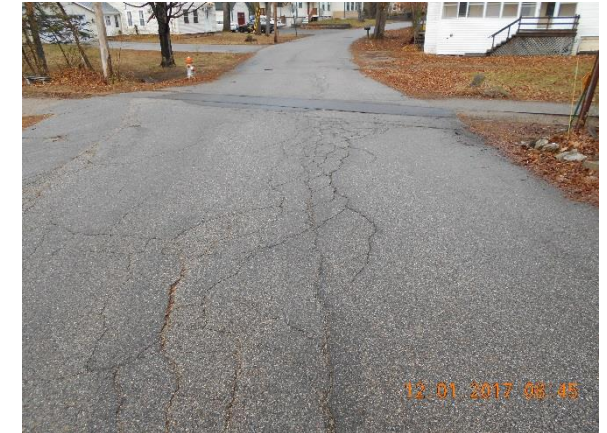
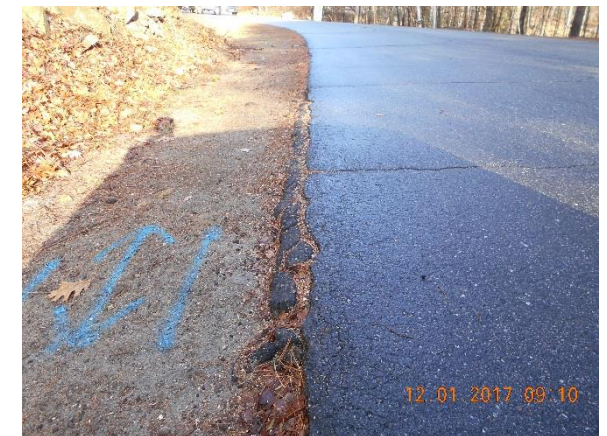
RIVER STREET

- PCI varies 58 to 74
- Crown and cross-sectional shape appear satisfactory despite level of cracking
- Very low shoulders in some areas
- Moderate alligator throughout
- Moderate longitudinal and transverse cracking throughout
- Drainage satisfactory

- Reclamation with supplemental stone aggregate
- 3" nominal thickness pavement
- Underdrains
- Gravel backing
- Ditching
- 1.5" overlay for section 1
- Year scheduled = 2027

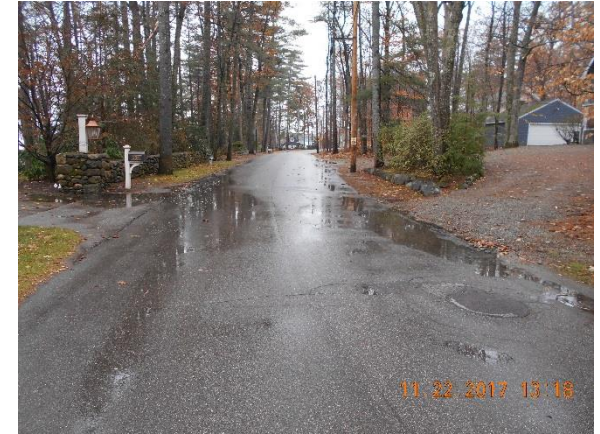
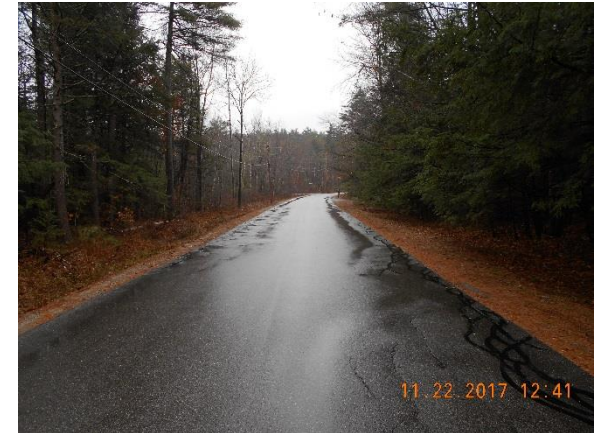
SEWALL ROAD

- PCI varies 61 to 95
- Section 3 appeared to have been reconstructed more recently but section 1 and 2 also in fair condition
- Isolated puddle areas otherwise road side drainage appears satisfactory with ditches, shoulders, and asphalt swales
- Areas with stone walls tight to edge of pavement
- Low severity cracking through out
- Marina located on road

- Crack sealing
- 1.5" overlay
- Gravel backing
- Ditching
- Milling in areas with curbing to maintain appropriate reveal
- Year scheduled = 2019

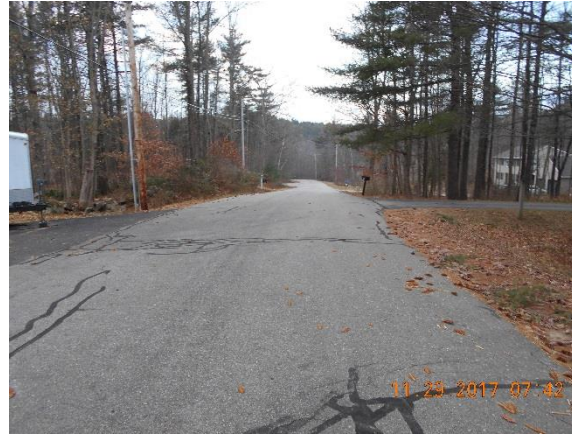
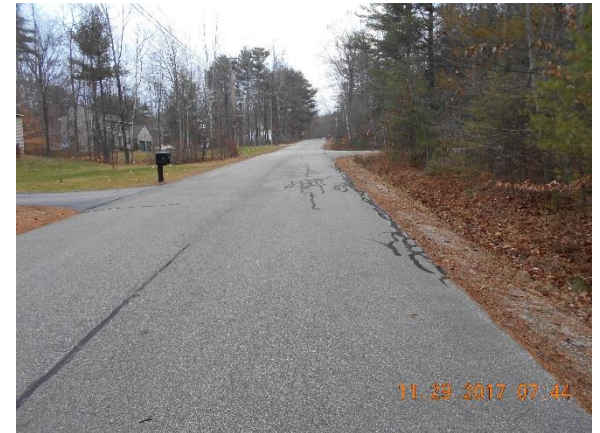
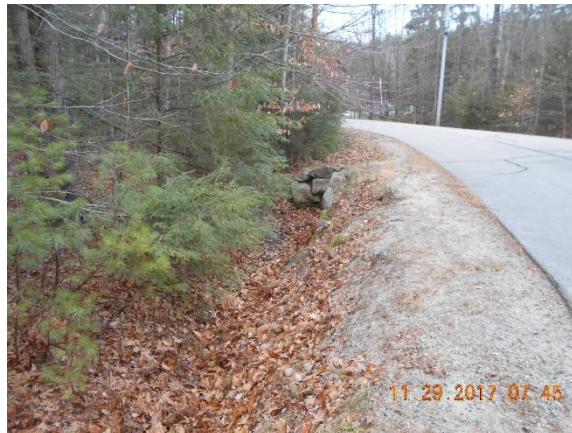
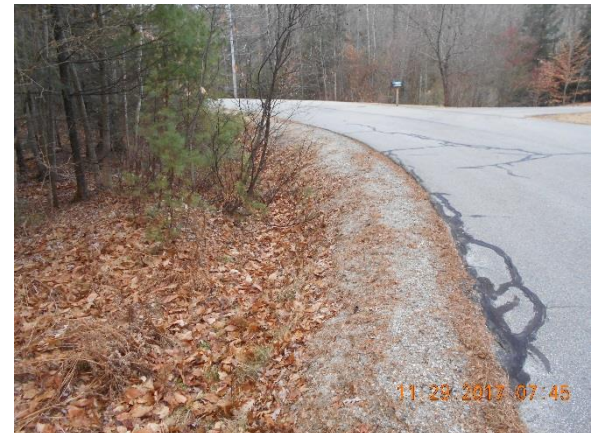
SLEEPY HOLLOW ROAD

- PCI = 80
- Surface drainage appears satisfactory
- Potential erosion in bottom of ditches
- Low to moderate cracking in all categories

- 1.5" overlay
- Crack sealing
- Gravel backing
- Ditch maintenance
- Year scheduled = 2029

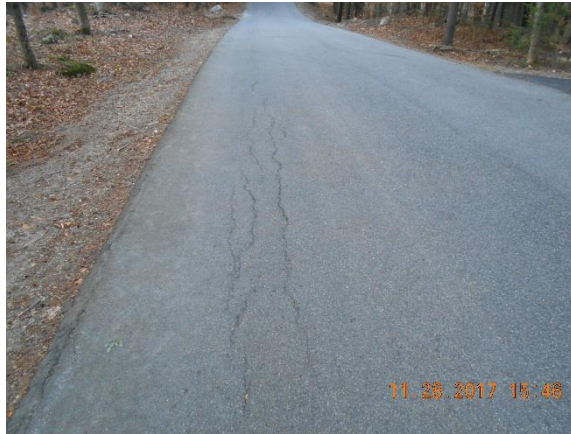
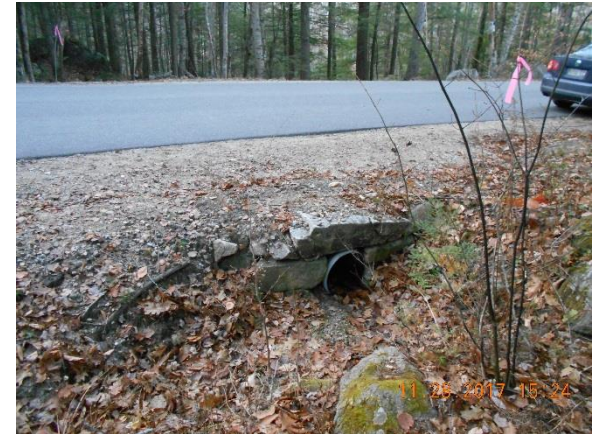
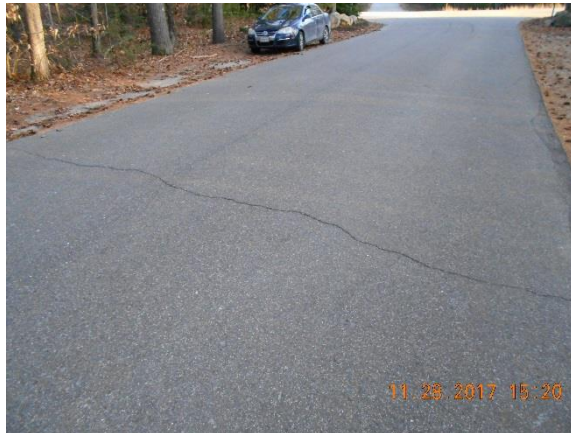
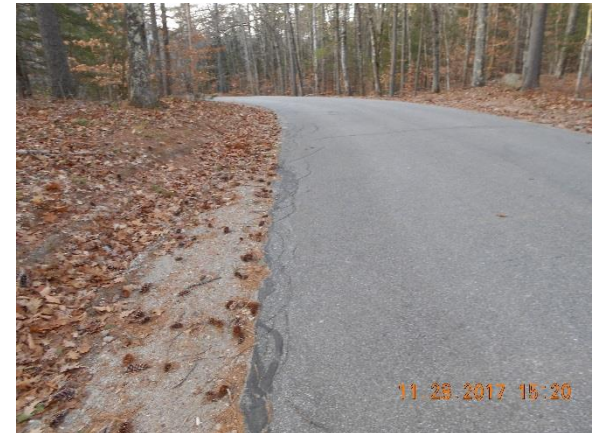
SPRINGFIELD POINT ROAD

- PCI varies 72 to 88
- Road reconstructed in _____
- Low shoulder areas
- Low severity cracking throughout
- Road is in fair condition overall

- 1.5" overlay
- Crack sealing
- Gravel backing
- Ditch maintenance
- Year scheduled = 2024

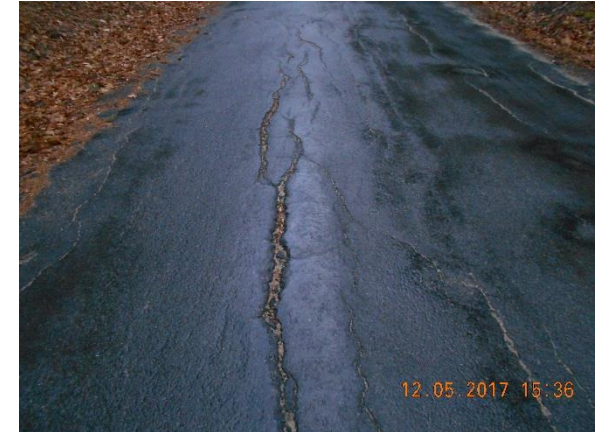
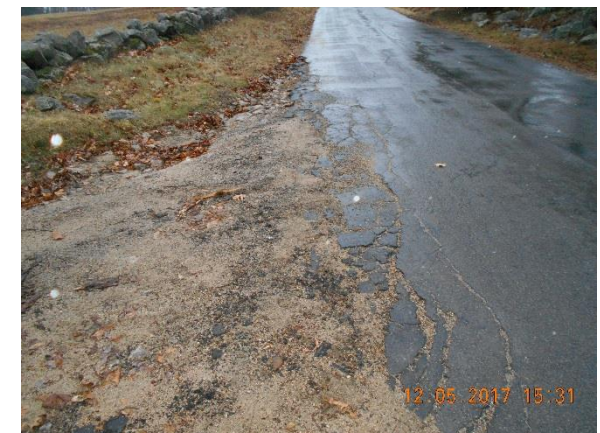
STODDARD ROAD

- PCI = 38
- Moderate and severe cracking throughout
- Poor drainage in areas, standing water in the gravel sections
- Some gravel sections have significant amounts of surface water draining from embankment in to shoulder/ditch areas

- Reclamation with supplemental stone aggregate
- 3" nominal pavement thickness
- Ditching (turf and stone)
- Closed drainage and underdrains
- Significant regrading of some gravel sections to raise road and eliminate embankments and provide ditches
- Large diameter culvert replacements
- Year scheduled = 2026

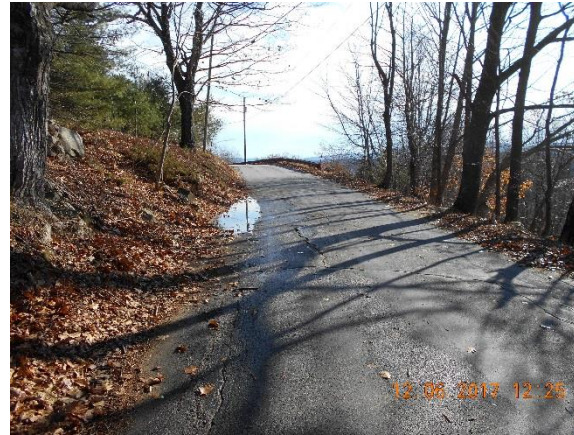
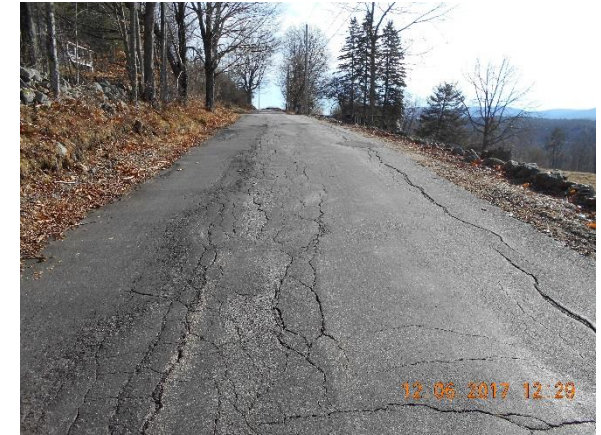
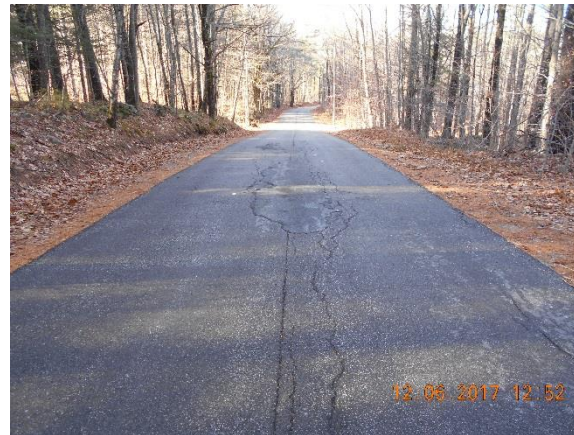
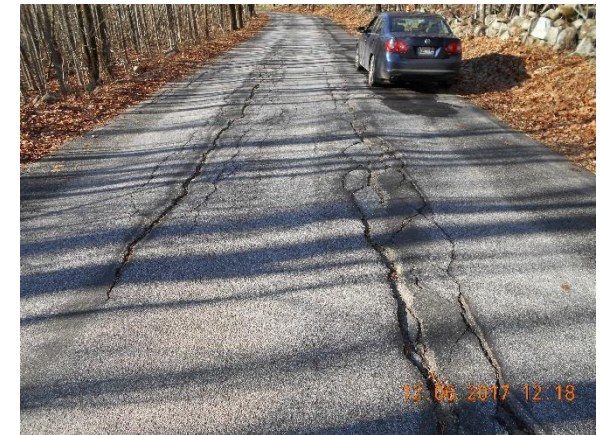
STONEHAM ROAD

- PCI ranges 13 to 73
- Section 1 has failed
 - Narrow road cut into hill side
 - Standing water
 - Extensive cracking
 - Moderate rutting
 - Retaining walls on down gradient side in areas
- Sections 2 and 3 rebuilt in 2013
 - Moderate longitudinal and transverse cracking through out
 - Inlet or outlet not observed for flowing culvert crossing near N. Wakefield Road. CPE outlet pipe observed is dry (overflow?)

- Section 1
 - 10" crushed gravel, rehandled reclamation with supplemental stone aggregate
 - Closed drainage and underdrains
 - Asphalt swales/berms
 - Ditching
 - Gravel backing
- Section 2 and 3
 - 1.5" overlay
 - Crack sealing
 - Asphalt curbing
 - Underdrains
 - Gravel backing
 - Ditch maintenance

- Year scheduled = 2019/2020

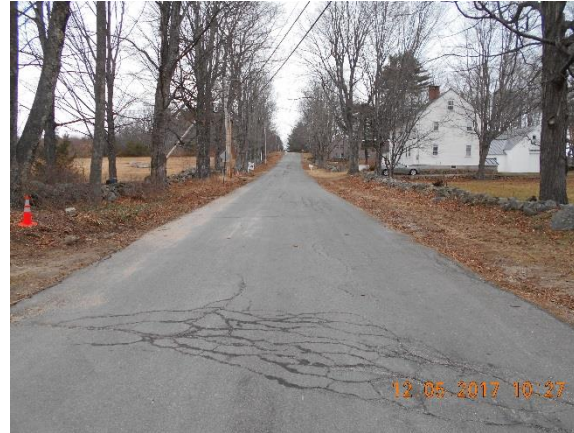
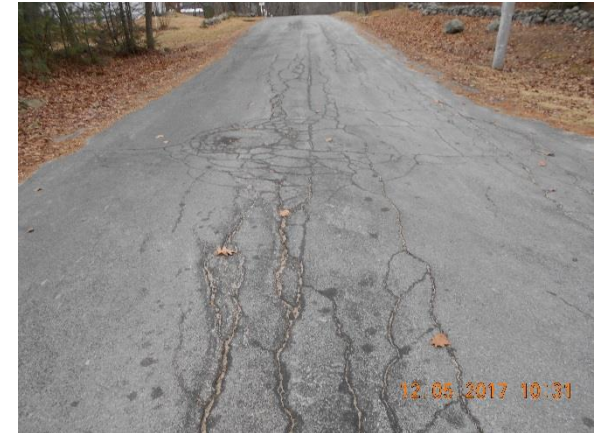
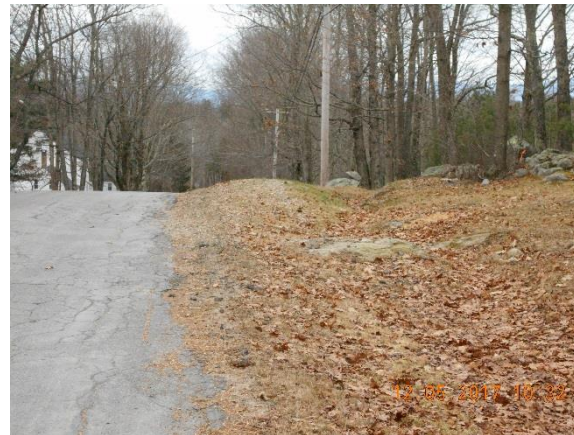
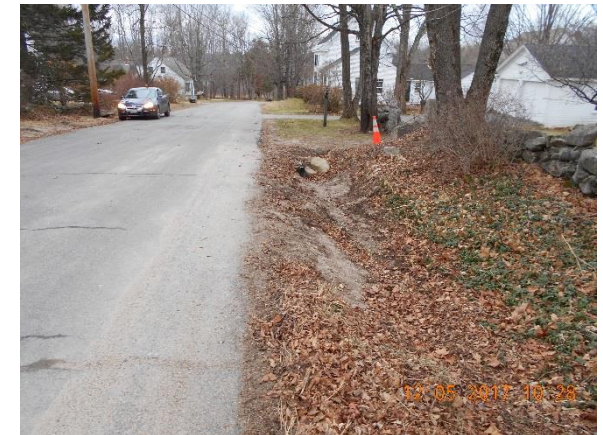
TRASK MOUNTAIN ROAD

- PCI = 47
- Moderate cracking though out
- Some ditching on lower half
- Exposed ledge in shoulder area of road
- Gravel section in satisfactory condition with good ditching that appears stable

- Paved section
 - Reclamation with supplemental stone aggregate
 - Underdrain
 - Ledge removal
 - Gravel backing
 - Ditching
 - Year scheduled = 2026
- Gravel Section
 - Routine maintenance grading
 - Ditching

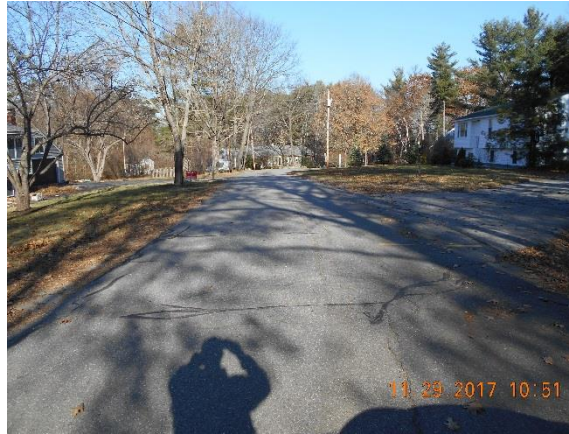
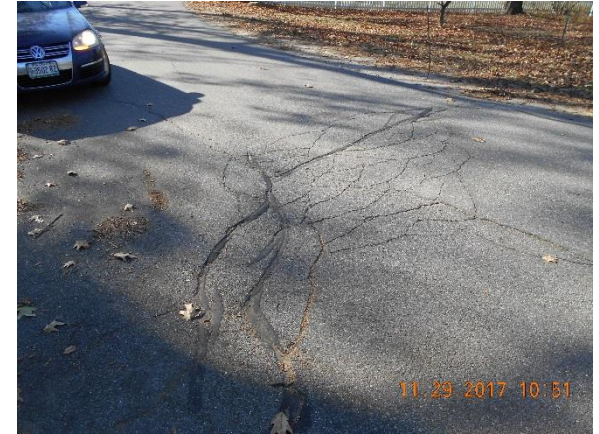
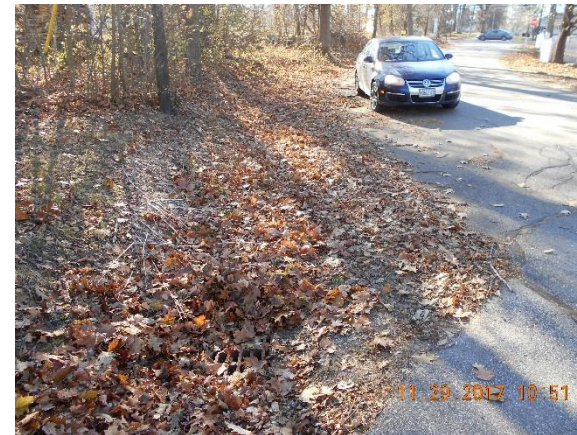
TREADWELL LANE

- PCI = 72
- Moderate cracking through out
- Drainage appears satisfactory
- Some ditches with CBs

- 1.5" overlay
- Milling may need to be reviewed for grading in areas with curbing
- Crack sealing
- Gravel backing
- Ditch maintenance
- Year scheduled = 2025

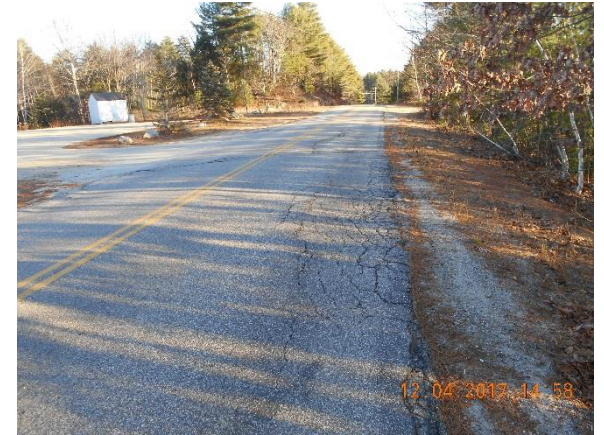
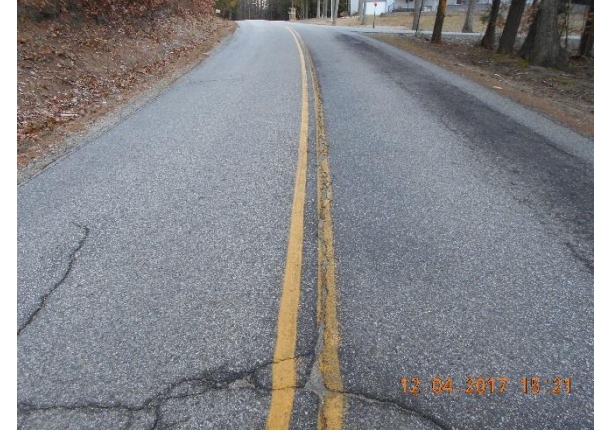
TROTTING TRACK ROAD

- PCI varies 32 to 60
- Moderate and severe cracking through out
- Previous shimming completed
- Large embankment areas across from rec fields appears to be eroding
- Ditching where present appears functional

- 10" crushed gravel, rehandled reclamation with supplemental stone aggregate
- 4" nominal pavement thickness
- Closed drainage and underdrains
- Large diameter culvert replacement
- Gravel backing
- Ditching
- Year scheduled = 2024 & 2025 (multiple years due to estimated budget).

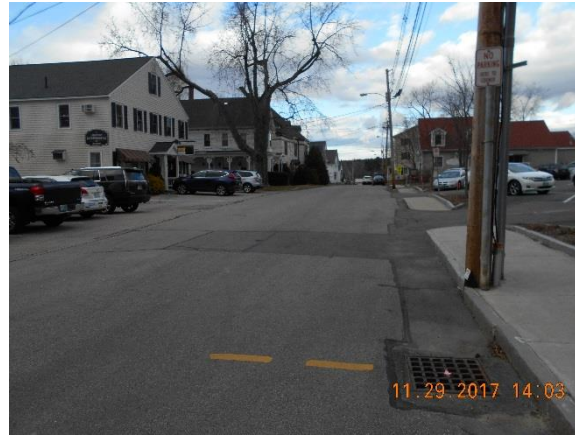
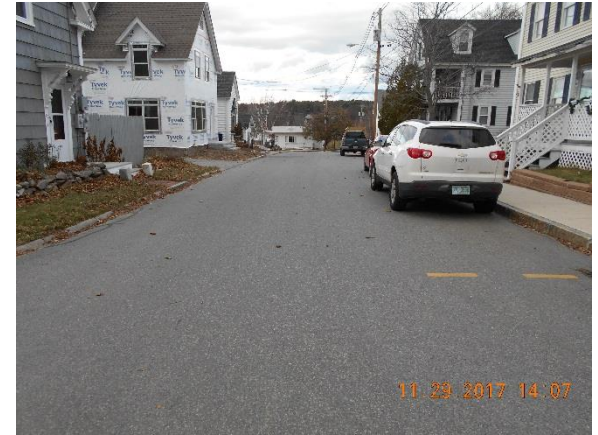
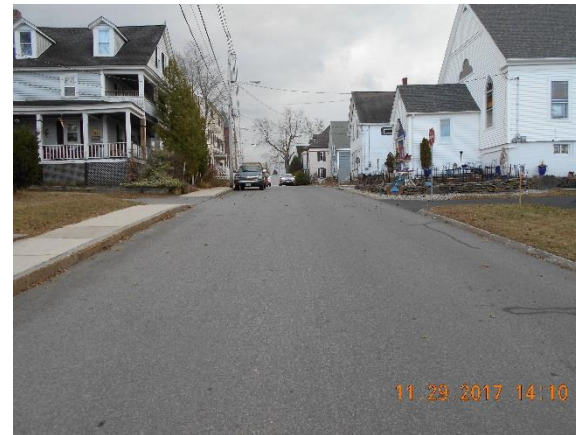
UNION STREET

- PCI varies 73 to 89
- Road overall in good condition
- Access to Town Hall parking lot
- Some trench patching
- Curbed with close drainage system

- Mill with 1.5" overlay
- Year scheduled = 2025

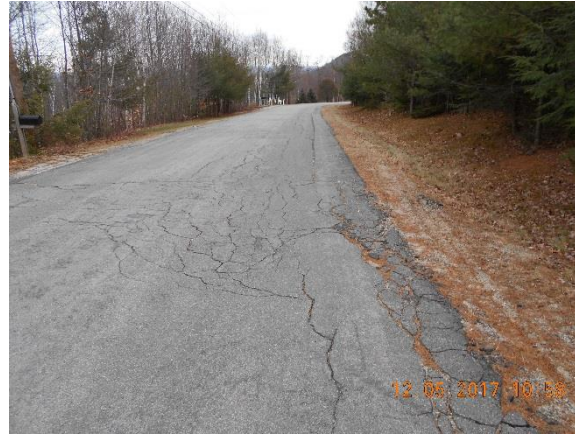
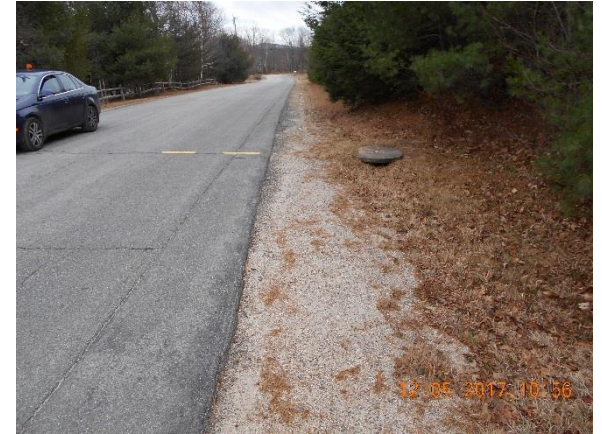
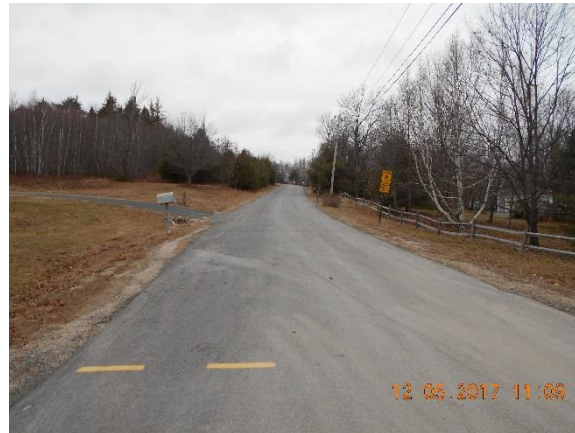
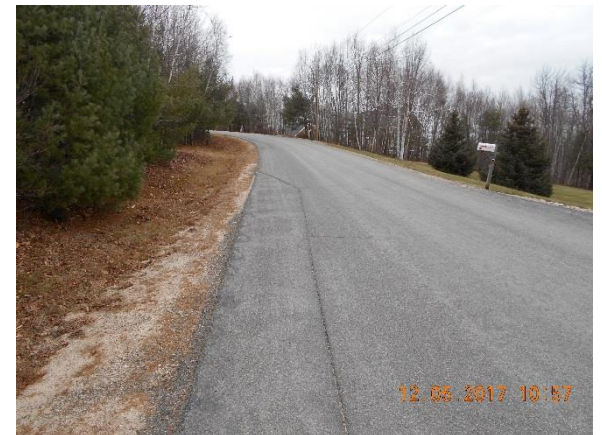
UPPER TRASK MOUNTAIN ROAD

- PCI = 55
- Moderate cracking through out
- Trench patching from previous drainage installations
- Ditches with catch basins

- Reclamation with supplemental stone aggregate
- 3" nominal pavement thickness
- Underdrains
- Gravel backing
- Ditching
- Year schedule = 2028

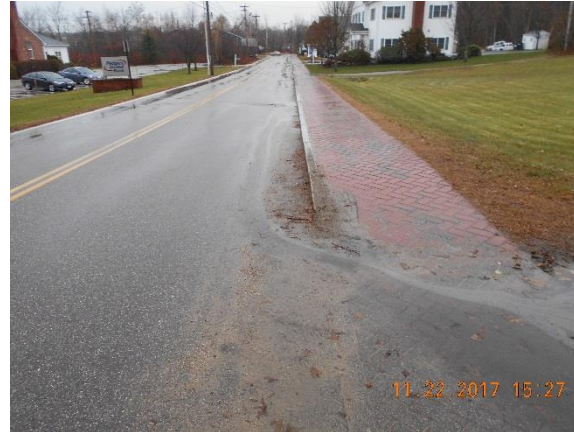
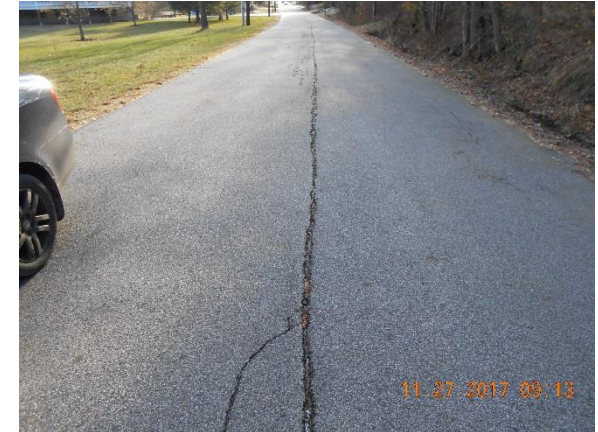
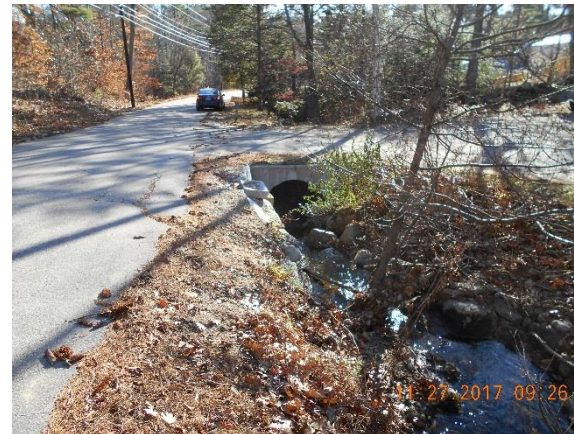
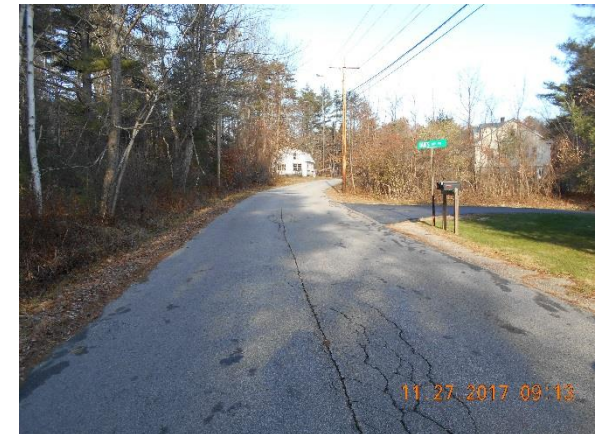
VARNEY ROAD

- PCI varies 75 to 78
- Potential when rutting apparent due to run-off path
- Runoff and sand from adjacent properties flowing into roadway
- Low severity cracking with exception of severe centerline cracking
- Section 1 is curbed on upgradient sides with CBs

- 1.5" overlay
- Review need for milling in curbed areas prior to overlay
- Review condition of large diameter culvert prior to overlay
- Gravel backing
- Ditching
- Year schedule = 2028
