**SUMMARY REPORT
AND
FINAL DOCUMENTATION**

**WOLFEBORO ROADWAY
EVALUATION**

**TOWN OF WOLFEBORO
WOLFEBORO, NEW HAMPSHIRE**

UEI PROJECT 2211

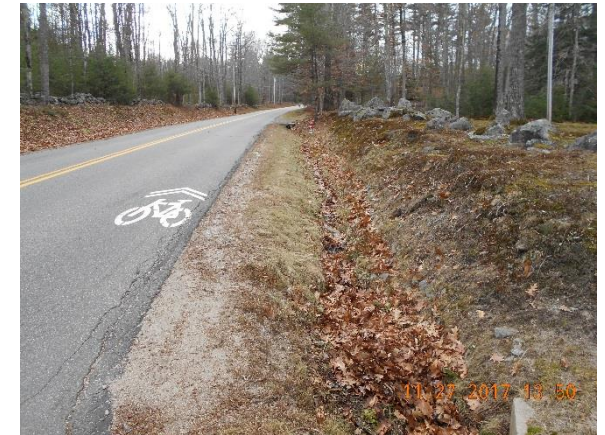
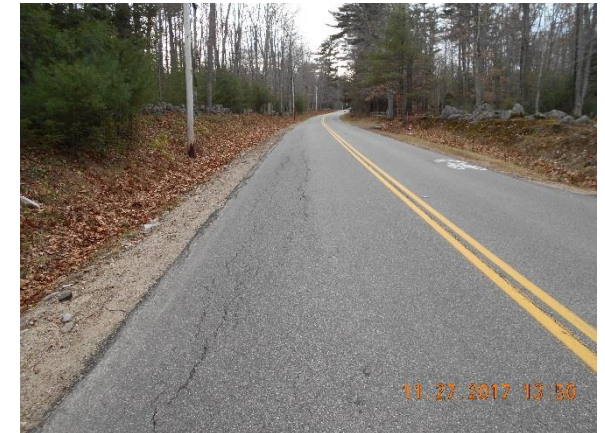
WAUMBEC ROAD

- PCI varies 68 to 71
- Low shoulders at some CBs
- Minor wheel path ruts observed
- Some ditching tight to edge of pavement
- Previous crack seal work completed in areas
- Some stone ditches
- Road may be used as a cut through to avoid down town, 18-wheeler tractor trailer observed driving through

- Post as “No Thru Trucking”
- Crack sealing
- 1.5” overlay
- Ditching (turf and stone)
- Gravel backing
- Year scheduled = 2023
