DEPARTMENT OF
WATER AND SEWER UTILITIES

Subject: Wolfeboro Rapid Infiltration Basin Site
Response to January 27, 2010 Letter

TO: David W. Ford, P.E., Director of Public Works and Water & Sewer Utilities
FROM: Benjamin T. Green, P.E., Weston & Sampson
DATE: January 20, 2010
SUBJECT: Wolfeboro – Rapid Infiltration Basin Site – “Unexpected Issue”
C.C. Blake A. Martin, Weston & Sampson

TO: David Ford, Town of Wolfeboro
FROM: Janet Robinson
Cc: David Dedian
DATE: February 10, 2010
RE: Review of Potential Ecological Effects of Sand Breakout

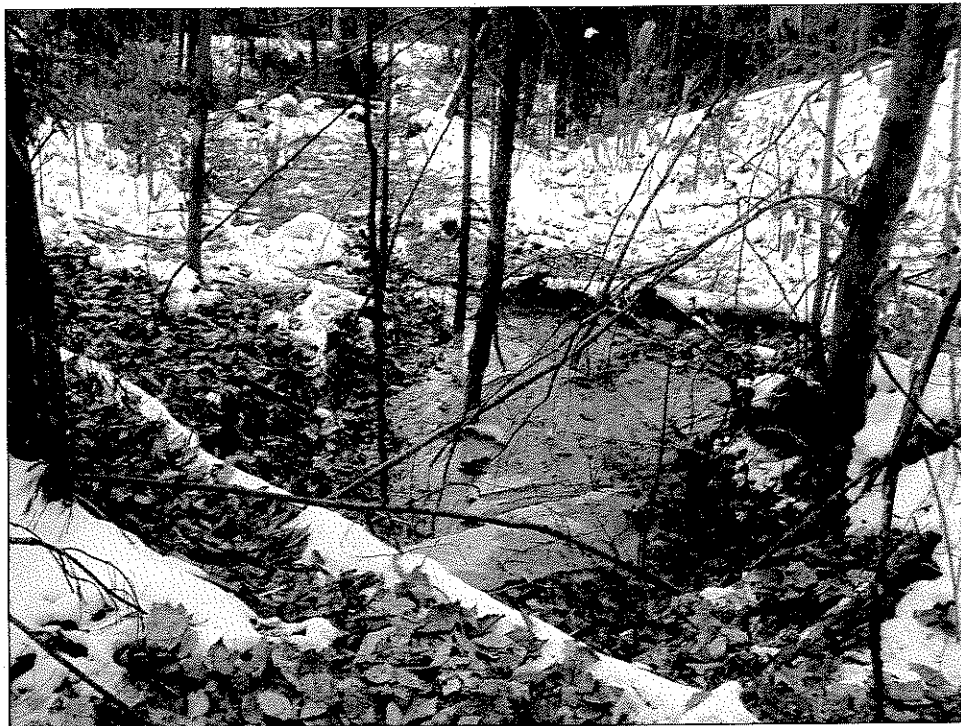
- At the location of 19 MB#8, an eroded, semi-circular scarp was observed with seepage from two areas. Seepage from the left area (facing downstream) appeared to be issuing from the erosion scarp from an approximately 3 in. diameter soil “pipe” at approximately 15 to 20 gpm. Seepage from the right area appeared to be issuing upwards from the ground surface at the toe of the scarp. I estimated the flow to be approximately 10 to 15 gpm. A pile of fine sand was observed between the two seepage exit points, See photos 1 through 4.

Photo 01 - The seepage breakout point at 19MB#8 looking southerly (downstream).

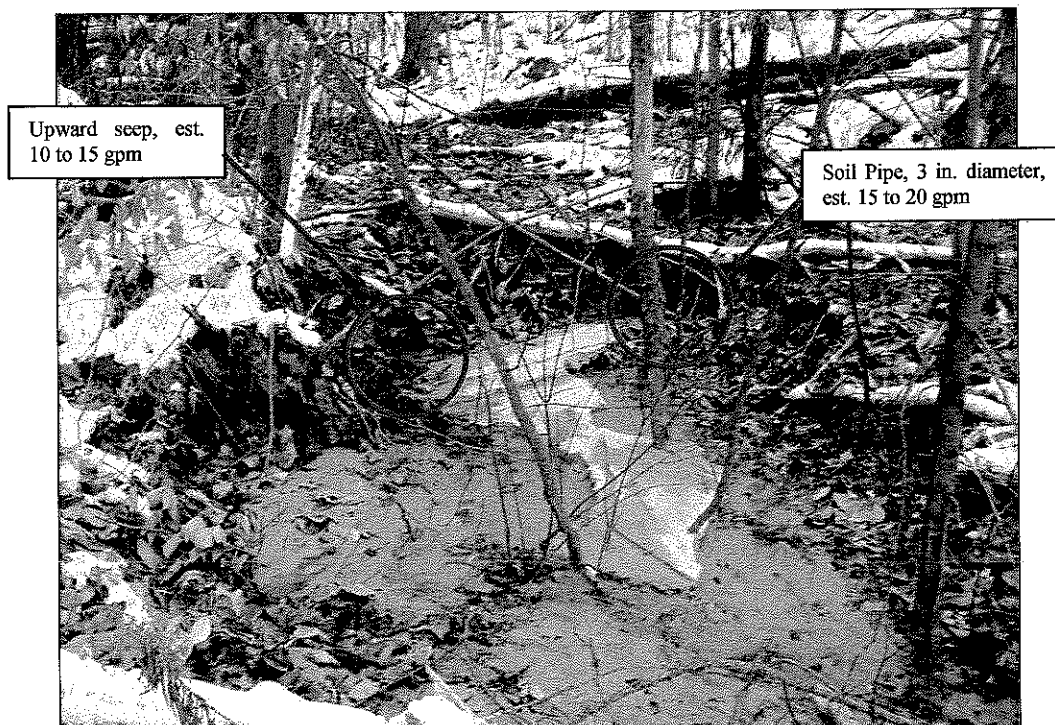
Photo 02 - The seepage breakout point at 19MB#8 looking at the areas of seepage origin.
Note the pile of sand between the seeps.

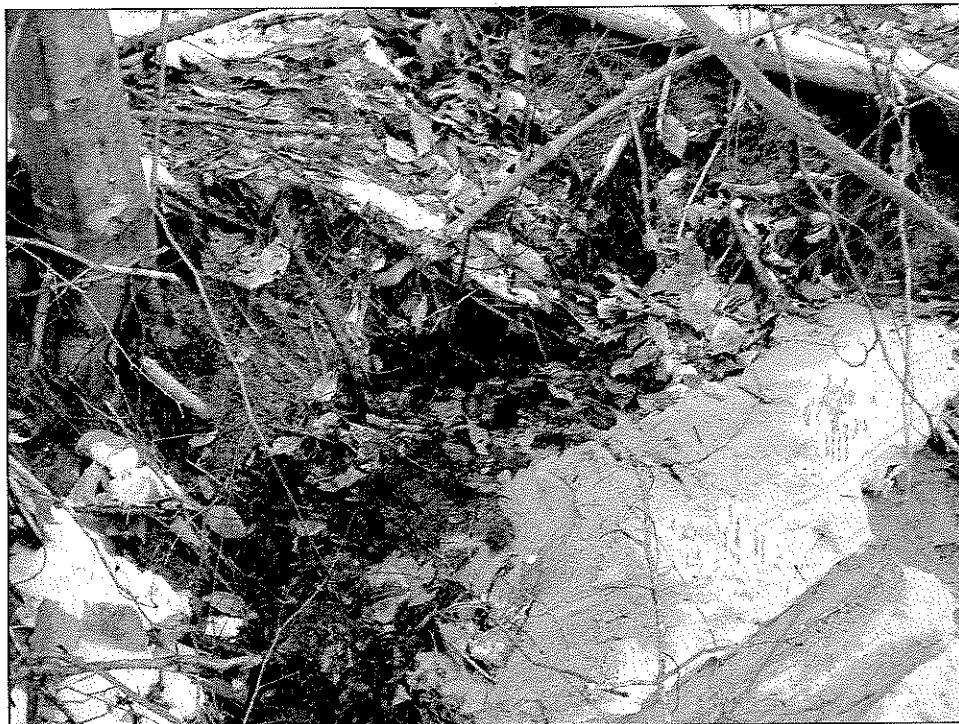
Photo 03 - A close-up of the upward seep at the origin.

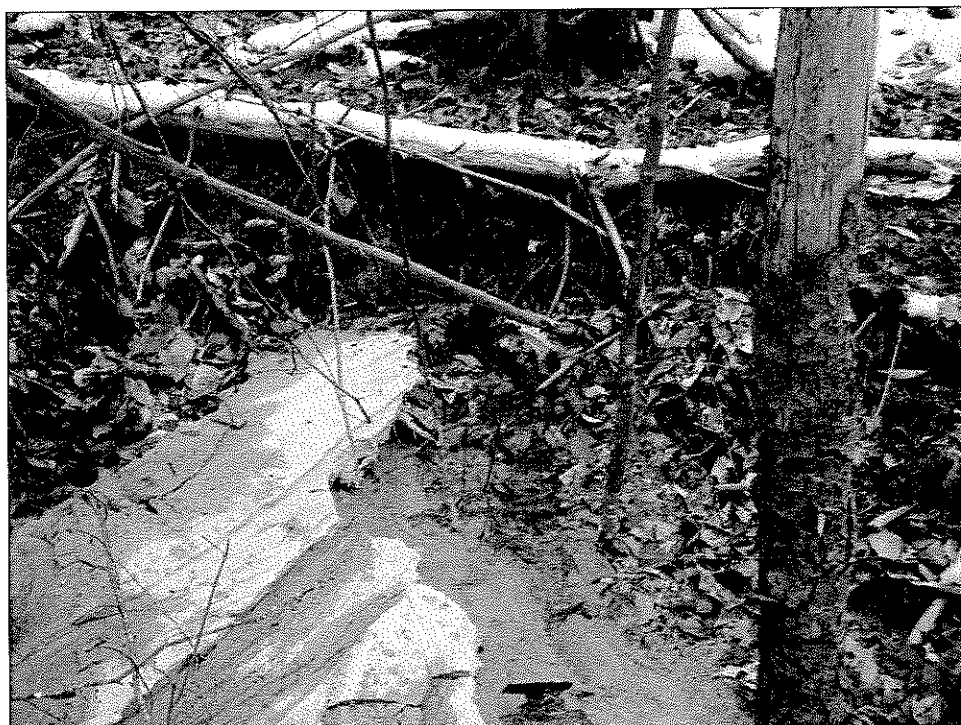
Photo 04 - A close-up of the soil pipe seep at the origin.

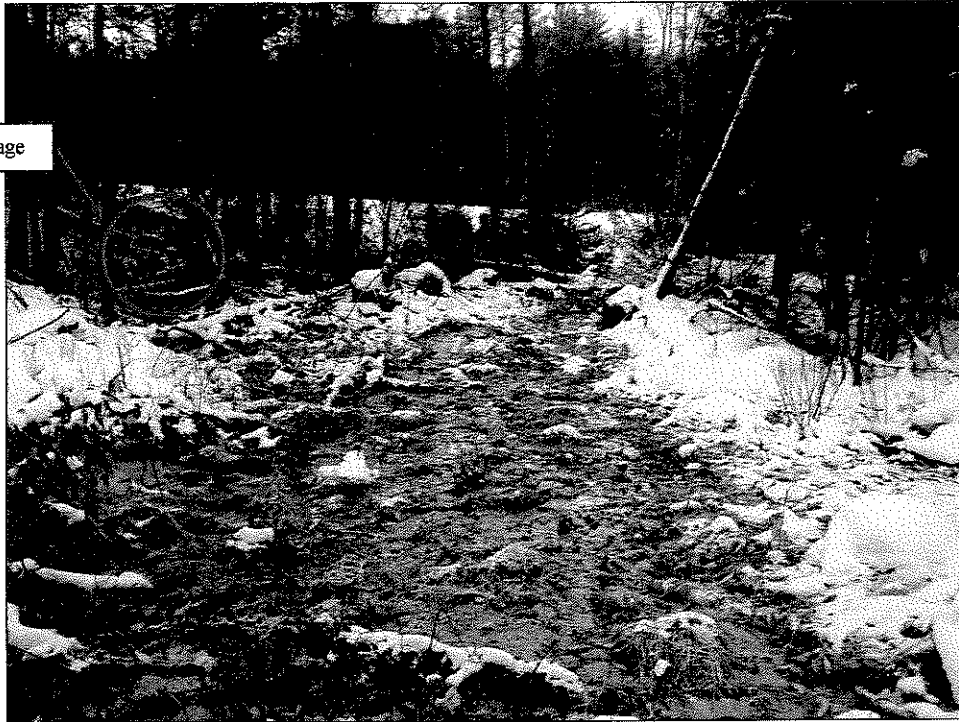
- Downstream of the seepage exit points, the seepage becomes overland sheet flow. Green algae growth was observed at one location. Approximately 80 ft. downstream from 19 MB#8, a 15 in. deep nick point was observed. At this location, the seepage becomes channelized flow. See photos 5 through 9.

Photo 05 - The overland flow downstream of the seeps. Fine sand was observed in the wetland grasses. The other seepage origin point can be seen in the left side of this image.

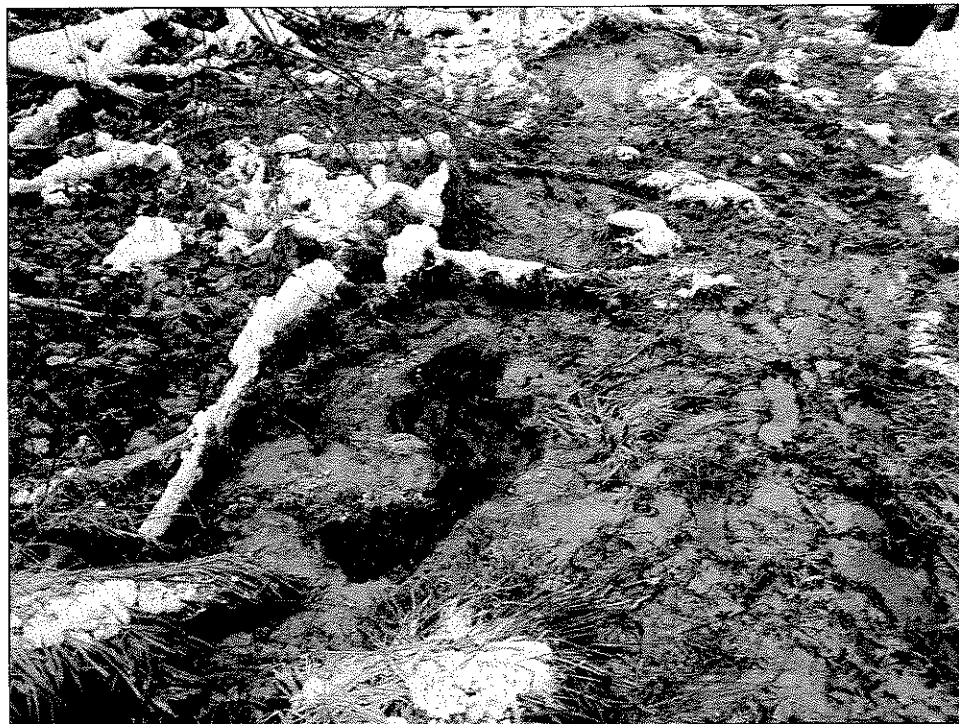
Photo 06 - Green algae observed in the overland flow.

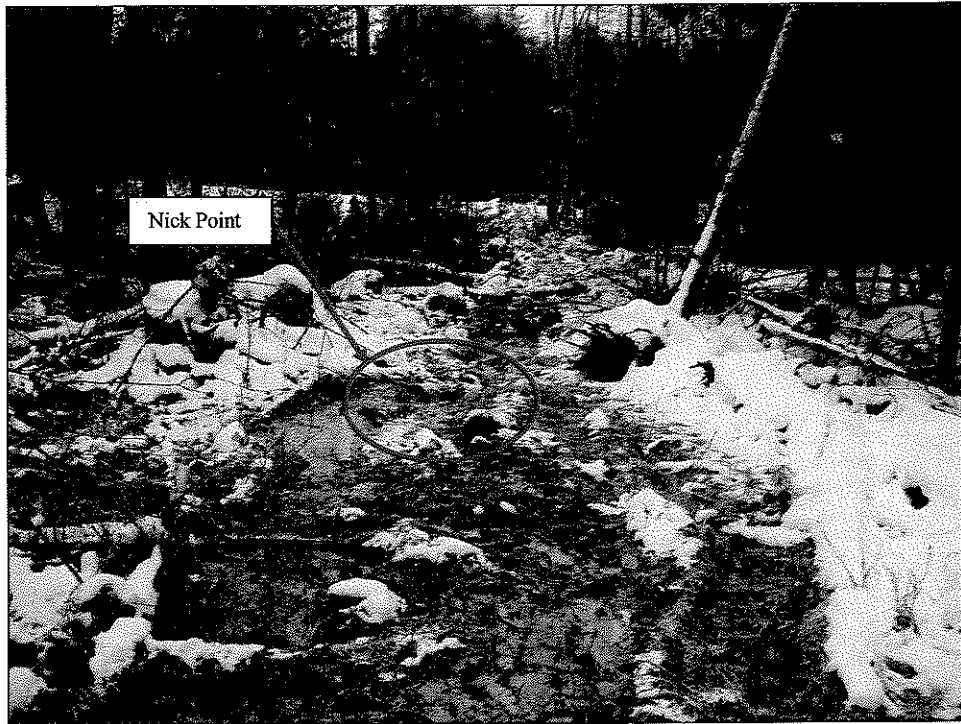
Photo 07 - The overland flow beginning to channelize and create a nick point approximately 80 ft. from the seepage origin.

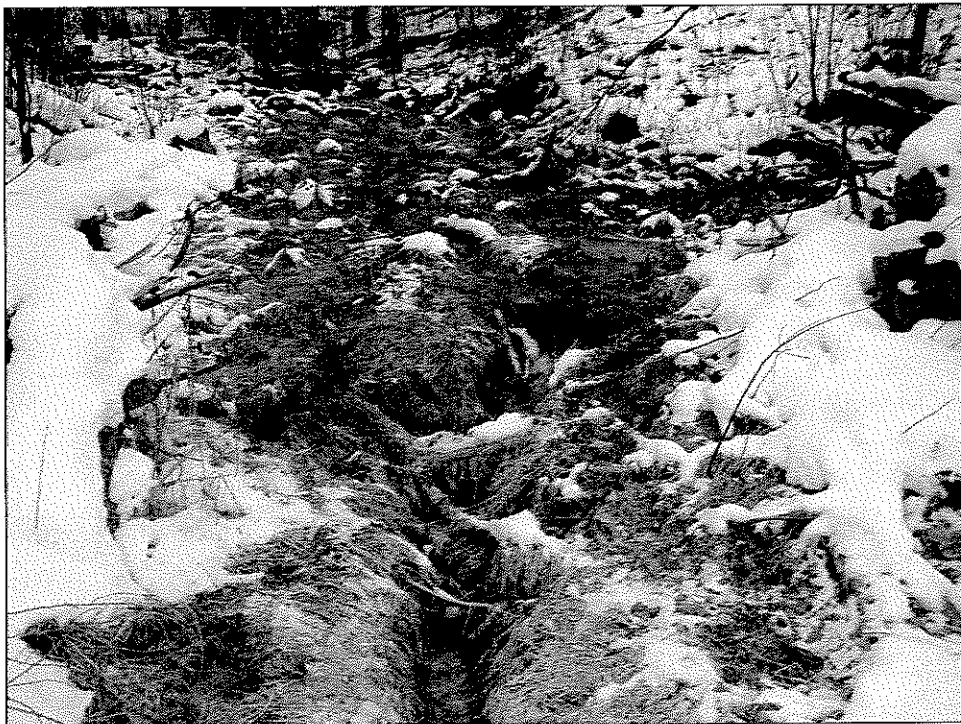
Photo 08 - A close-up of the nick point looking upstream. The headcut is approximately 15 in. deep.

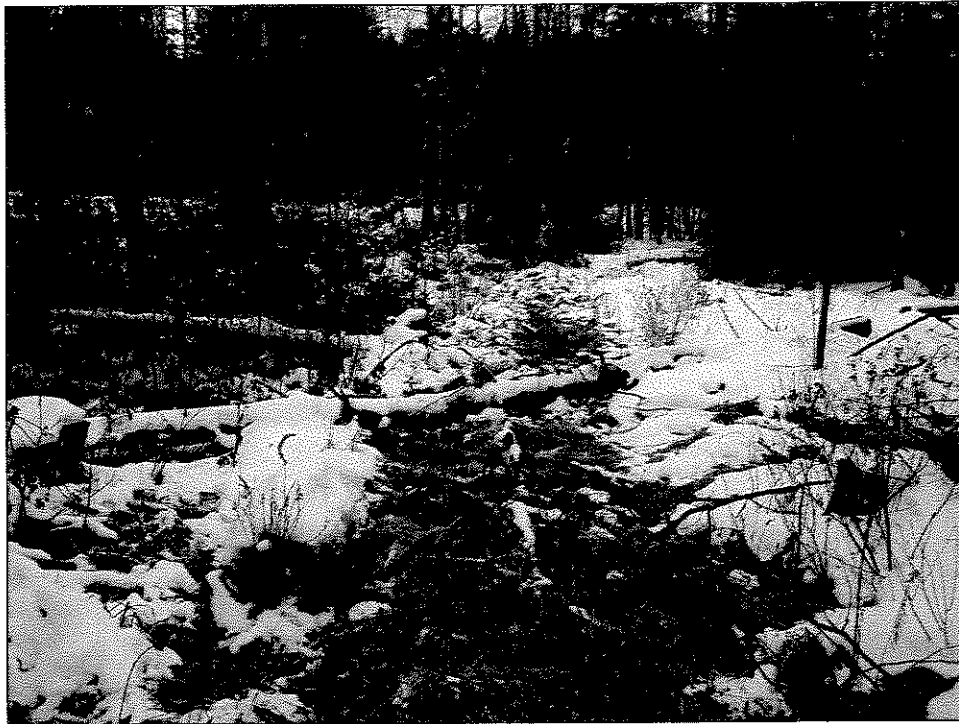
Photo 09 - The channelized flow downstream of the nick point.

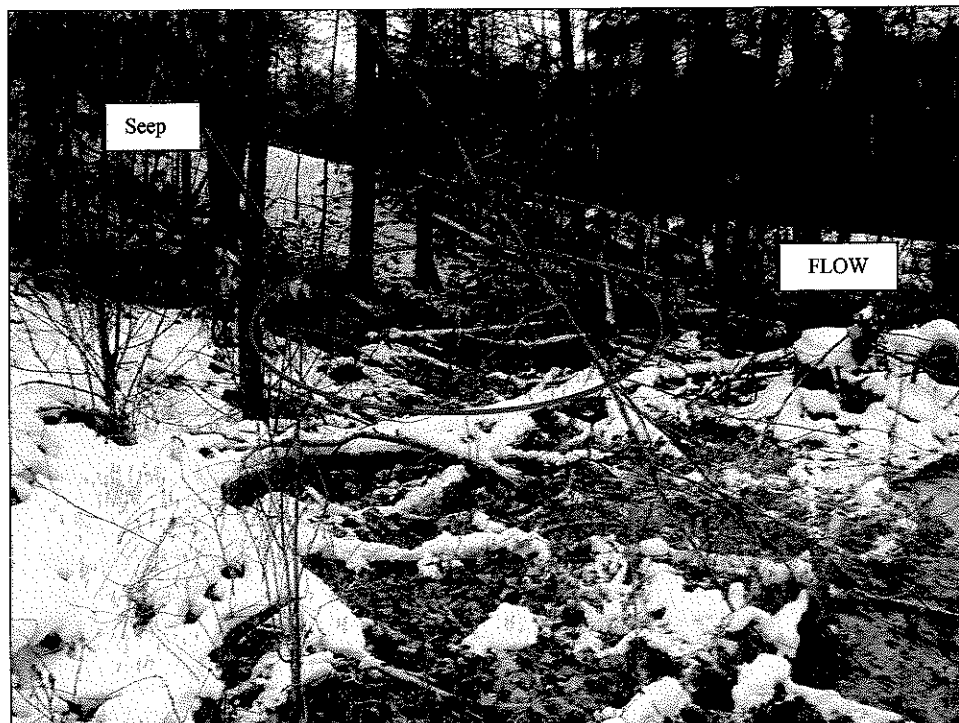
- Standing water was observed along the toe of the slope near the nick point to the left (east) of the channelized seepage flow. Immediately downstream of the standing water, another seepage exit point was observed. Approximately 3 to 5 gpm of flow from this area was estimated. There may be some hydraulic connection between this seepage point and the observed overland flow. This seepage exit point flows overland in the southwesterly direction, parallel to the channelized flow. The channelized flow and flow from this seepage point merge together downstream in what appears to be the "Western Wetland Area." The standing water at this location is up to 6 in. deep and green wetland vegetation was observed. See photos 10 through 13.

Photo 10 - The second seep location looking towards the access road. There may be flow communication between the overland flow and this area.

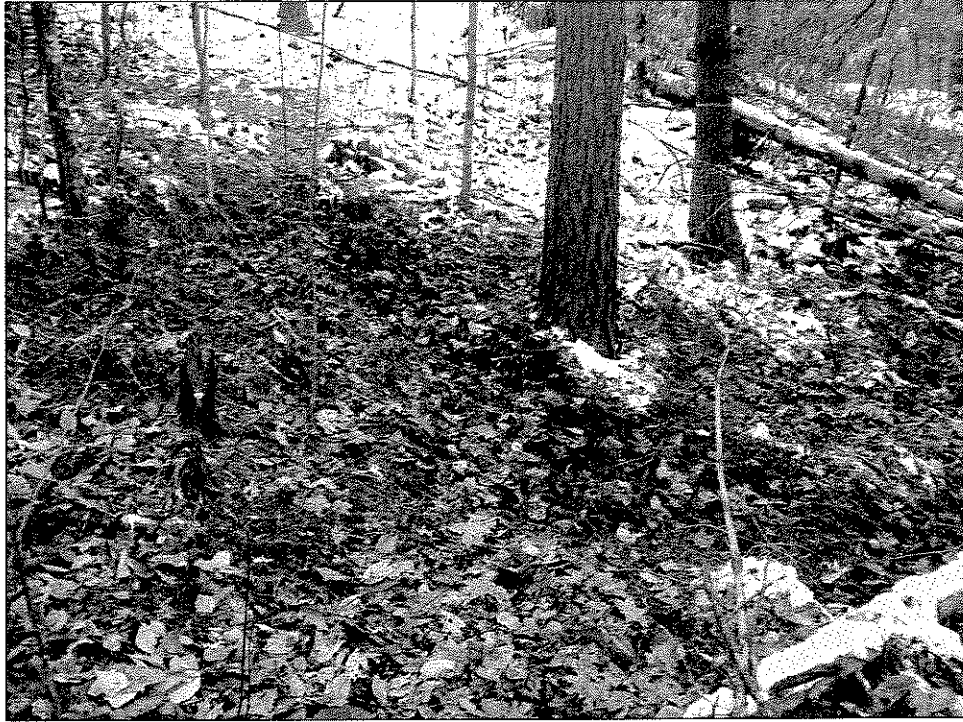
Photo 11 - Wetness and standing water located up gradient of the second seepage point.

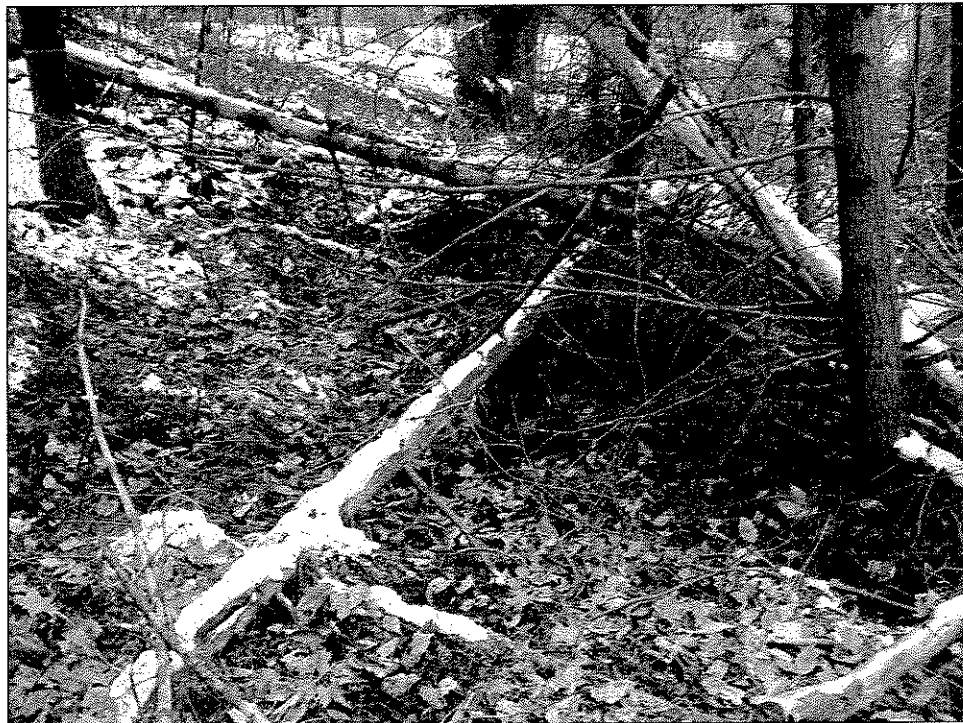
Photo 12 - The second seepage exit point looking downstream.

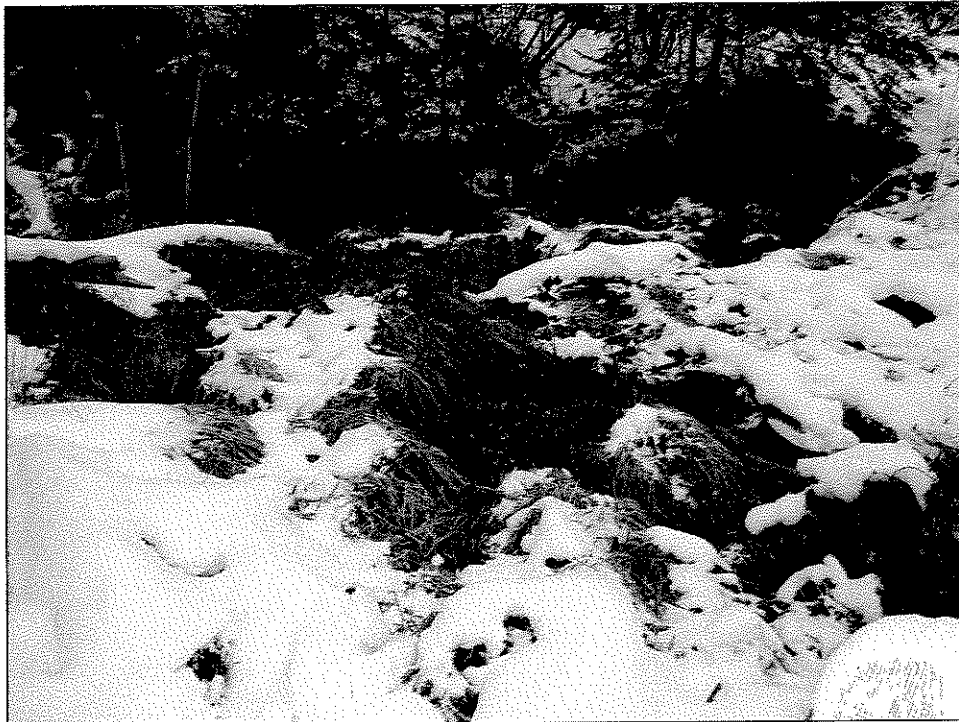
Photo 13 - The wet area at combined flow from the two seepage areas. Green vegetative growth was observed. Standing water in this location was over 6 in. deep.

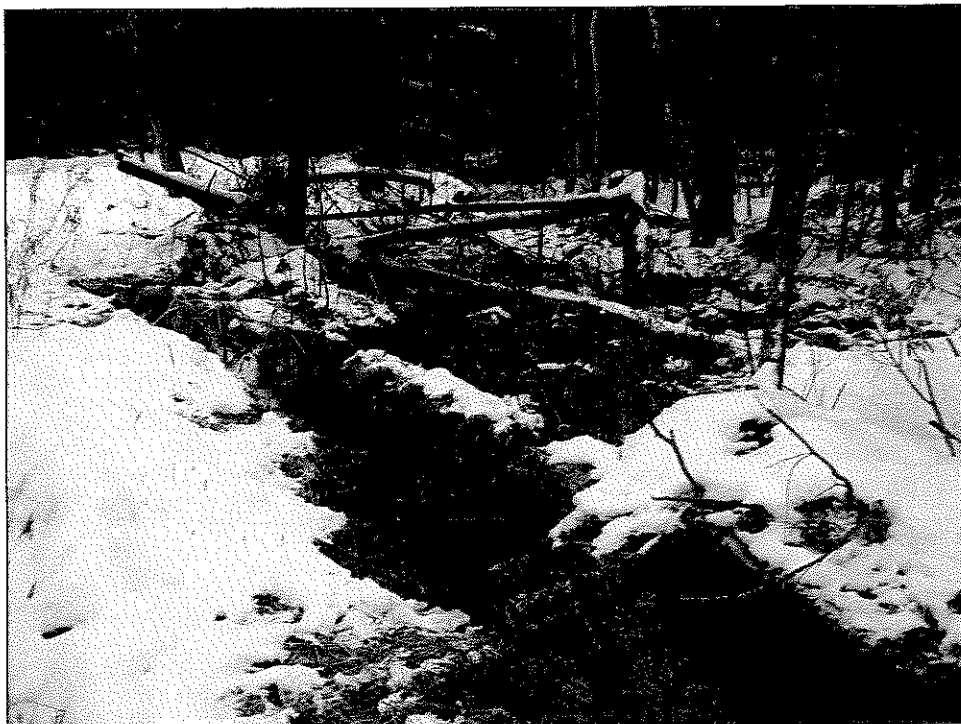
Photo 14 - Combined flow downstream of all seeps.

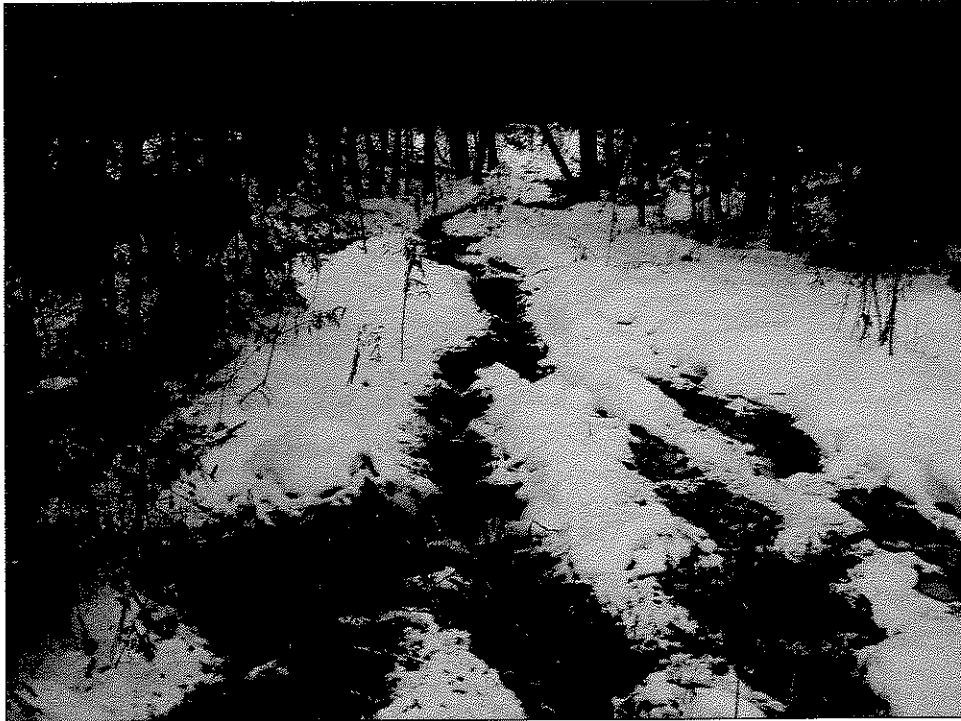
- Downstream of the merging of flow, the channelized water splits briefly before rejoining and flowing along former skidder ruts. Downstream of this location, the flow joins a natural/drainage channel and eventually flows through a drainage structure underneath the access road.

Photo 15 - Downstream channelizing of the seeps. The flow channels split upstream of this image and rejoin at the top of this image.

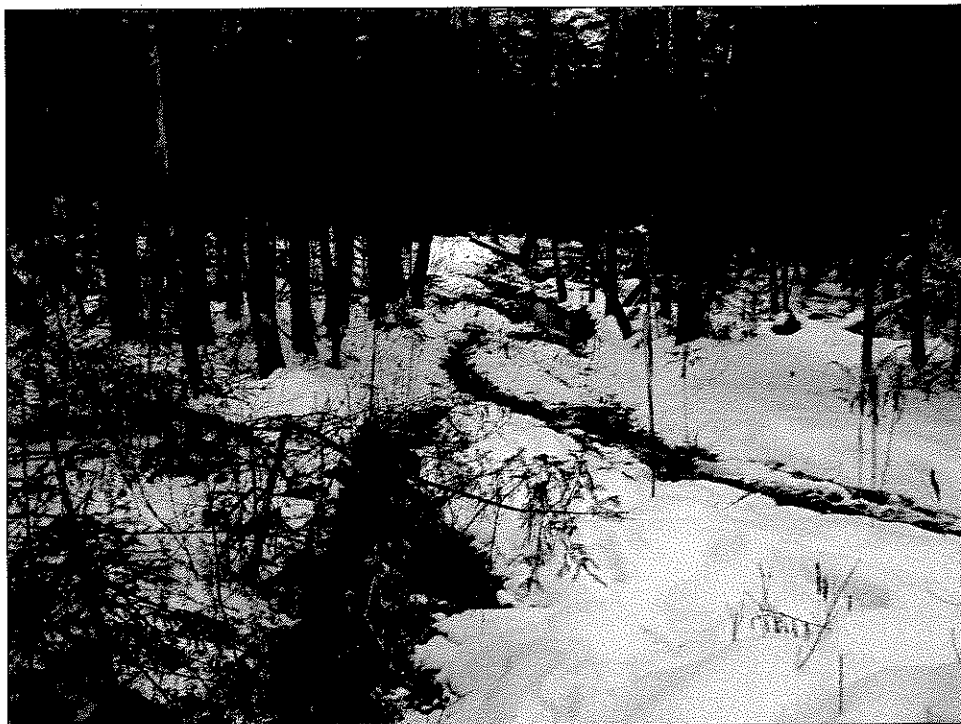
Photo 16 - The combined flow near the access road channelized in former skidder ruts. The flow enters a natural/drainage channel and is conveyed underneath the access road.

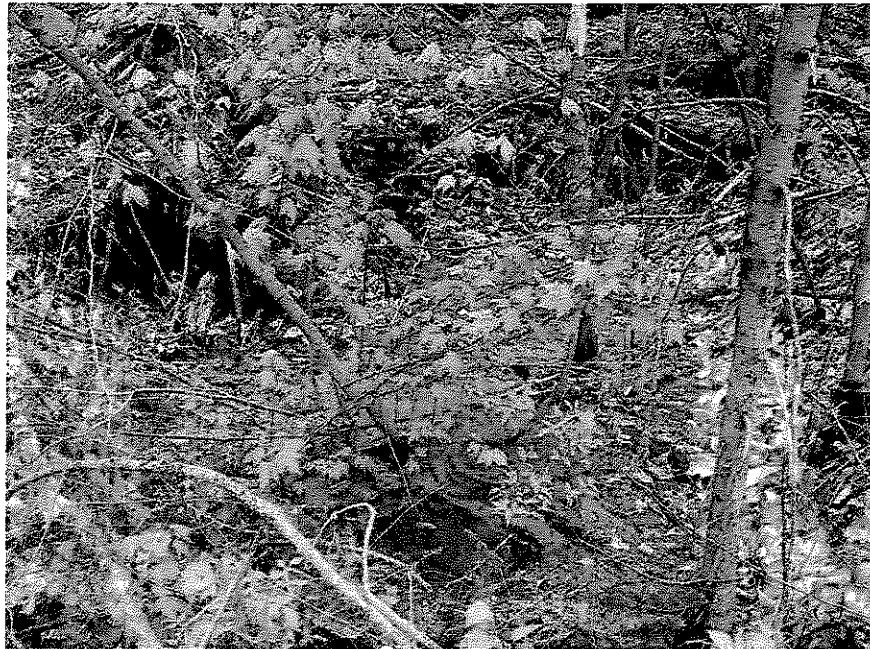
The spring at 19MB #8 is the westernmost discharge, and provides a water source associated with the western wetland. Water from this spring flows down an exposed hillside through both small channels as well as by more diffuse sheet flow, with standing water and saturated soils occurring in level areas near Nineteen Mile Brook. Believed to be formerly an intermittent discharge, this spring now flows continuously, forming a relatively new, fully aquatic habitat. Water depth in the drainage is typically two inches or less, and, prior to the discharge of sand, the substrate consisted of native soil, primarily sandy loam near the spring, with increasing amounts of fine sand near Nineteen Mile Brook. Photos 1 and 2 illustrate the spring and downstream areas as they appeared in April, 2009.

Photo 1. 19MB #8 spring in June, 2009

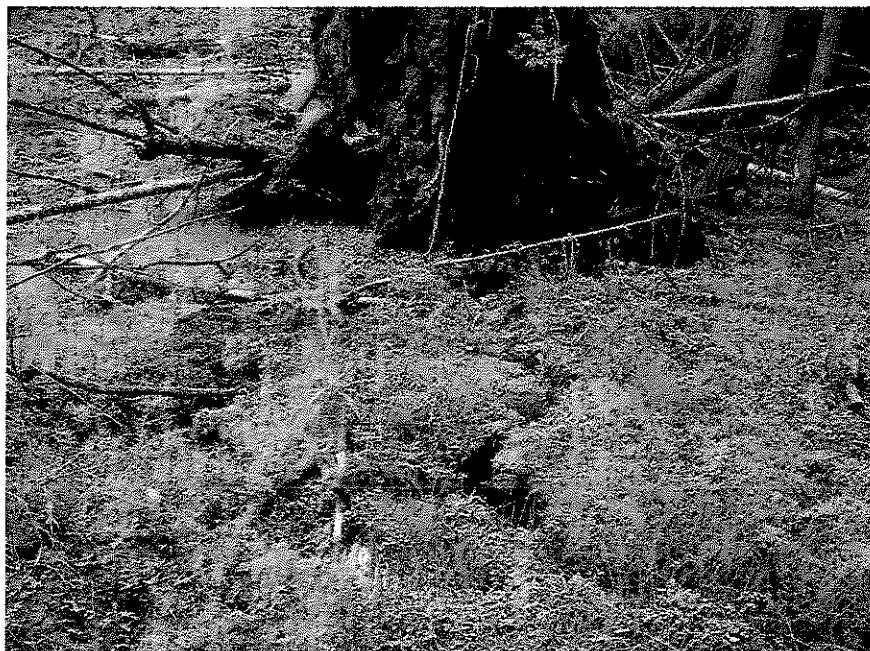
Photo 2. 19MB #8 flow channels downstream of spring in June 2009

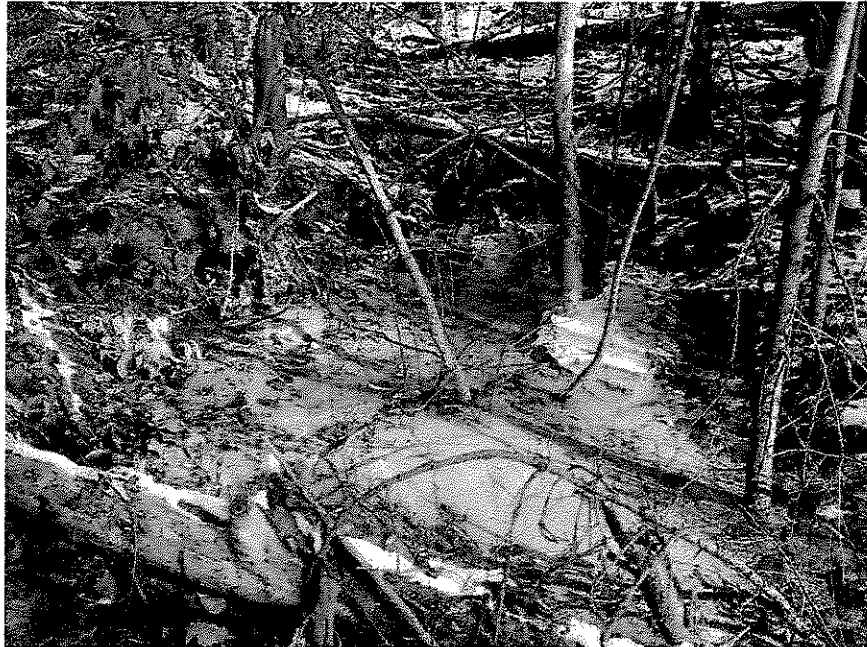
Currently, the area of the spring discharge and downgradient channels contains quantities of fine to very fine sand, with traces of silt (Photos 3, 4, and 5). Near the spring area, this sand is six inches or more thick, with decreasing quantities and depths with distance downstream. Flowing water from the spring and in the downstream channels is clear, and quantities of detritus and fine woody debris line the watercourse in slower-current areas. In lower reaches, sand is integrated into the natural sandy substrate, with fine debris and coarse particulate organic matter (CPOM) present in eddies and side channels (Photo 6). Rooted vascular aquatic plants are present in the channel, which extends to Nineteen Mile Brook. However, the presence of small lateral bars (Photo 6) and partially buried stream structures indicate the addition and continuing movement of introduced sand. Fine sand is present on the surface of large boulders in Nineteen Mile Brook at the confluence of the spring-fed stream (Photo 7). While the substrate further downstream from the confluence was not visible due to the presence of extensive surface ice, the composition of the discharged sand is similar to the native sand substrate present throughout Nineteen Mile Brook (Photo 8).

Photo 3. 19MB #8 spring in February 2010

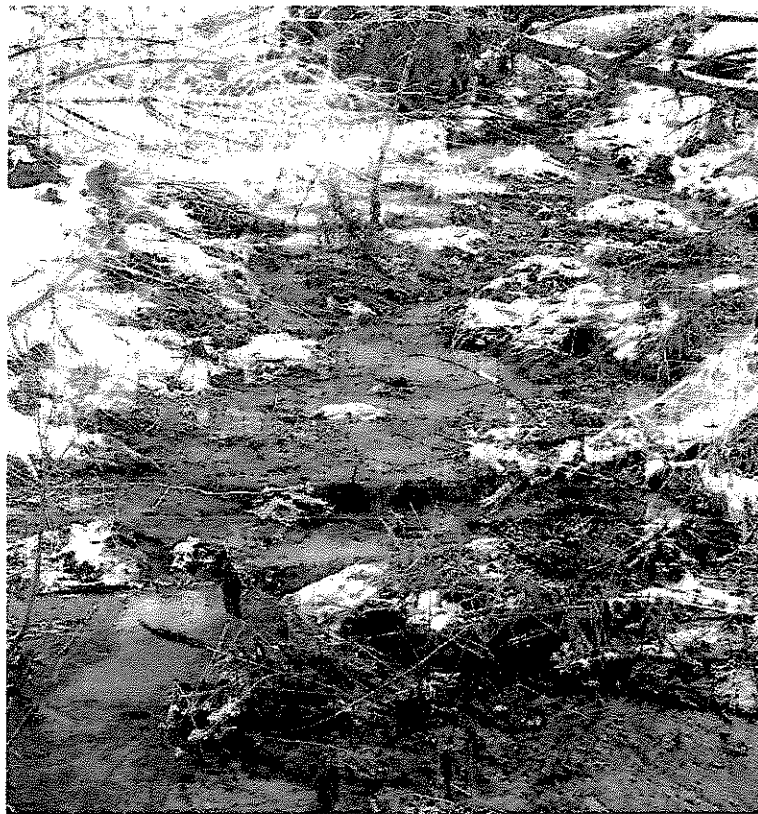
Photo 4. Channel downstream of 19MB #8, February 2010

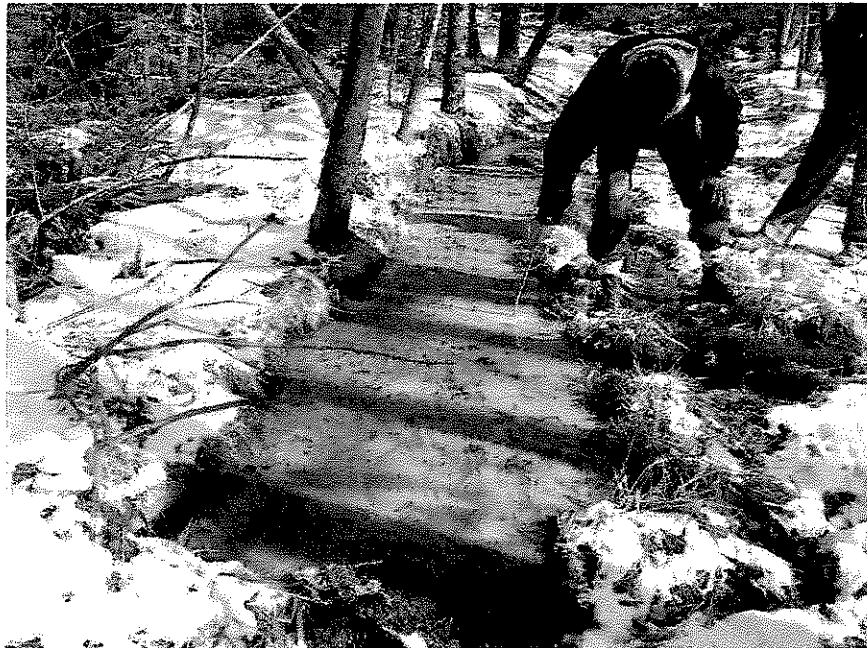
Photo 5. Channel downstream of 19MB #8, February 2010

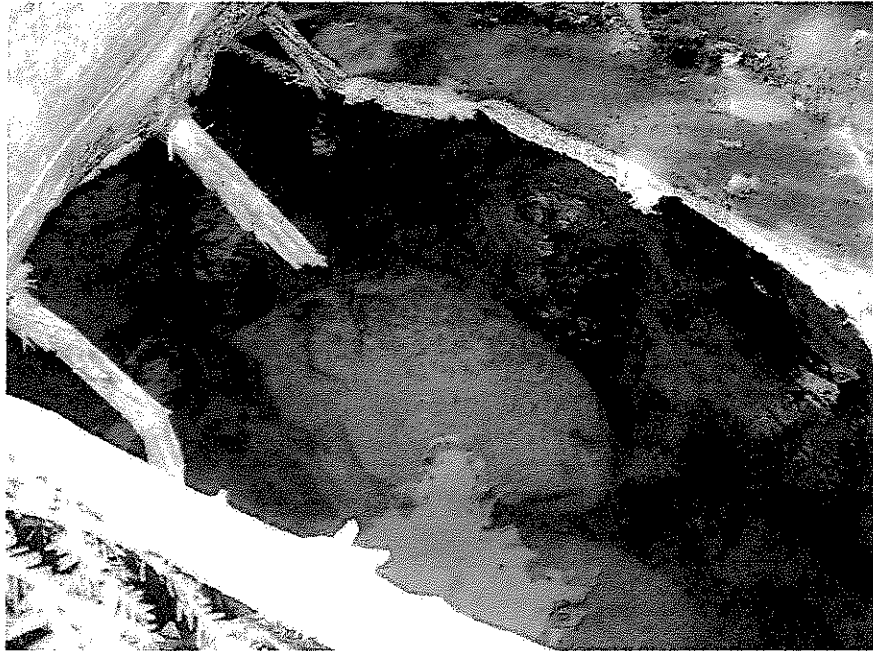
Photo 7. Sand on boulder in Nineteenmile Brook at confluence of 19MB #8 stream.

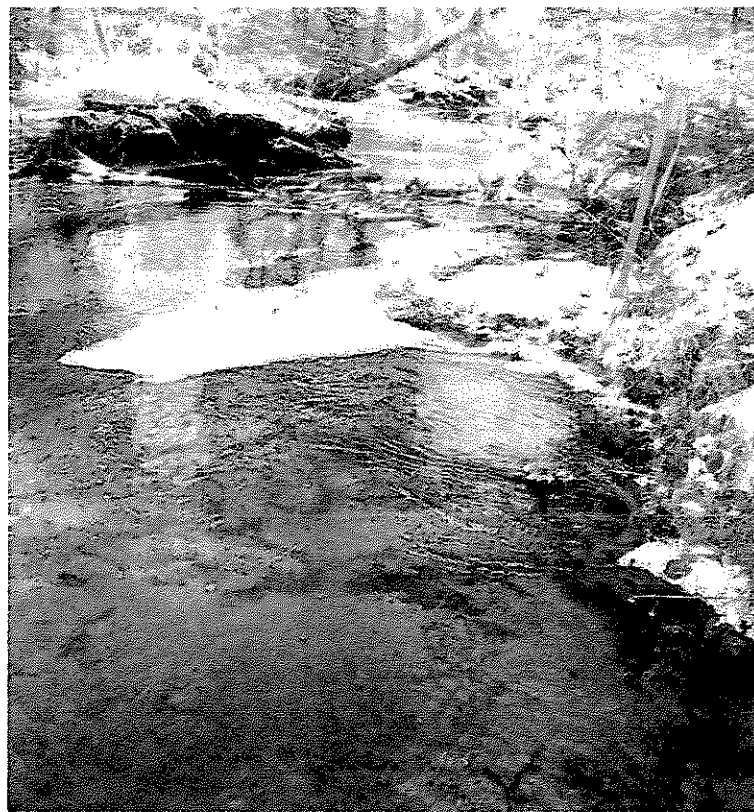
Photo 8. Sand substrate of Nineteenmile Brook upstream of 19MB #8

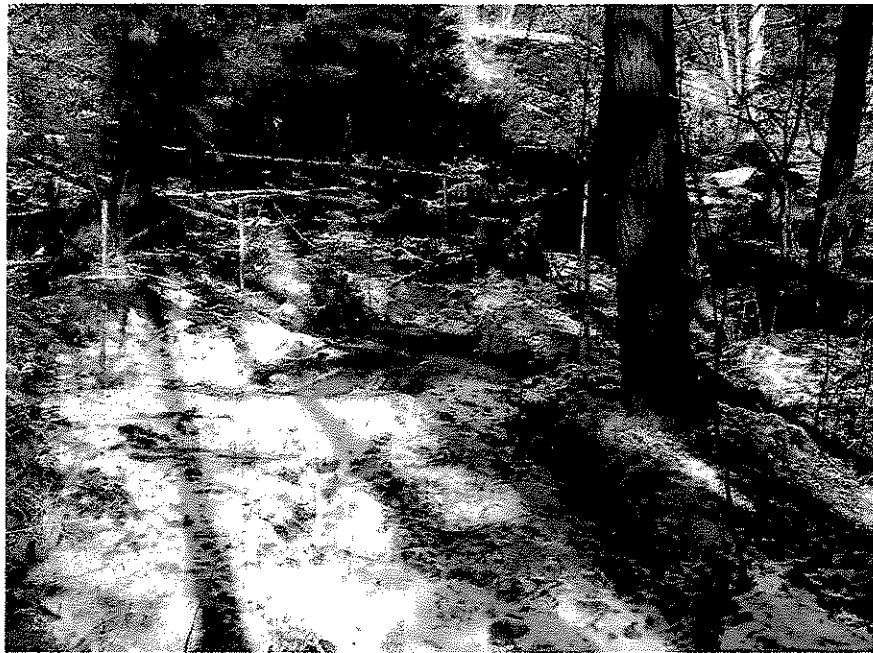
19MB #10 is the more easterly spring, and exists within a wetland commonly referred to the central wetland. Most of the spring flow in this area remains within the wetland, although a small drainage passes underground and eventually resurfaces before connecting to Nineteen Mile Brook. Near the spring, released sand functionally covered approximately 1,600 square feet of a forested wetland, as determined by a survey by wetland scientists (Photo 9 and 10). Some of this sand was removed by hand in 2009. Most of the remaining sand is contained within the wetlands.

Photo 9. Sand discharge at 19MB #10 spring

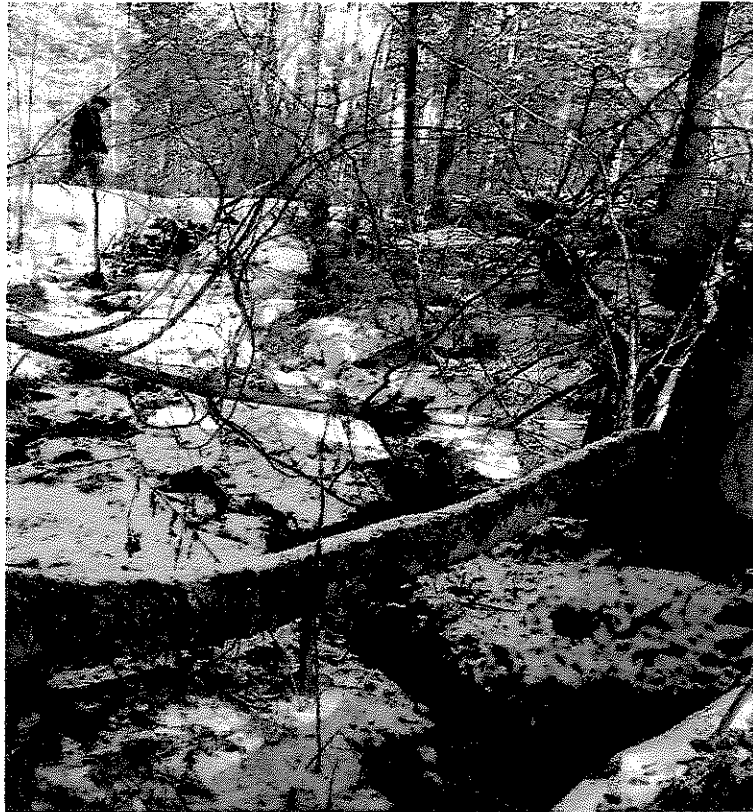
and sandy bottomed channel that connects to Nineteen Mile Brook (Photos 11 and 12). Most sand, which is distributed around the spring, is not expected to enter this drainageway, but rather to be contained within the vegetated ground surface of the wetland. Sand that enters the drainage would have similar effects to those described for 19MB #8, but with less consequence, due to the small size of the drainage.

Photo 11. Drainage from central wetland
