Town of Wolfeboro  
Public Safety Building

Feasibility Study Final Report  
August 8,2018

# EXISTING FACILITY CONDITIONS ASSESSMENT

WOLFEBORO PUBLIC SAFETY BUILDING - EXISTING CONDITIONS ASSESSMENT

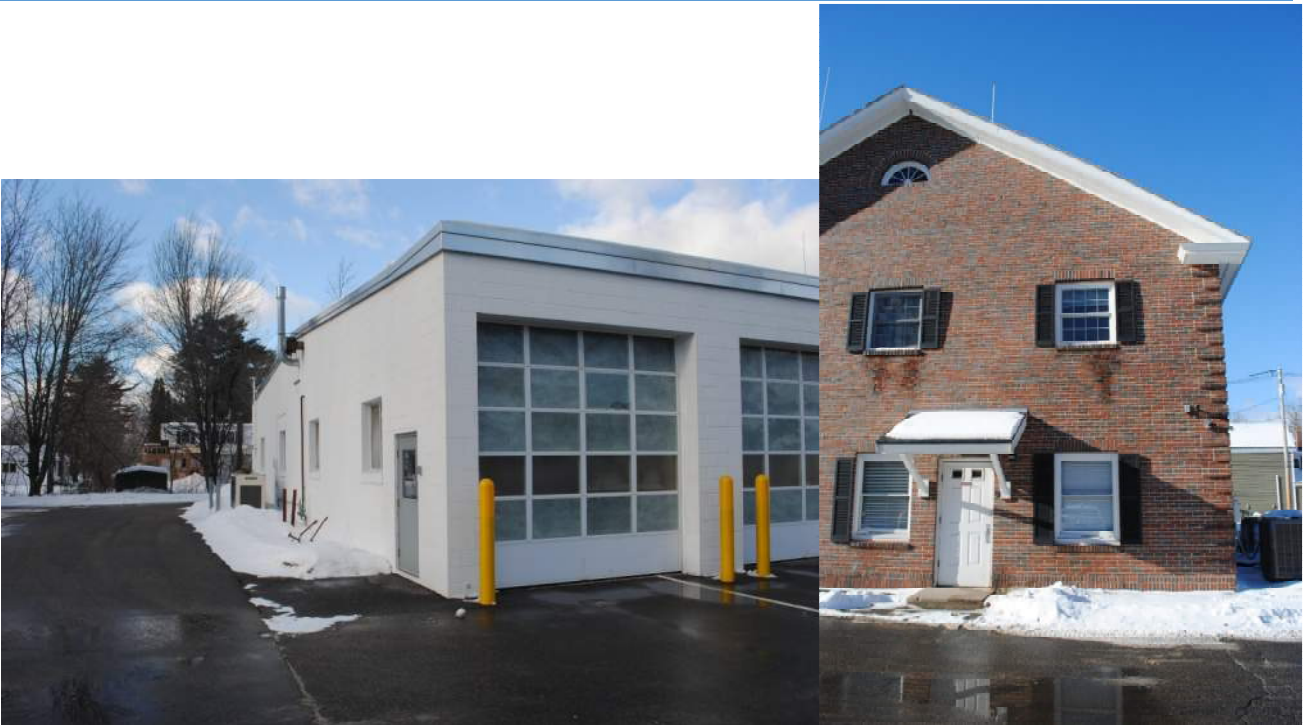
Apparatus Bay south elevation overhead doors (with damage).

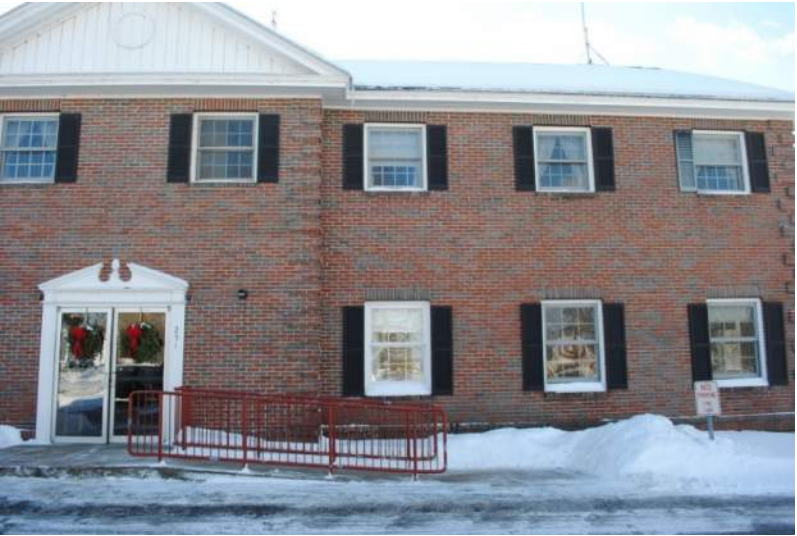
Handicap code accessible is limited to the first floor level Public Lobby. There is no elevator in this facility. Access is limited to the main entry lobby space. Doorways and corridors beyond the Public Lobby do not provide proper side clearances and circulation necessary for access. The facility meeting room and breakroom on the second floor level are inaccessible.

Public entry handicap ramp

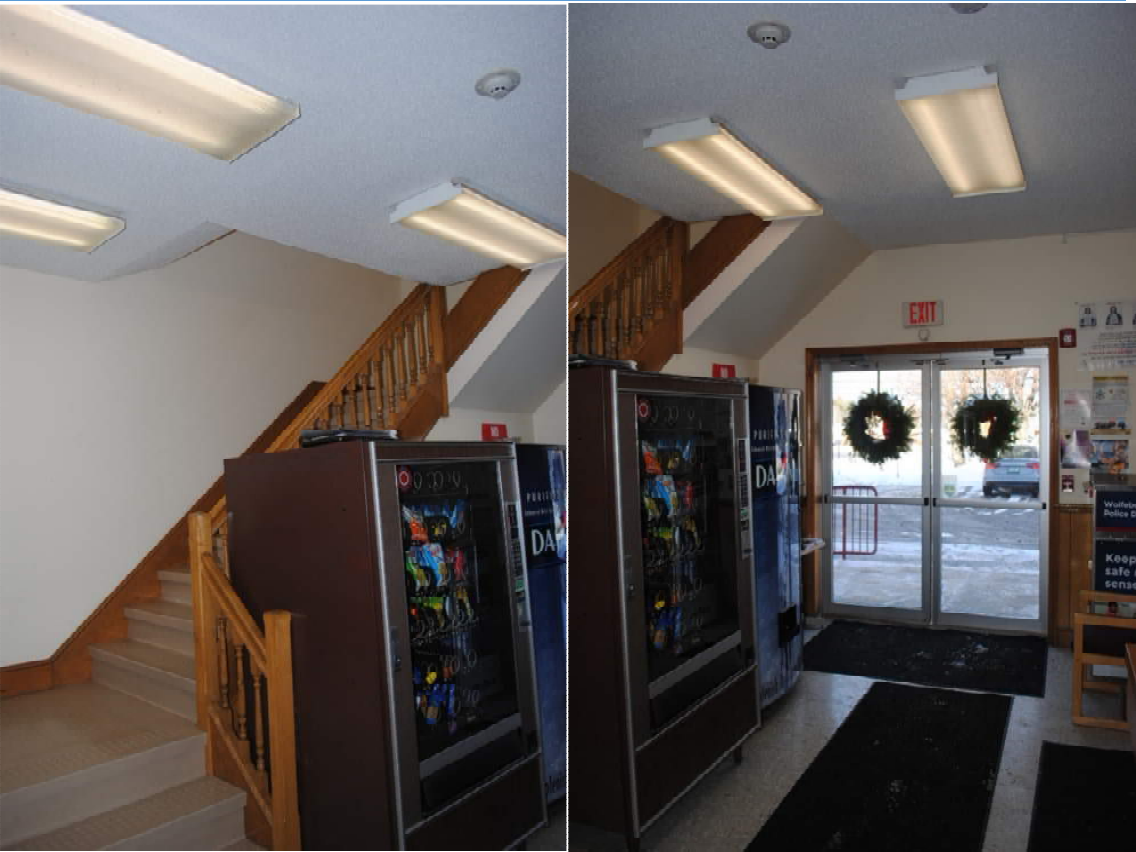
Exit stairway from Second Floor through Public Lobby.

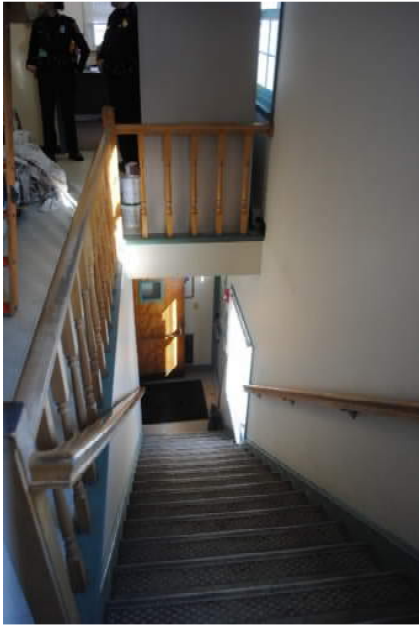
Exit stairway from Second Floor Police Department side

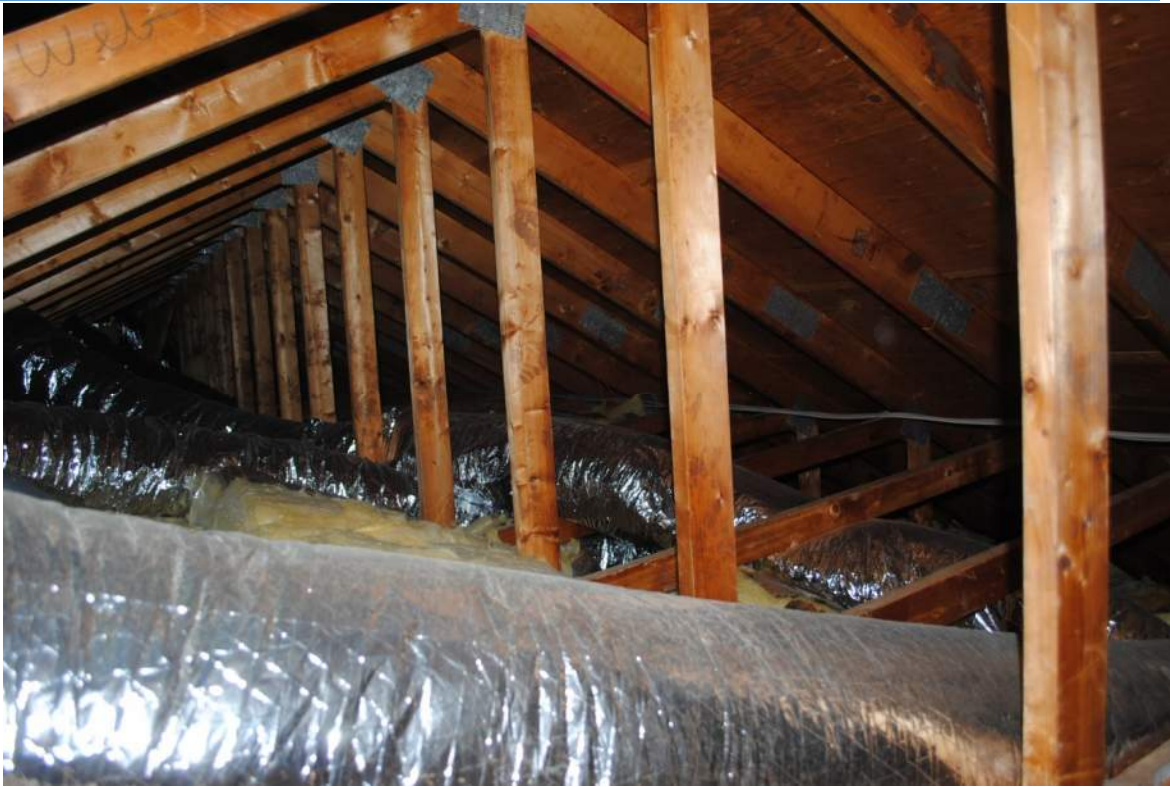
Mechanical systems above second floor ceiling.

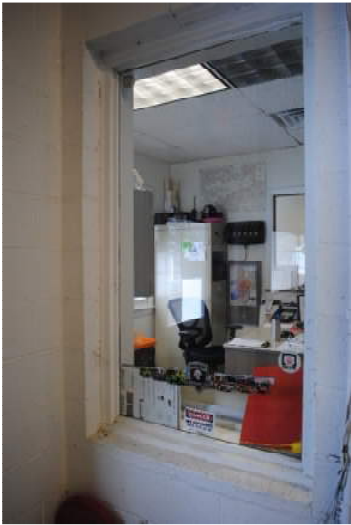
Fire Department Apparatus Bay (Storage Use Occupancy) block wall and rated sliding fire door. NOTE: window on left of wall is an unprotected opening through the concrete block separation wall into the Office (Business Use Occupancy)

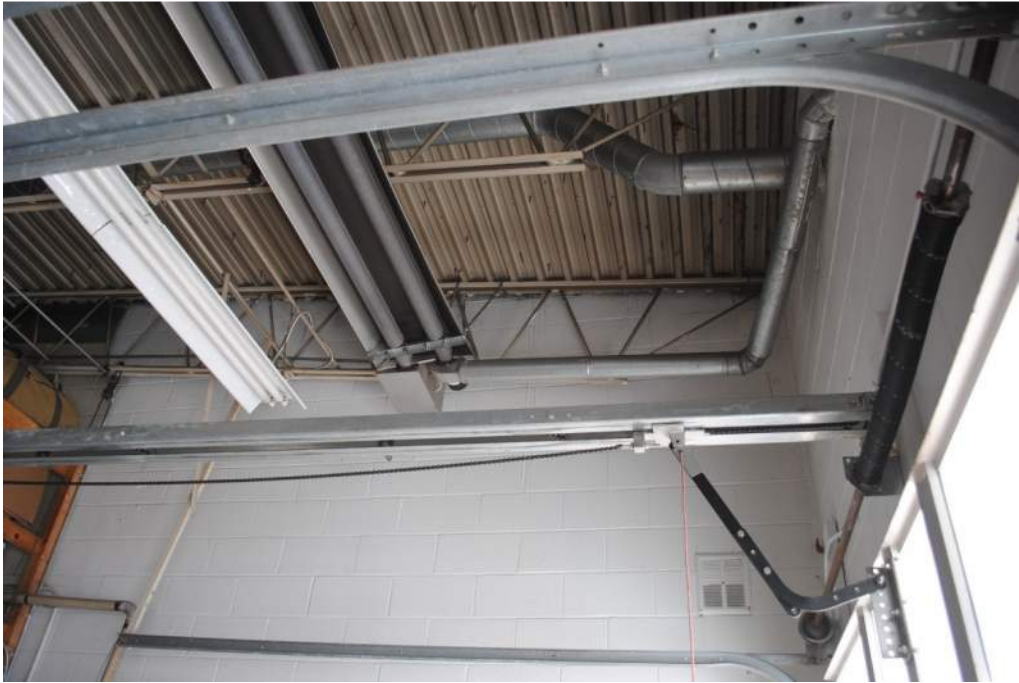
Separation wall in the Police Department Sallyport

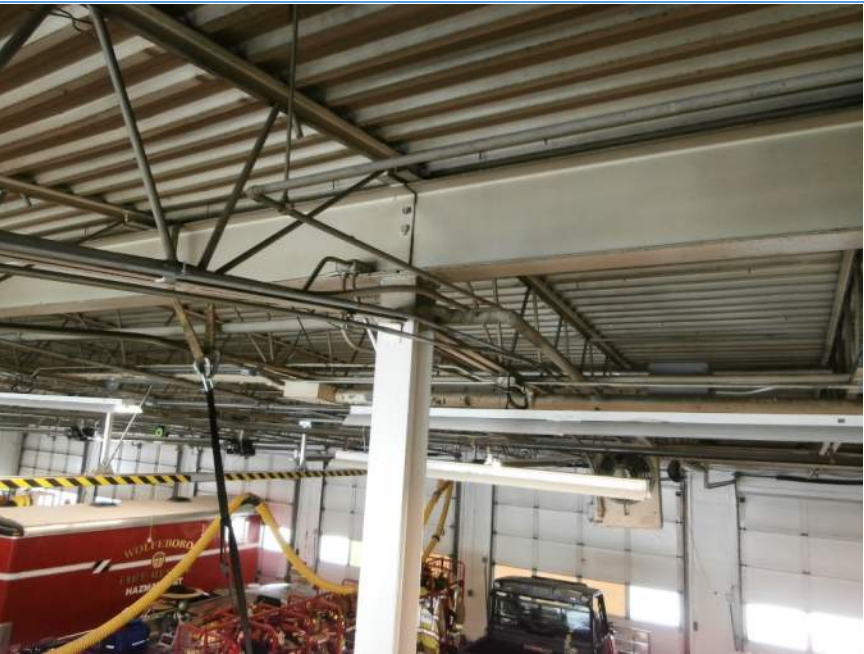
Open web joists and centerline steel framing, Apparatus Bay.

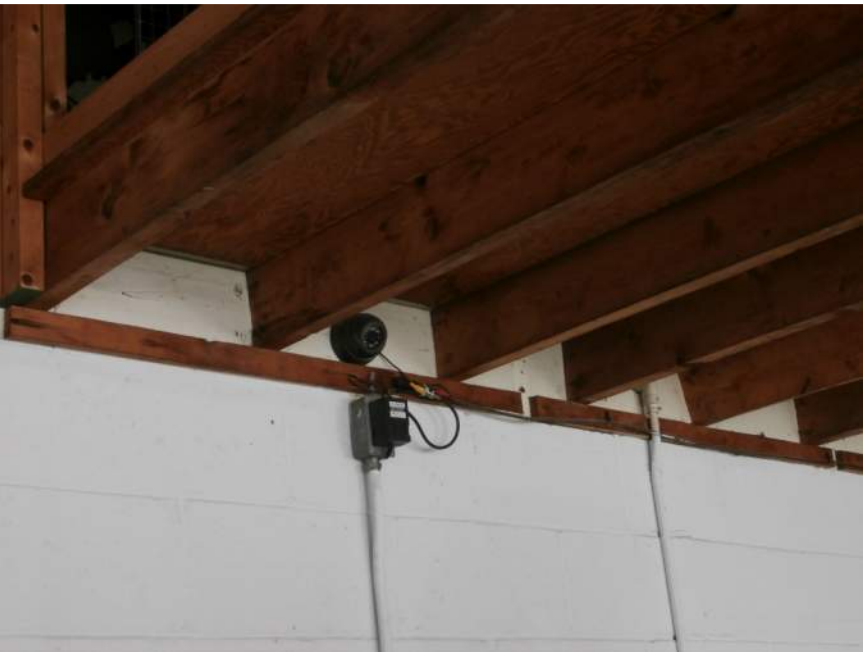
Sally port mezzanine framing ledger.

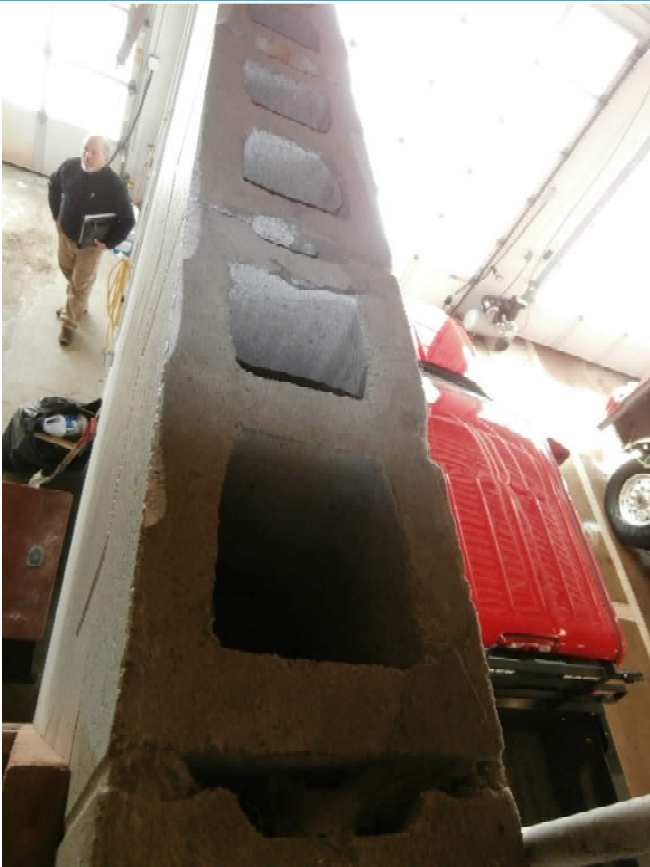
Top: Sally port interior wall, ungrouted and unreinforced / Bottom: South side entry canopy

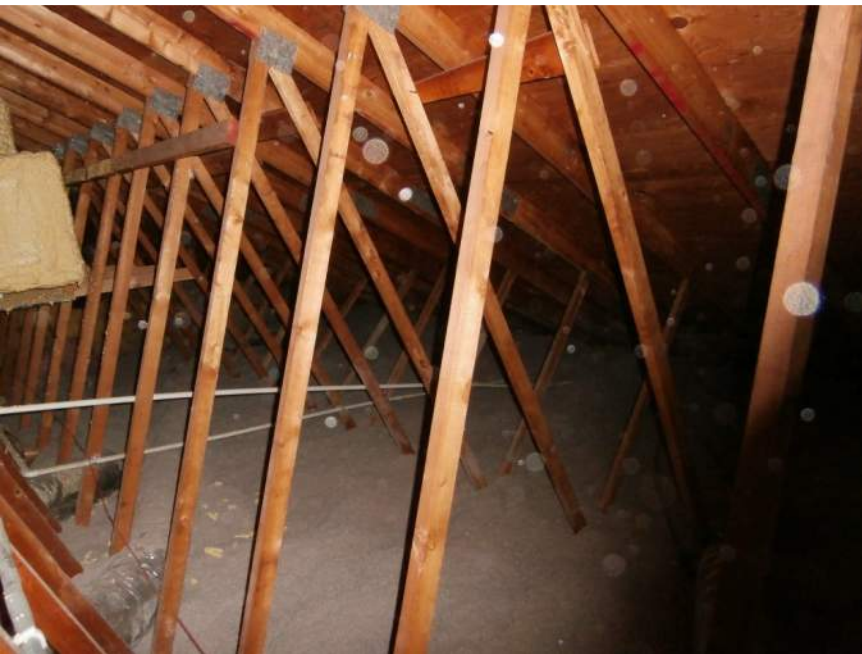
The roof trusses in the northern end of the building are a “Fink” configuration (identified on the original roof framing plan as “Belgian Trusses”). These Fink trusses are notable in that the web members are unusually small member sizes (2x3 lumber).

With regard to all of the 39 foot span roof trusses (Scissor and Fink Trusses) these trusses have no Continuous Lateral Bracing (CLB; also known as through-truss bracing). CLB is commonly required by the truss designer and its purpose is to limit the buckling length of truss web compression members. The complete absence of CLB in this roof structure is a concern. It is possible – but unusual - to design wood trusses of this size so as not to require CLB bracing. Given the member sizes used– especially for the Fink trusses – it is likely that these trusses should have had CLB installed. Determining whether CLB is required in the absence of further information regarding the original truss design and the lumber grades is a complex task.

Fink roof truss 2x3 web members, no thru-truss bracing.

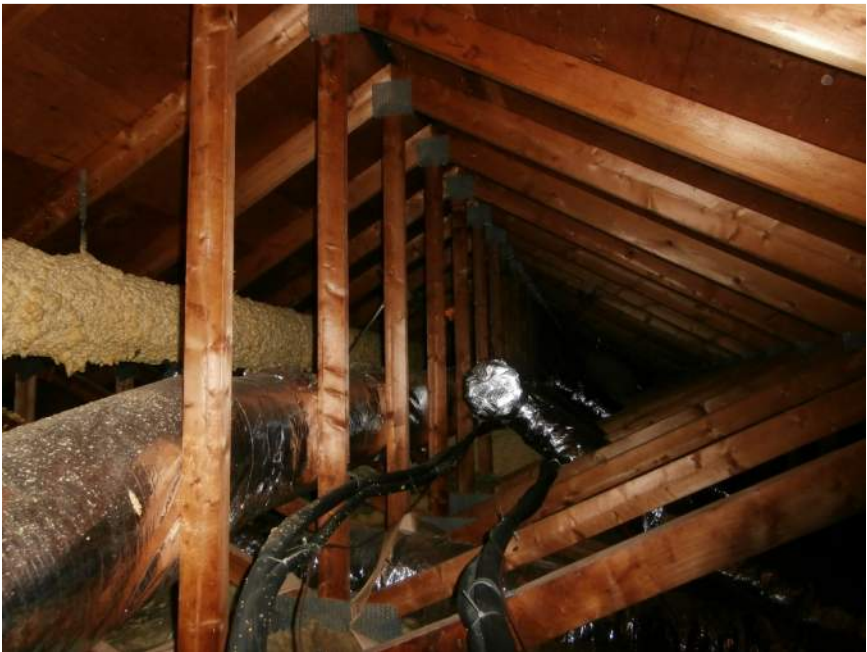
Scissor trusses – no thru-truss bracing

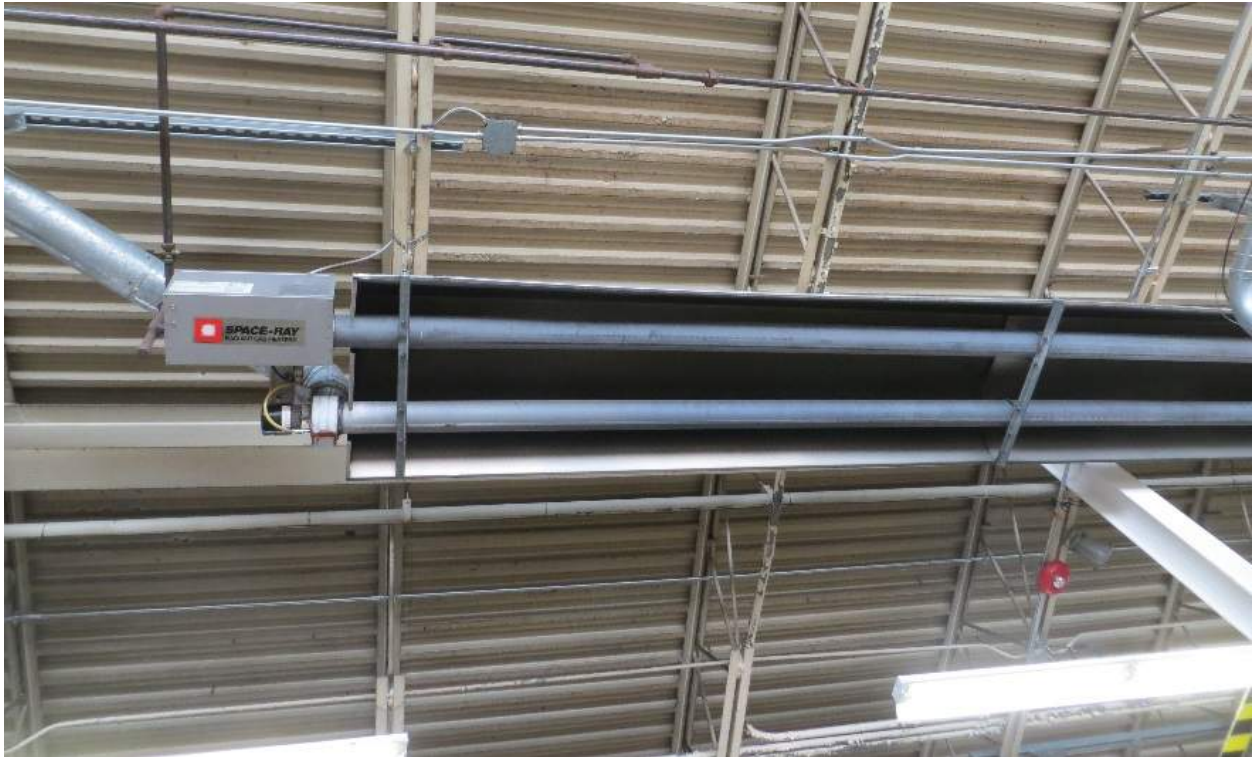
The apparatus bays for the fire and police department are heated by LP gas fired infrared tubes installed high in the bays and power vented through a common pipe out the back of the fire department truck bay. Three Space-Ray heaters rated for 130,000 BTU/hr serve the fire department. One (1) 130,000 BTU/hr heater serves the police department sally port. Heaters are controlled by an electronic wall mounted thermostat, one for each department. All reports indicate that in the 15 plus years the heaters have been installed, no issues have been noticed and the heat output is more than sufficient for the space. The heaters were observed to be in fair condition. At more than 15 years old, small signs of vent deterioration and tube pitting are starting to show. It is estimated the tubes have 5-7 years of useful life remaining before deterioration starts to warrant replacement. Additionally, residue around the vent pipe joints was observed indicating back-pressure may be allowing some products of combustion into the space.

Example of Infrared Tube Heaters

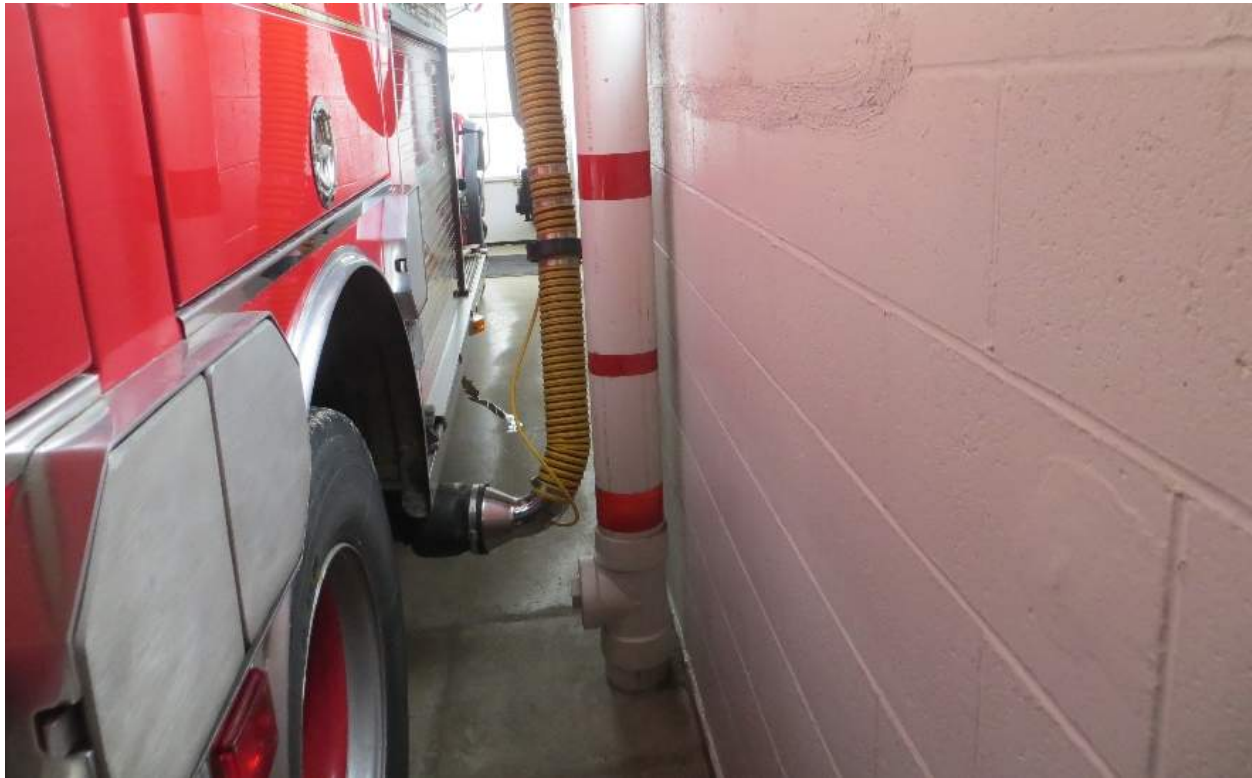
Vehicle Exhaust System Connected to Fire Truck

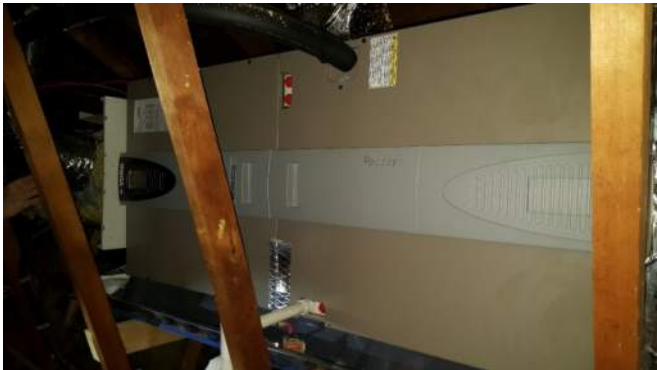
Existing Heat Pump Serving Police Department

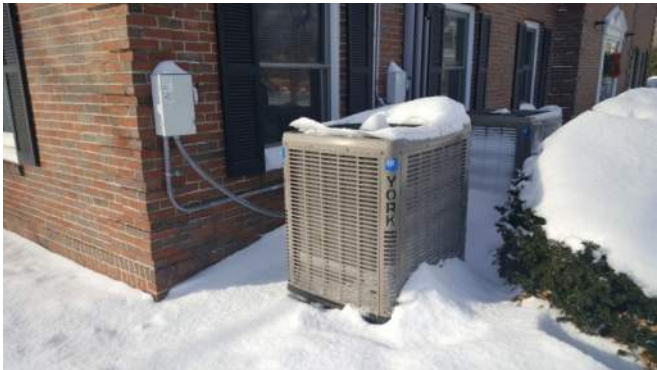
Existing Condensing Units Serving Heat Pumps

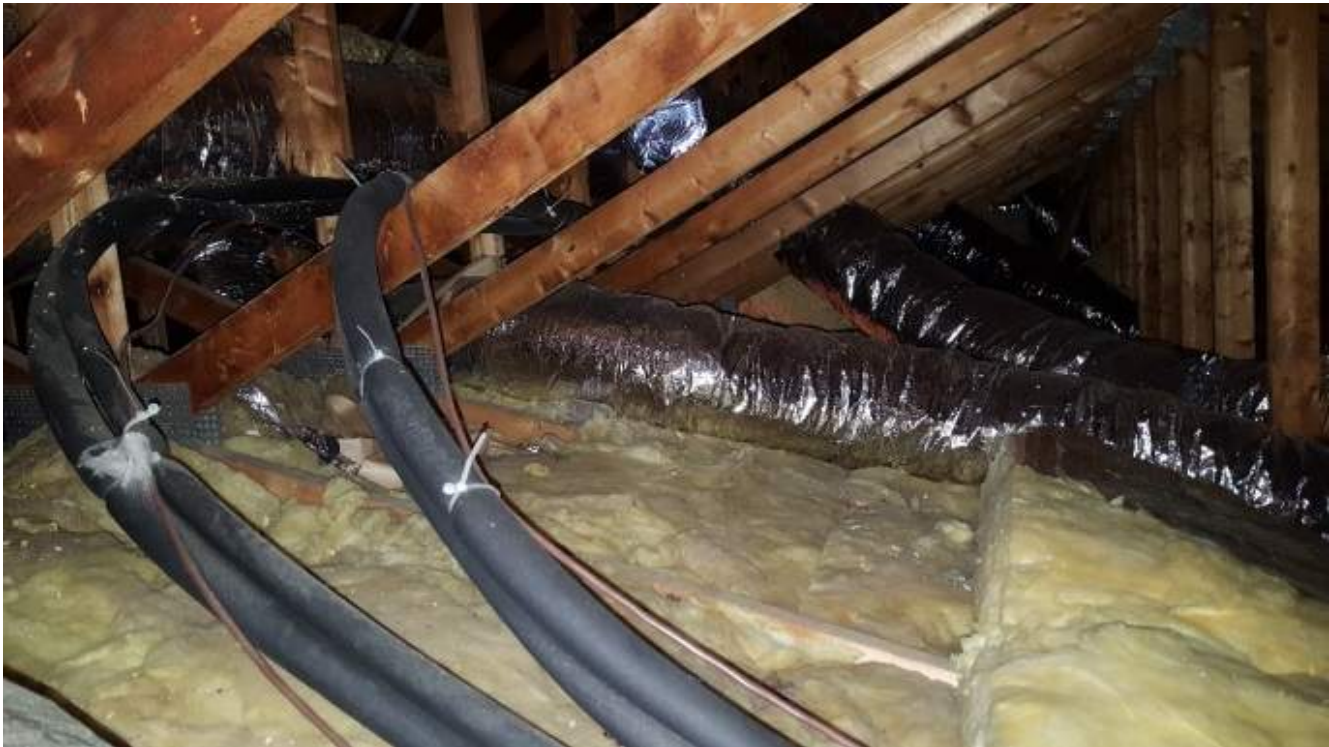
All branch ductwork in the building appeared to be insulated flex ductwork. The flex duct is in good shape, although it is kinked in some areas and most likely restricts airflow from the heat pump to some degree with long twisting runs.

Existing Ductwork in Attic

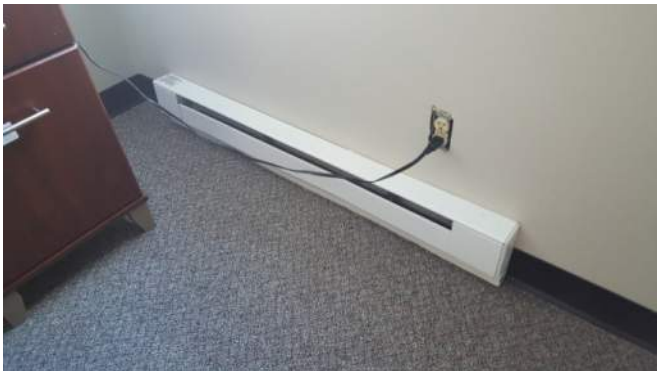
Example of Recently Installed Electric Baseboard

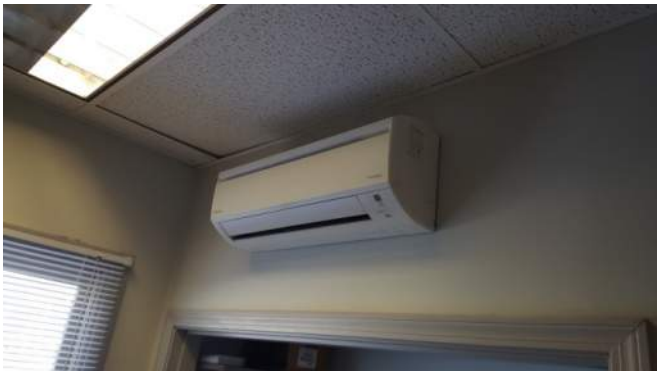
Ductless Split Serving Dispatch Room

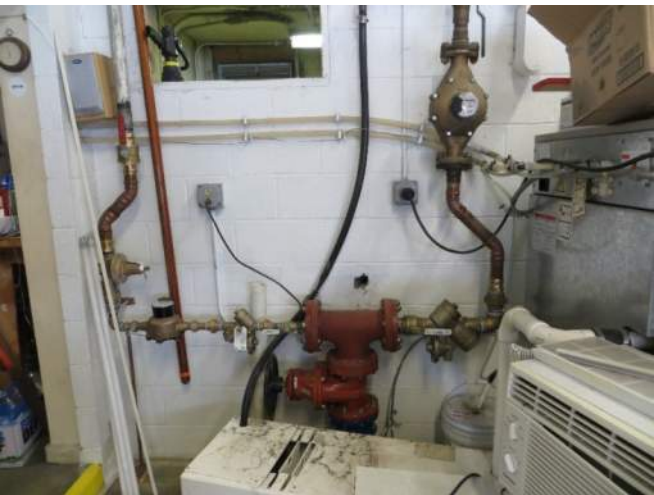
Building Water Entrance

The building water entrance lies in the apparatus bay, and begins with a 4” cast iron entrance thru the slab with a gate valve for isolation. The entrance splits into two separately metered services, a 1” metered service to the police and fire station building, and a 2” dedicated to the apparatus bays. Copper tubing is connected to existing uninsulated system and is in good condition. There is no water pressure boosting system, and the observed water pressure at fixtures was noted to be excellent.

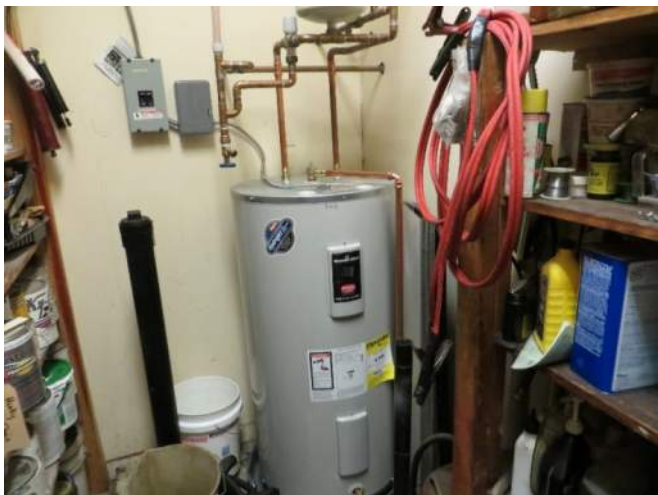
Domestic Hot Water Heater

Hot water for the entire facility is heated by a recently installed Bradford White 50 gallon electric hot water heater. Installed in 2017, the heater is in like-new condition and was noted by staff to be of sufficient capacity for the current usage. Along with the new heater, a new mixing valve and new copper tubing has been installed around the heater. The Fire Department Staff reported hot water supply and delivery time was adequate at all fixtures, indicating good pressure and relatively short runs of hot water piping. No hot water recirculation was found to be installed. While not required by the 2009 International Plumbing Code, installation of a recirculation line to fixtures furthest from the heater may further improve hot water delivery times and prevent growth of bacteria in warm stagnant pipes.

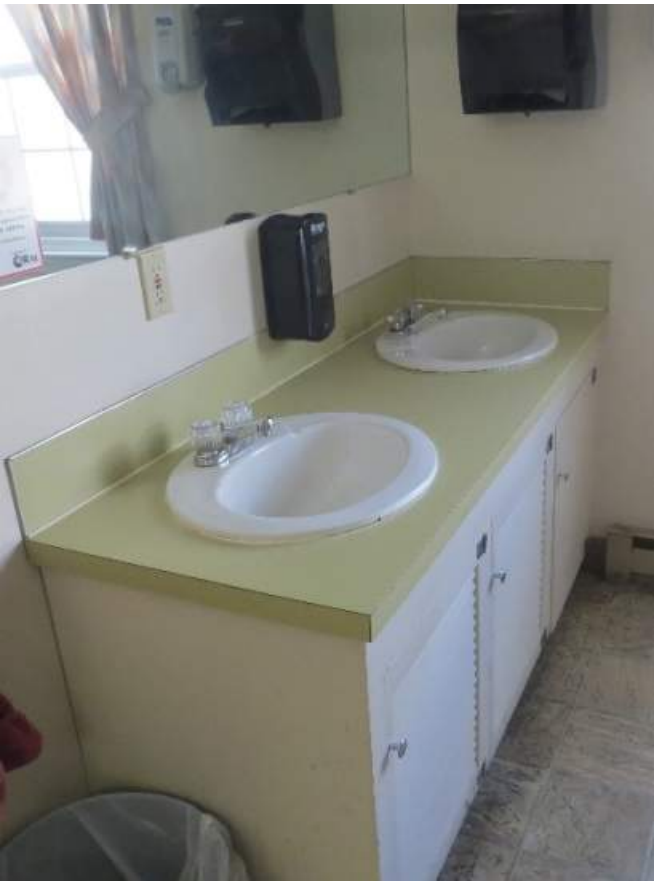
Plumbing fixtures were noted to be manual operation and of varying condition throughout the building. Lavatories are vitreous china construction of the counter or wall mount type and were observed to function properly and without leaks. Toilets are floor mount with manual Sloan Royal flush valves. Urinals are vitreous china with manual Sloan Royal flush valves. Showers were of the plastic insert type, with manual valves and non-adjustable heads. Fixtures did not appear to meet ADA standards, and are generally dated in appearance. It is recommended that all fixtures be replaced should a renovation encompass any restrooms.

Example of Existing Plumbing Fixtures

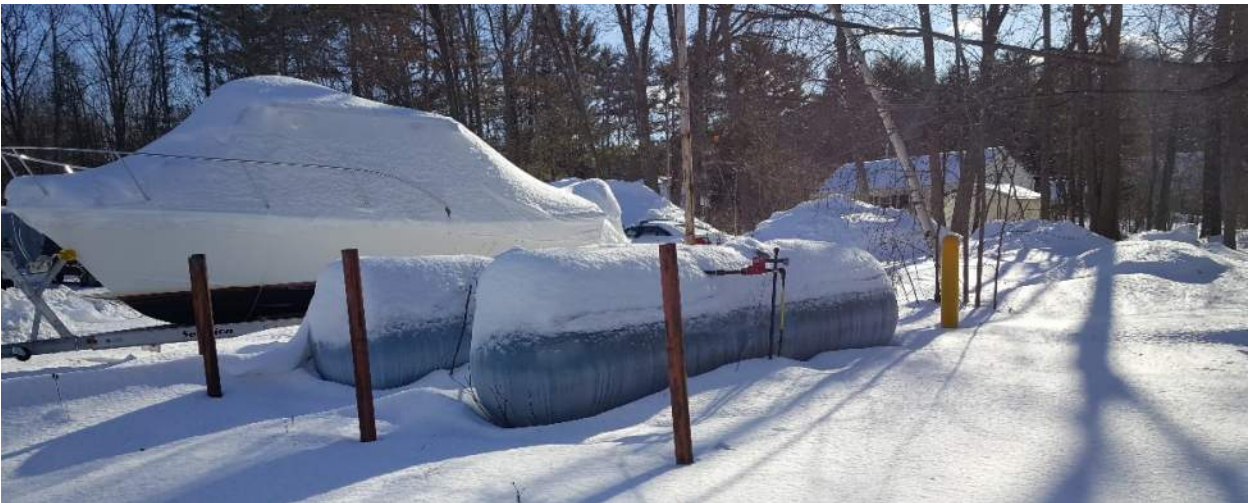
Existing LP Gas Tanks

LP Gas fired equipment in the building includes infrared tube heaters in the apparatus bay and the generator. An existing 1 ½” line formerly serving the fire and police department is capped and no longer in use. Two above grade, 1,000 gallon tanks located to the back of the site provide LP gas to all equipment. Two wall mounted regulators provide separate and dedicated low pressure LP gas to the generator and building interior. Gas piping within the building is schedule 40 steel with screwed fittings. The piping, tanks, and regulator all appear to be in good condition and no signs of deterioration were observed.

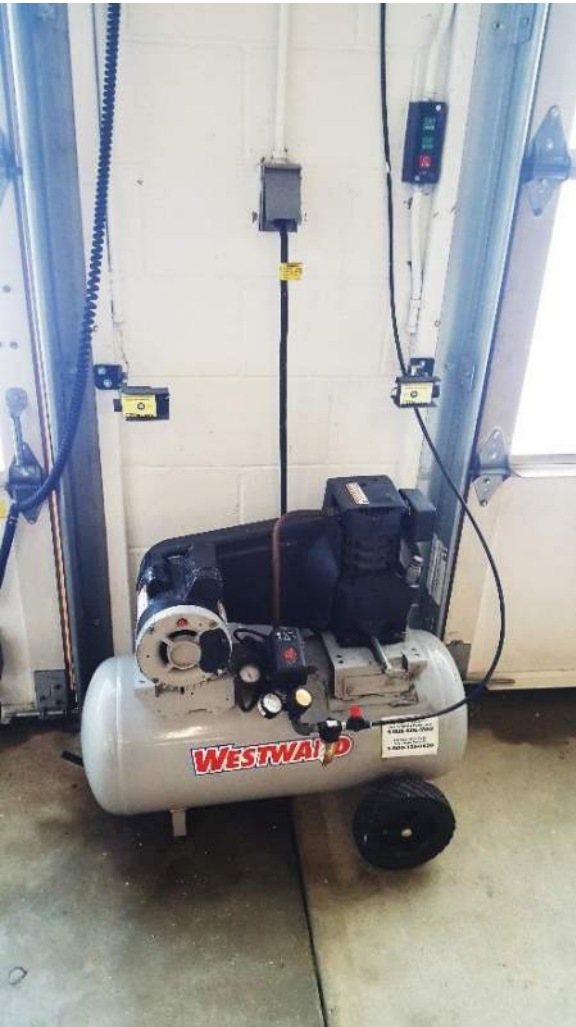
Existing Air Compressor

There are two air compressors located in the Fire Department Apparatus Bay. A 21 CFM, 60 gallon Ingersoll Rand compressor is located at the far end of the Apparatus Bay and serves the spaces general compressed air needs including filling tires. The system was reported to be sufficient for the needs of the apparatus bay and is in good condition. Given its condition and capacity the reuse of this compressor should be sufficient to handle a renovation or added space. A second compressor is located between tow overhead doors in the Fire Department Apparatus Bay and is dedicated to the Plymovent Vehicle exhaust system. The compressor is in excellent condition, and was observed to be functioning properly. The compressor is recommended to be reused if the apparatus bay is renovated.

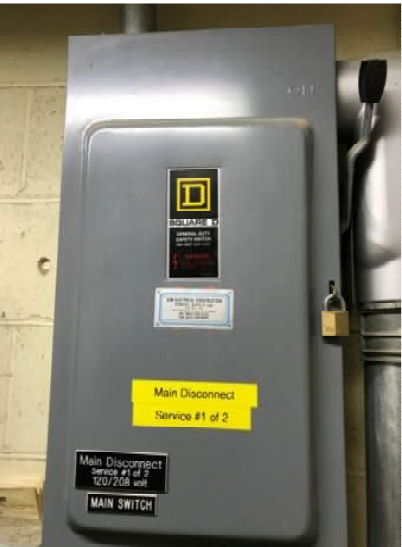
Building Electrical Service #1

It should be noted that utility demand readings are not available for evaluation, as this utility does not bill demand charges. Yeaton is unable to assess the actual service capacity without costly third party testing and chart recording metering. We feel comfortable with our recommendation for a new single three phase service upgrade as noted.

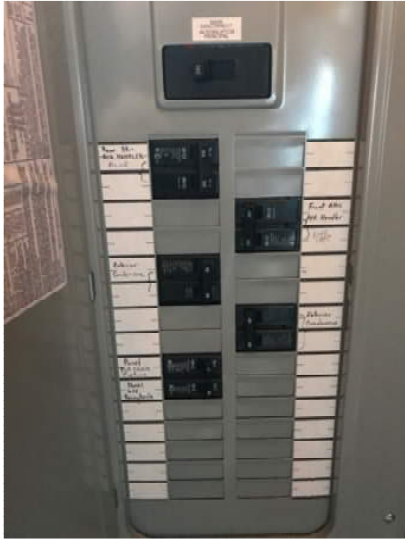
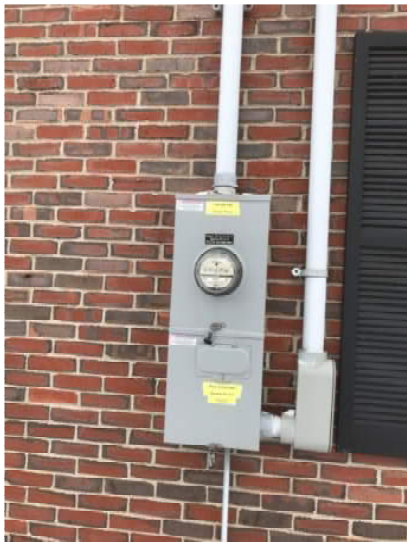
Building Electrical Service #2 is the fairly new overhead electrical service which terminates in the building attic to serve heating and air conditioning equipment. This service is installed as a 200 ampere, single phase at 120/240 volts, fed with overhead utility conductors to an outdoor meter/disconnect. The service disconnecting means is clearly labeled. From this service meter/disconnect, it travels vertically up the outside of the building to a panelboard in the attic. As part of any major renovations to the building, we would recommend removing this single phase service and combining the two electrical services as one, as described in the previous paragraph.

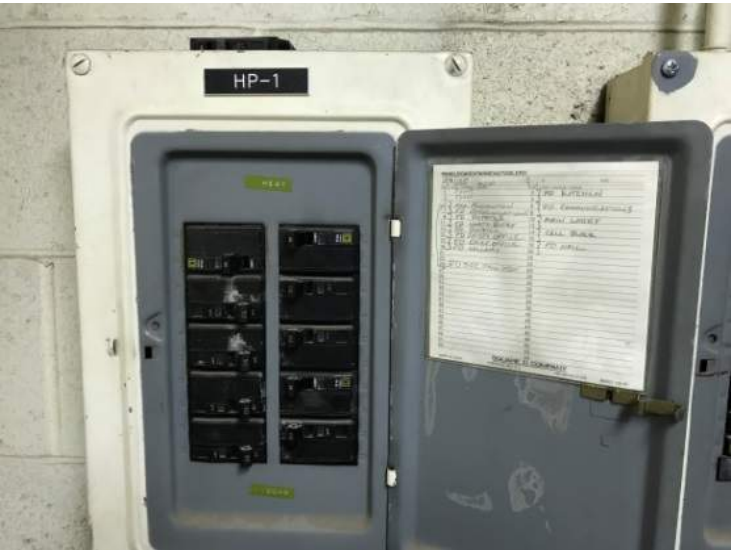
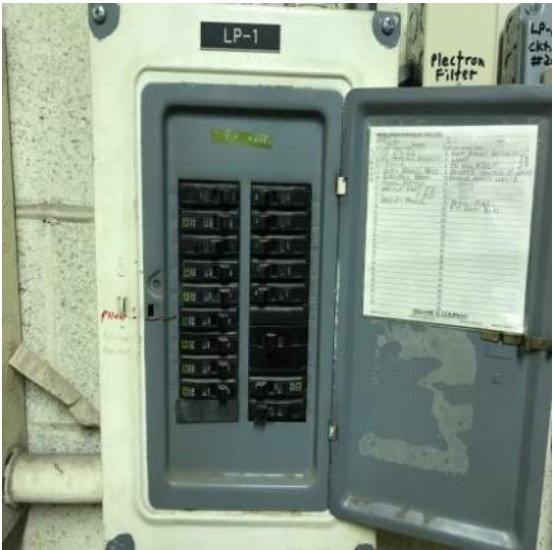
Circuit Breaker Panelboards appear to be original and are installed as residential style load centers, fed from the main distribution panel described in the Building Electrical Service #1. There appears to be five lighting and plug load panels, and two heating panels. As part of any major renovations to the building, we would recommend replacing all of these residential load centers with new commercial rated panelboards.

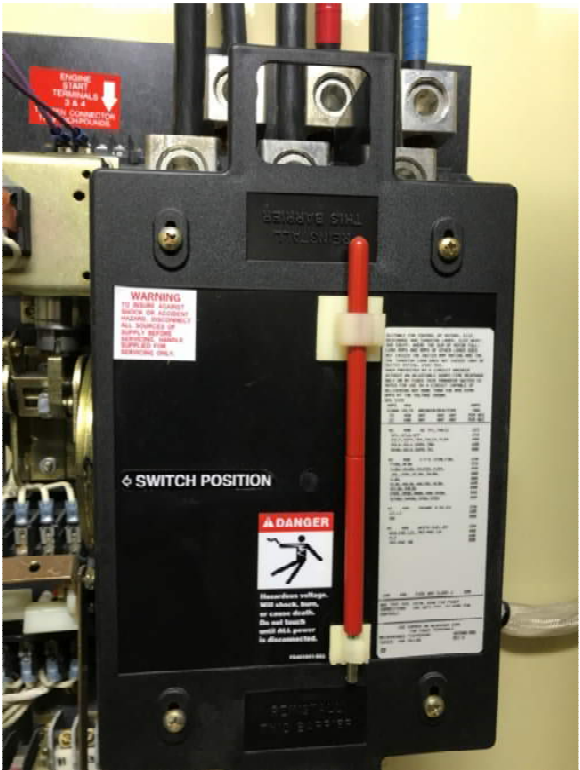
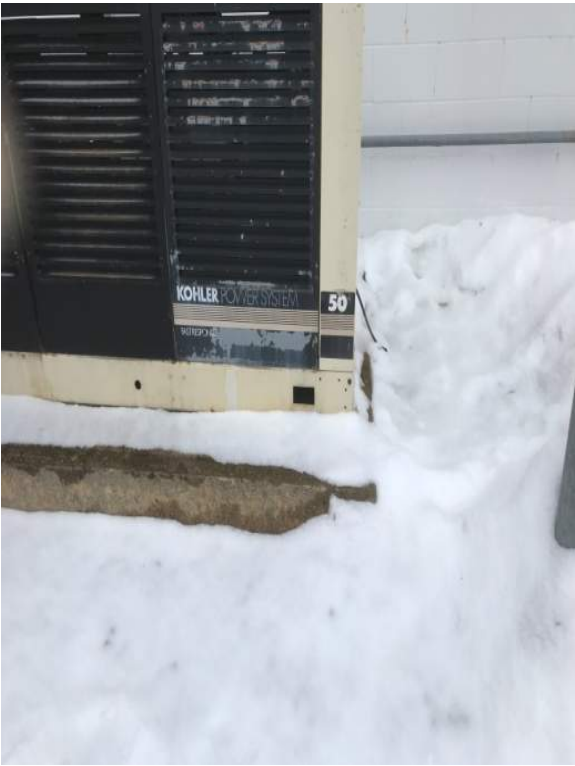
Standby Power Systems

The existing three phase electrical service #1 is supported by a propane fueled emergency generator and 200 ampere transfer switch. The existing outdoor rated generator is a Kohler 50 KW machine, which is good for 173 amperes at 208 volt three phase. This generator size compliments the existing 200 ampere service and present demand. We would recommend no changes to this system, short of reconfiguration of the non-code compliant emergency lighting system wiring down-stream of the transfer switch. If the owners desire addition standby power to support air conditioning systems, then consideration should be given to replacing this generator and transfer switch to a 100 KW machine to compliment a 400 ampere building service solution.

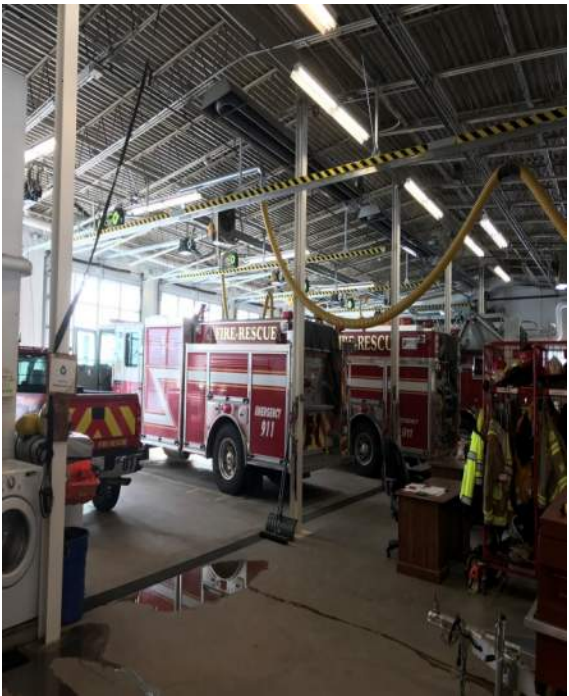
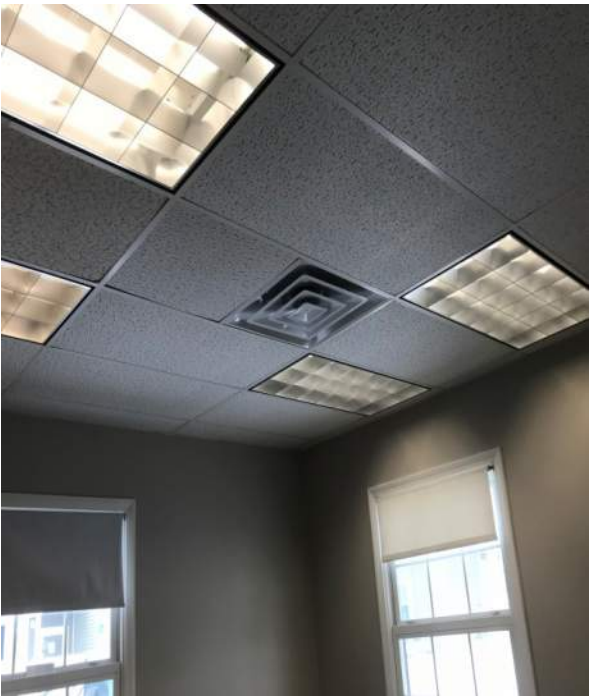
Lighting and Emergency Light

The building lighting systems are a mix of compact and linear T8 fluorescent, incandescent and some recently installed LED. Recessed lighting is linear fluorescent parabolic louver product with T5 HO linear strip lights in the apparatus bay. As part of any major renovations to the building, we would recommend changing all of the lighting to LED product to gain performance, energy savings and eliminate lamp changes. Consideration could be given to keeping the more recently installed apparatus bay lighting intact and adding like product to accommodate any bump out addition to the truck bays.

Code Compliant Emergency Lighting for the building is non-existent and is provided basically from normally powered lighting products and exit signs, wired and powered thru the standby generator power system and its transfer switch. The existing standby generator picks up the entire Building Electrical Service #1 thru this transfer switch. NFPA 70 and 101 require UL 1008 and UL 924 listed transfer equipment and shunt devices, in order to allow connection to a standby generator source. As part of any major renovations to the building we would recommend the installation of Code Compliant UL 1008 devices and distribution to pick up those lighting systems needed to provide illumination of the path of egress, exit access and to the exit public way. An alternate means to provide code compliant emergency lighting would be to install self- contained, battery powered emergency lighting units and exit signage, wired to the unswitched lighting circuits serving the paths of egress. The building is presently in violation of NFPA 70 and NFPA 101 from a life safety standpoint as the lighting system wiring is shared with other non-life safety circuits, and not separated or controlled in terms of UL 1008 and UL 924.

Technology what it is today would suggest that LED lighting be installed to replace existing, where substantial renovations are programmed. There are value added rebates and incentives from the electric utility, to defray some of the cost associated with these upgrades. The LED upgrades are recommended to eliminate the need for replacement lamp stock and the labor to install them as they burn-out. The LED lighting systems have no lamps to replace, and have expected life beyond 60,000 hours, which equates to 15 years at 4000 hours per year. Even after 15 years the lighting will still be operating, but only producing 90% of the initial rated lumens. There is energy savings and maintenance savings associated with replacing the existing fluorescent lighting systems with LED.

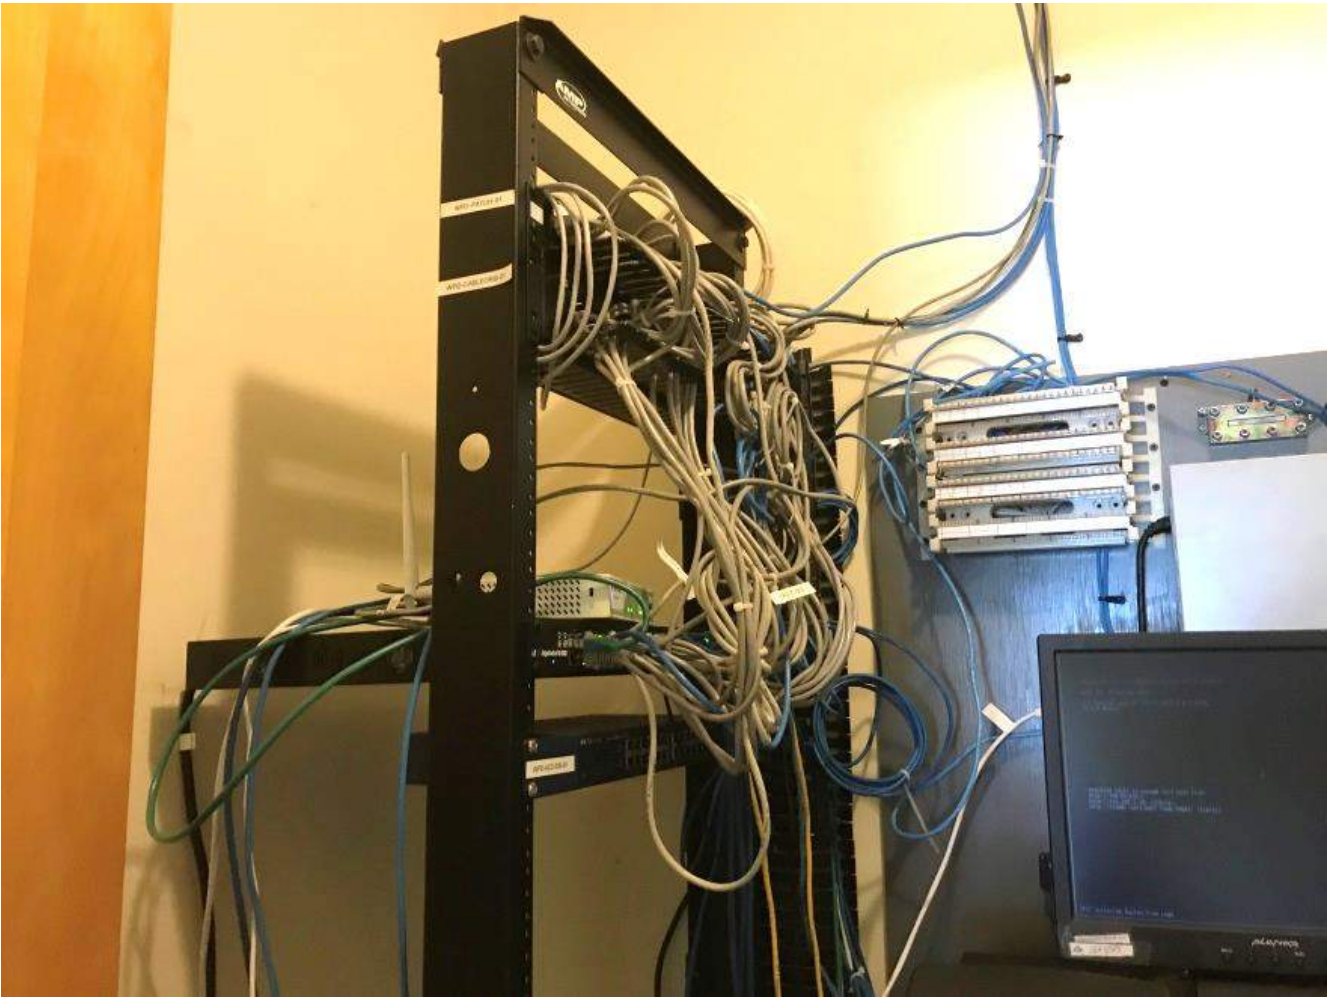
Connectivity Systems – Voice/Data

Existing connectively appears to be in good shape. We would suggest that review of these elements is subjective, as tenants traditionally make changes to their spaces to accommodate their needs, associated with technology, internet speeds and overall support of their spaces. In general, there is access to the outside world thru existing conduit systems. We recommend no changes to this system, short of expansion and cabling associated with renovations and additions.
