Town of Wolfeboro  
Public Safety Building

Feasibility Study Final Report  
August 8,2018

# EXISTING FACILITY CONDITIONS ASSESSMENT

WOLFEBORO PUBLIC SAFETY BUILDING - EXISTING CONDITIONS ASSESSMENT

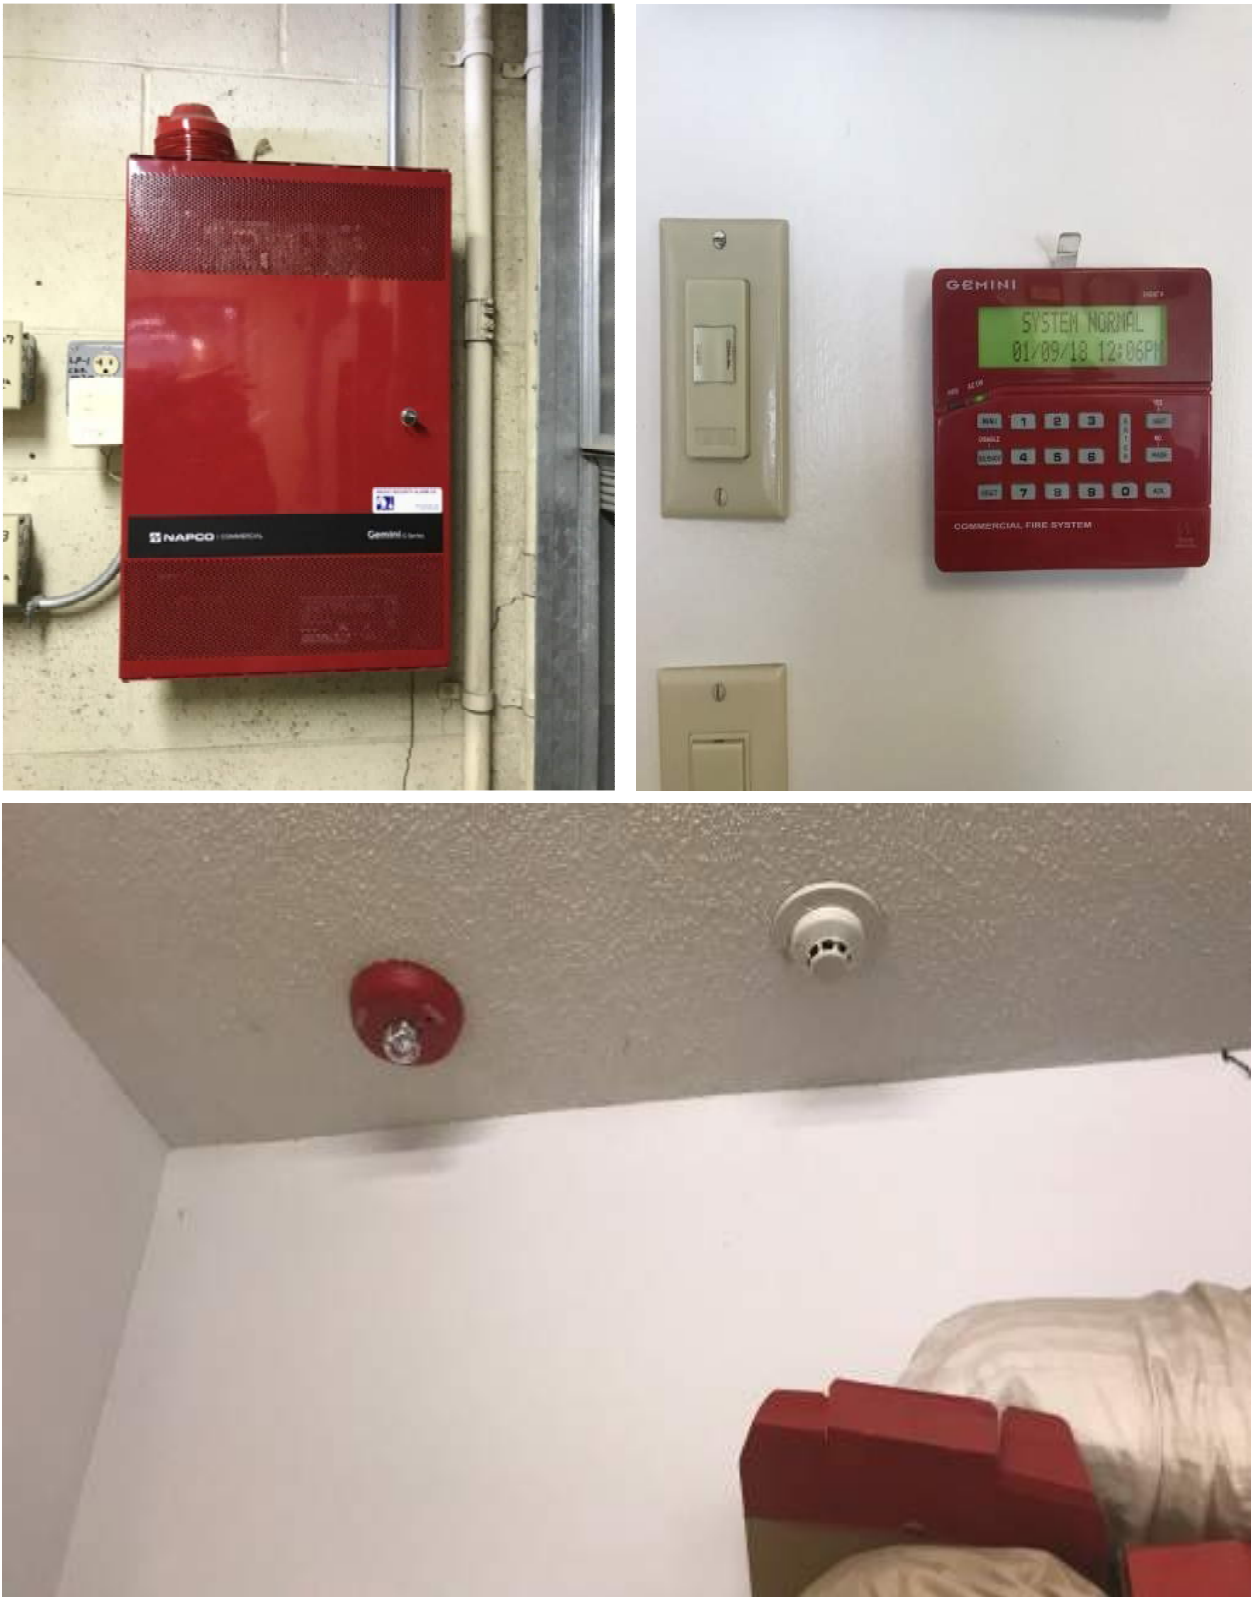
Fire Alarm Systems

The existing Fire Alarm System is presently supported by a recent vintage, addressable Napco Fire Wolf Fire Alarm Control Panel, with two indoor remote annunciators located in each of the fire and police dispatch rooms. The system has Horn/Strobe notification with full detection as the building is not sprinklered. There are a mixture of spot smoke and heat sensors to provide full coverage. The system appears to be monitoring conventional, non-addressable initiation devices which were installed from a previous system. The system is fully expandable. We recommend no changes to this system, short of expansion associated with renovations and additions.
