Feasibility Study

Conversion of the Wolfeboro Municipal Electric Department
Former Power Plant to a Community Center
22 Lehner Street, Wolfeboro

MARCH 18, 2022

Feasibility Study
Conversion of the Municipal Electrical Department former Power Plant to a Community Center
22 Lehner Street
Wolfeboro, New Hampshire

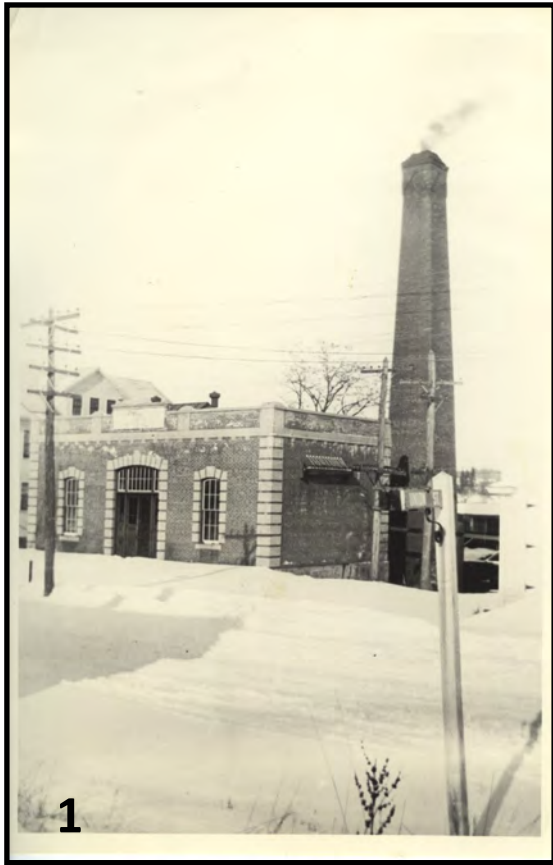
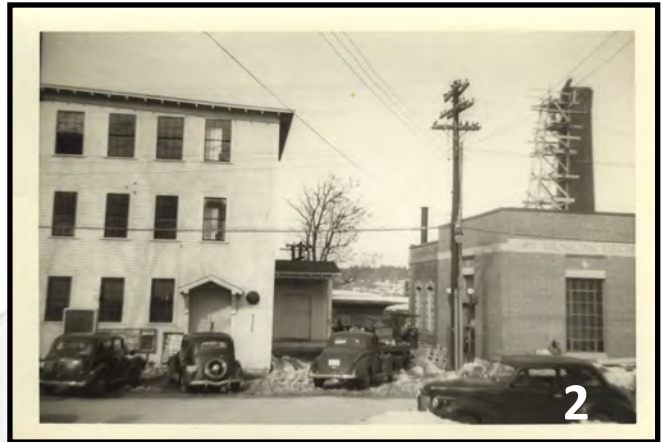
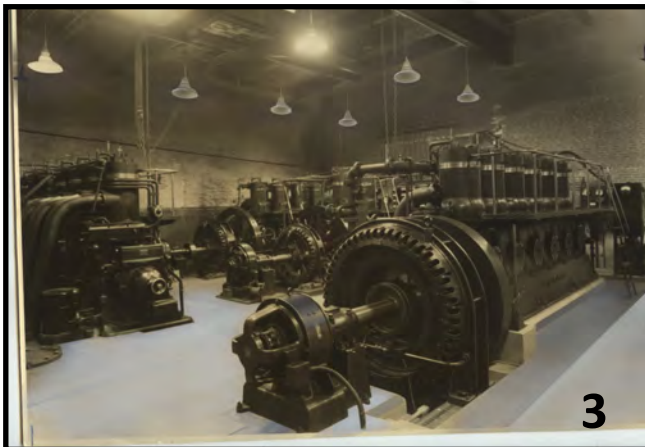
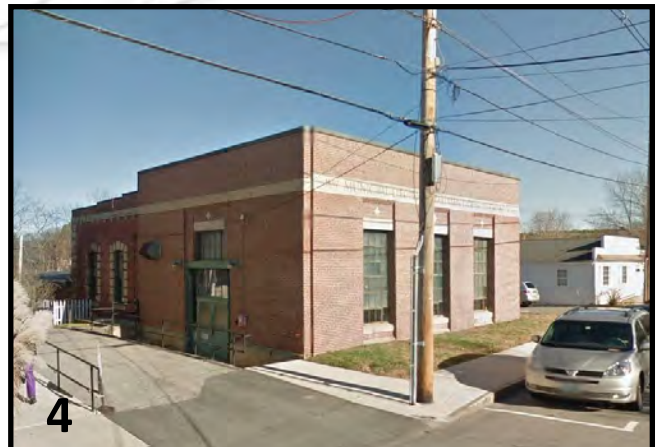
Photos From Left: 1. "Municipal Power Plant on Factory Street (now Lehner St.), 1897." - Wolfeboro Historical Society Website ; 2. "Viewed from Factory Street is the Electric Department building in spring, 1945 " - Wolfeboro Historical Society Website; 3. "The interior of the Electric Power Plant on Factory St. (now Lehner St.), c. 1945, after the new diesel generator has been installed." - Wolfeboro Historical Society Website; 4. View of the south and west side of the building as it exists today

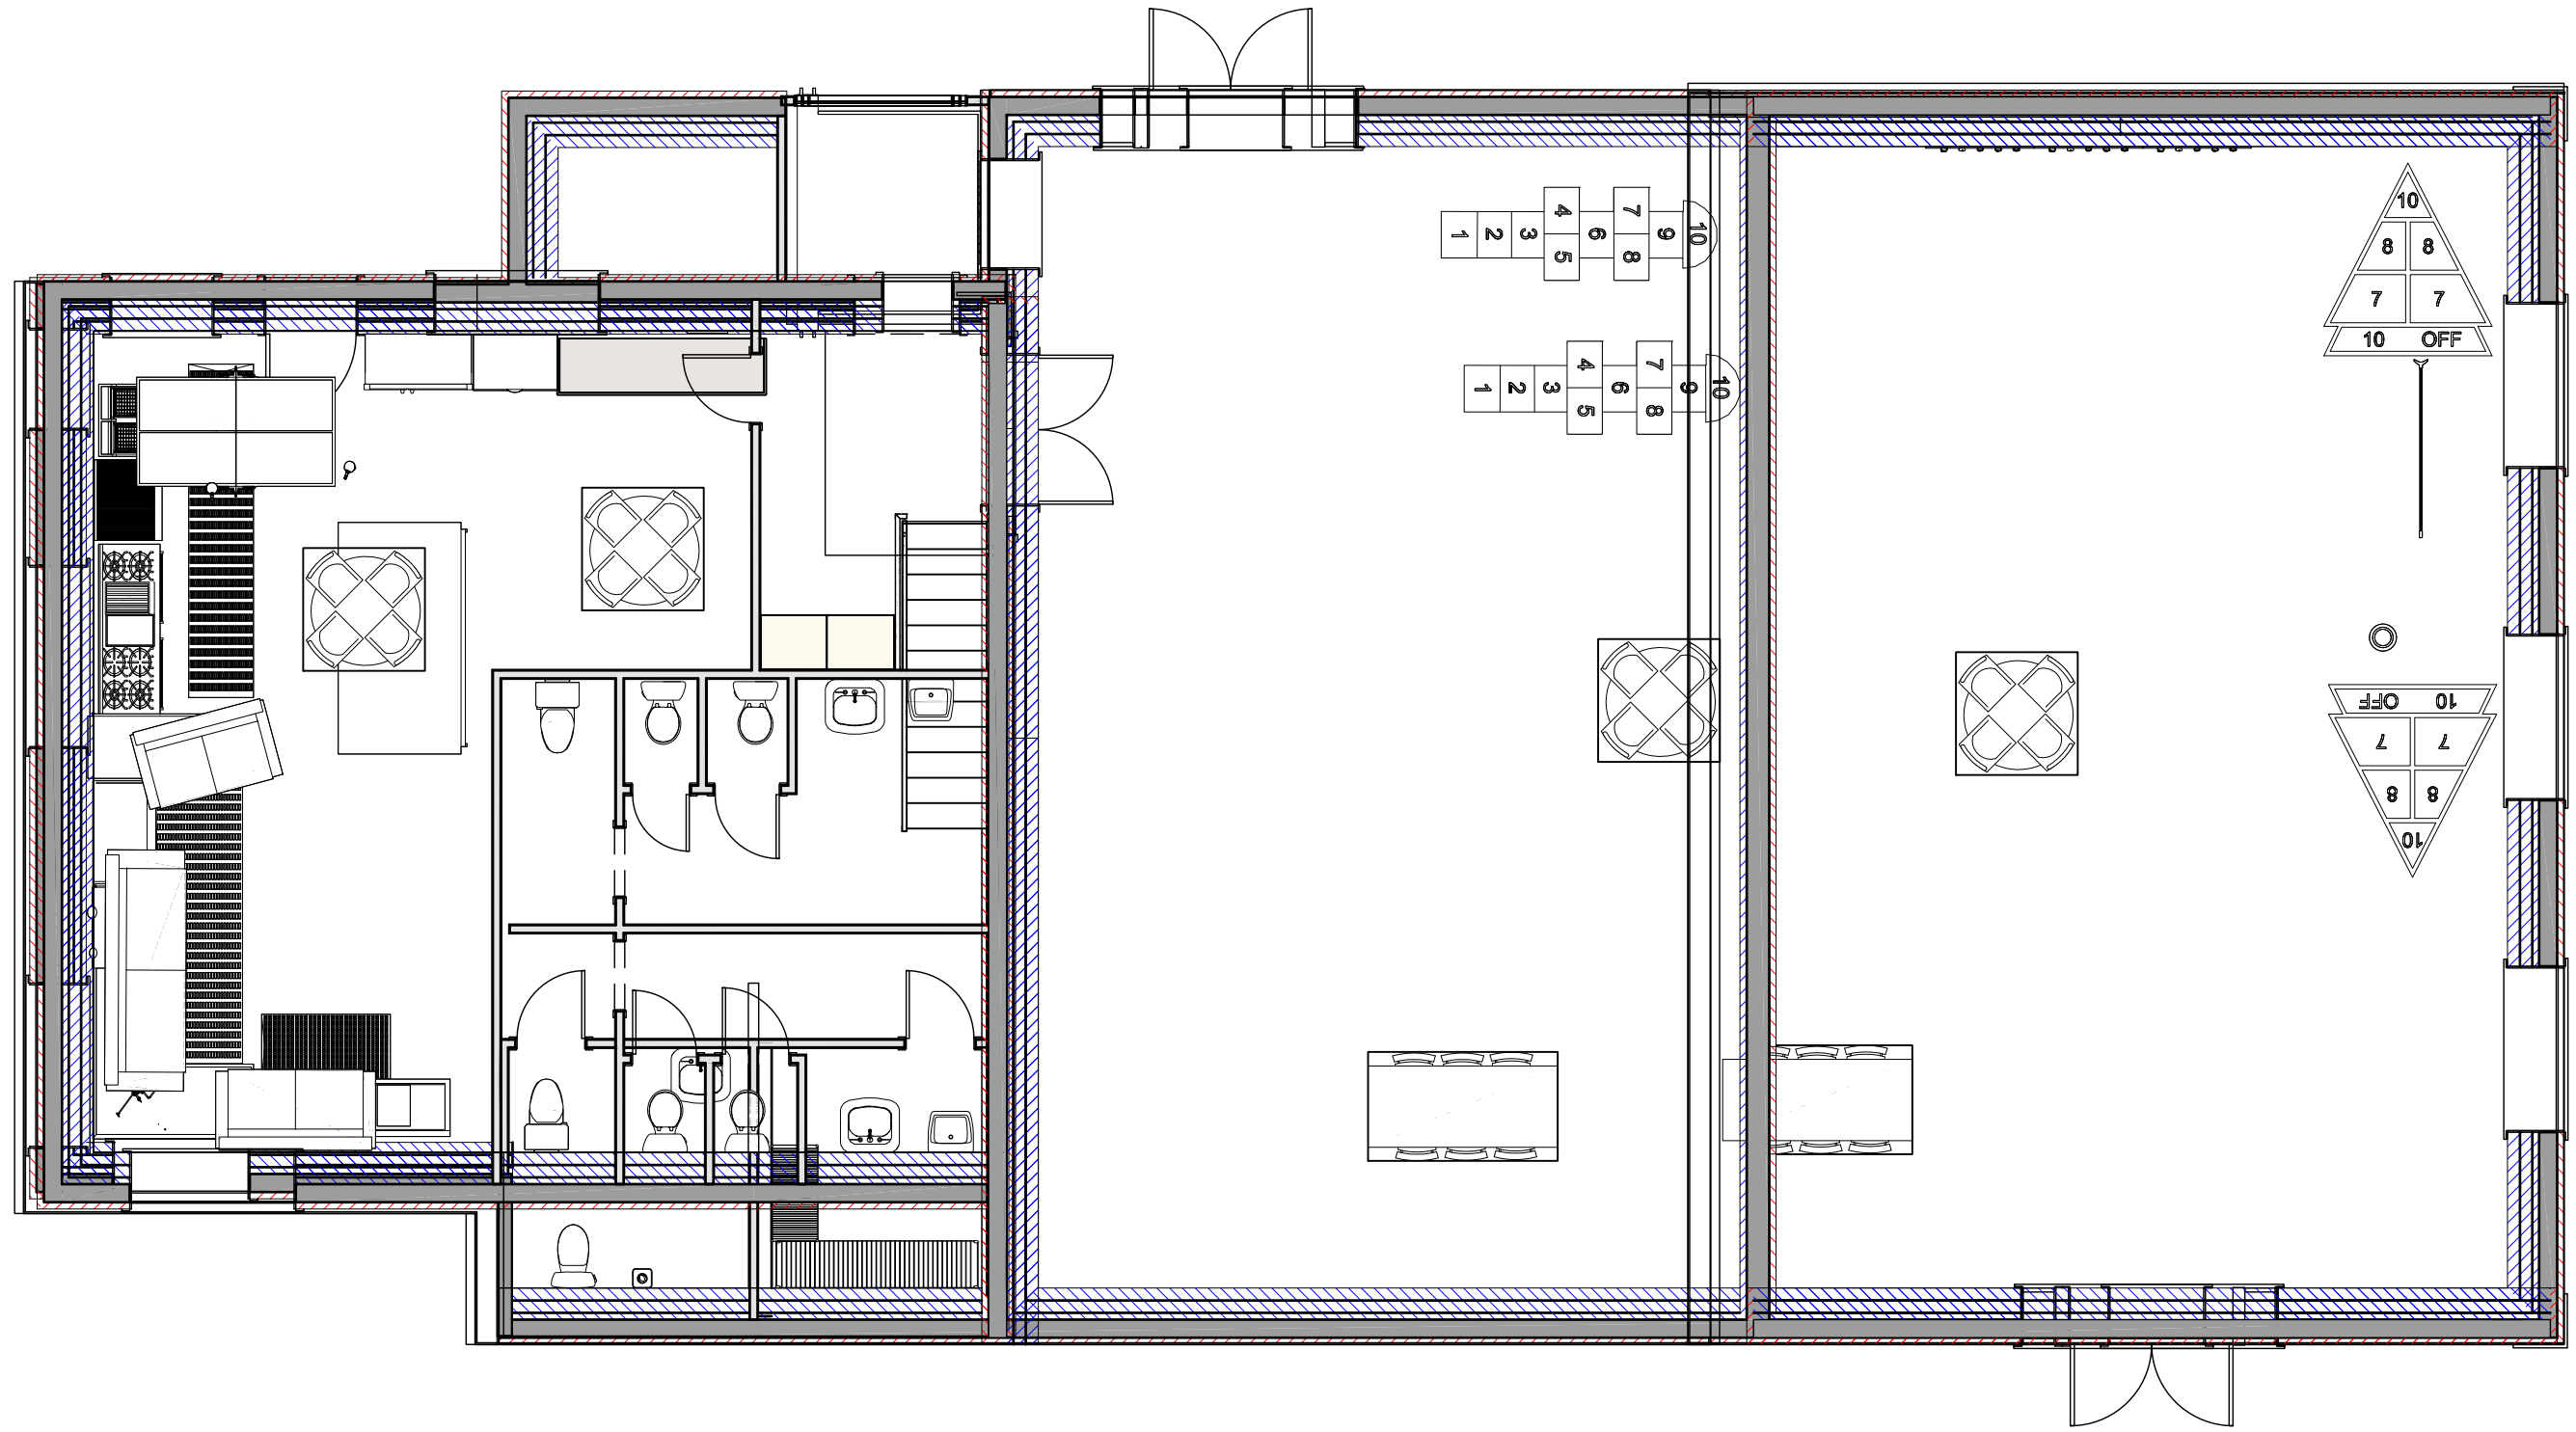
Conceptual Floor Plan for 22 Lehnner Street Community Center

changes to the building, such as an increase in loading to the floor to support additional structure or an increase of calculated occupant load, additional or heavier materials added to the roof structure, installation of heavy equipment, or other load increases. The conceptual plans provided to Bergeron Technical Services for this project indicate a possible second story being added to the north section of the building. Any additional stories would require that all elements affected by the addition of this second floor to comply with the (new construction) structural requirements of the IBC.
