Technical Memorandum

Date: March 14, 2019 (Draft); September 30, 2019 (Final)
Subject: **WOLFEBORO 2018 I/I TV INSPECTION SUMMARY**

Wolfeboro 2018 I/I TV Inspection Summary
March 14, 2019 (Draft) ; September 30, 2019 (Final)

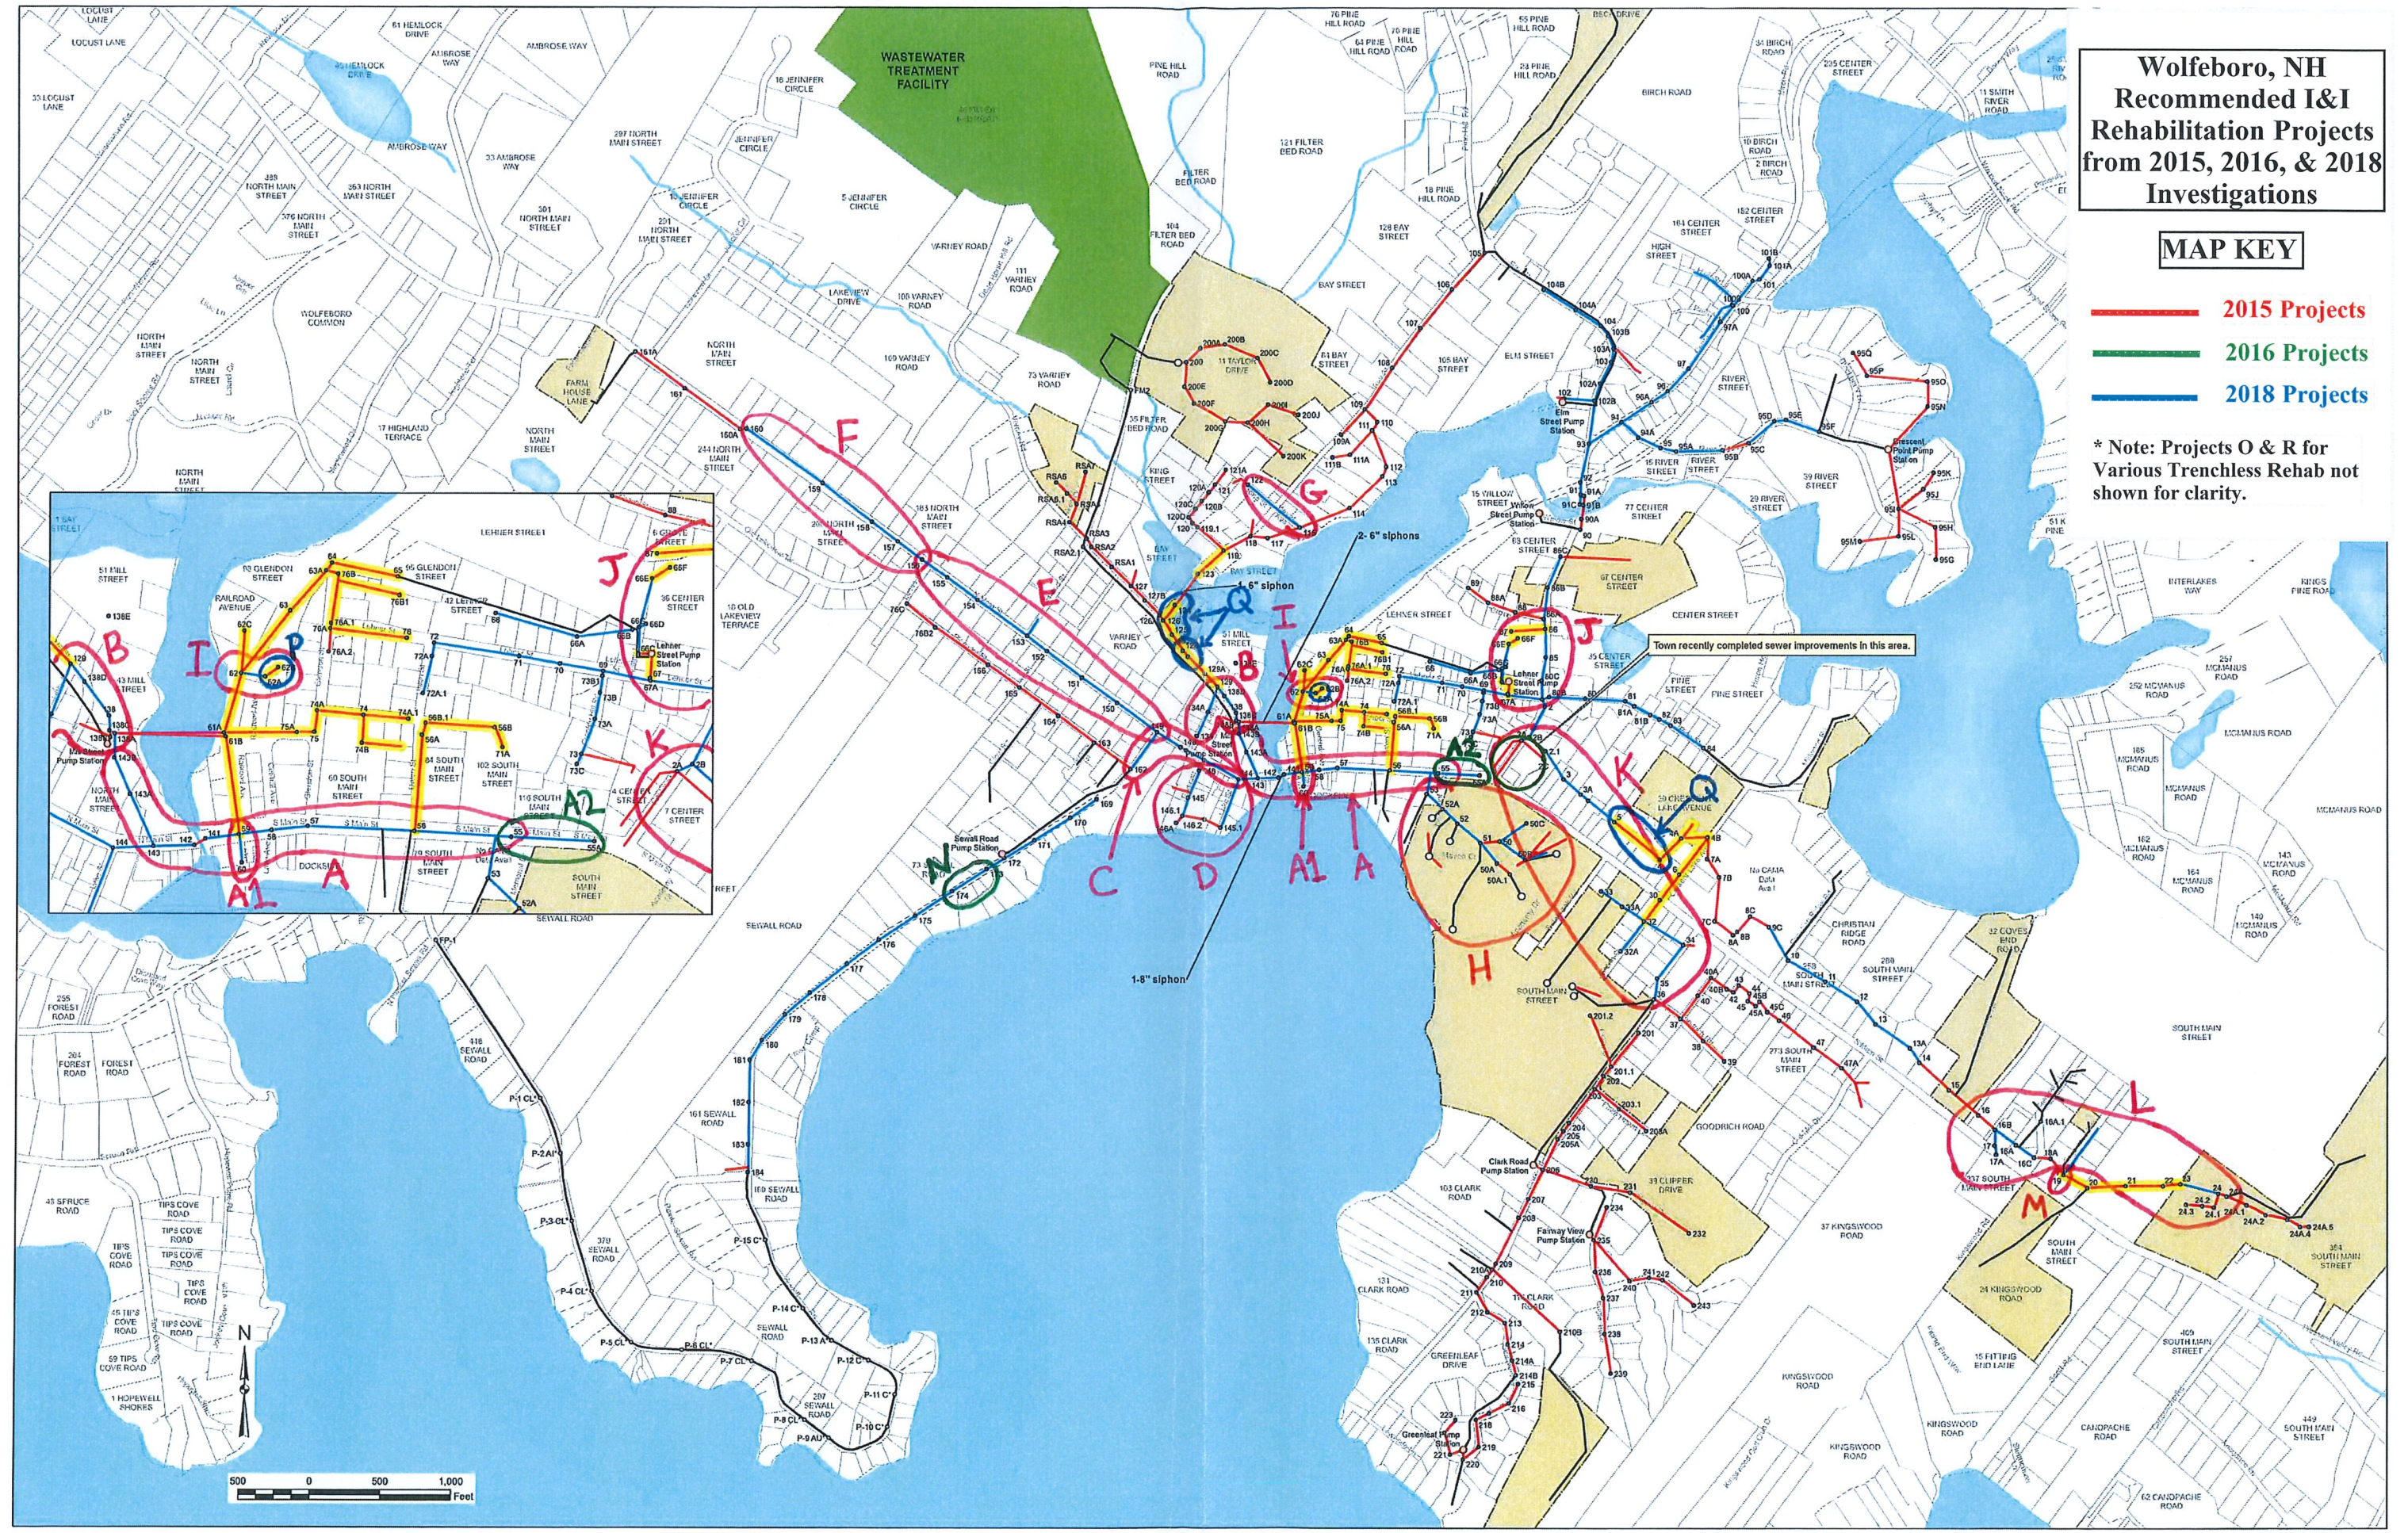
Wolfeboro, NH Recommended I&I Rehabilitation Projects from 2015, 2016, & 2018 Investigations

- 2015 Projects
- 2016 Projects
- 2018 Projects

* Note: Projects O & R for Various Trenchless Rehab not shown for clarity.
