Storm Water System Asset Management Program Wolfeboro, New Hampshire

January 2019

2321.02

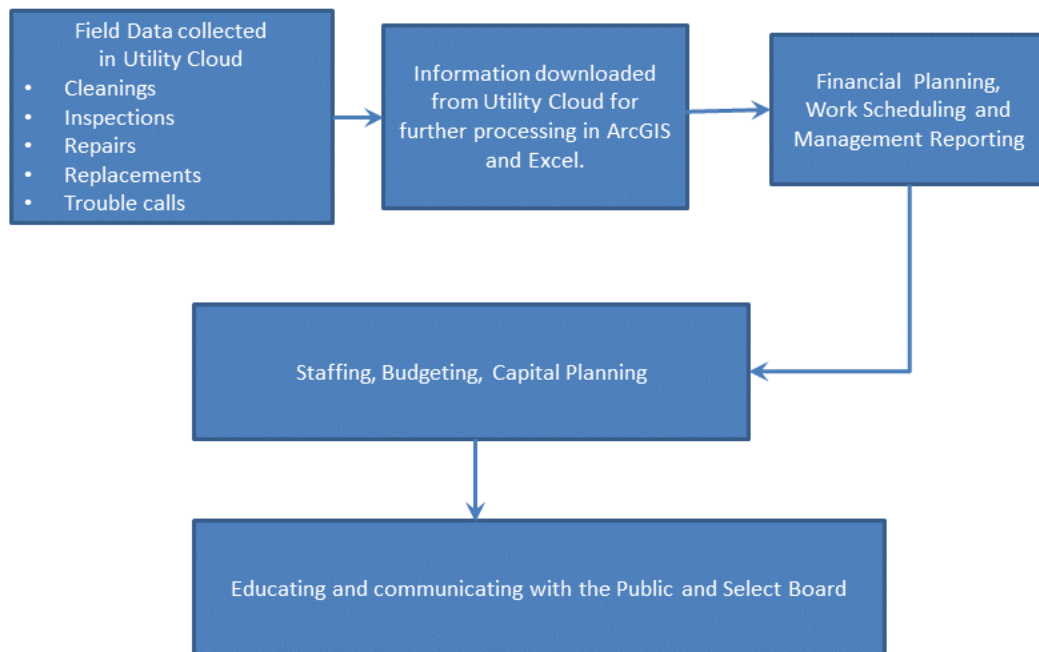
Figure 3. Information Flow Chart

The Town has assembled a great deal of data regarding its water distribution system, wastewater collection system, and now its storm water system. Because of ongoing inspections and evaluations, there is a significant amount of information available regarding the condition of the assets. However, accessing the data and keeping it up-to-date remains a challenge.

See Figure 3 for an information flow chart.
